LINCOLN COUNTY - WASHINGTON

ADA TRANSITION PLAN

FOR COMPLIANCE WITH THE AMERICANS WITH DISABILITIES ACT (ADA)

March 9, 2019

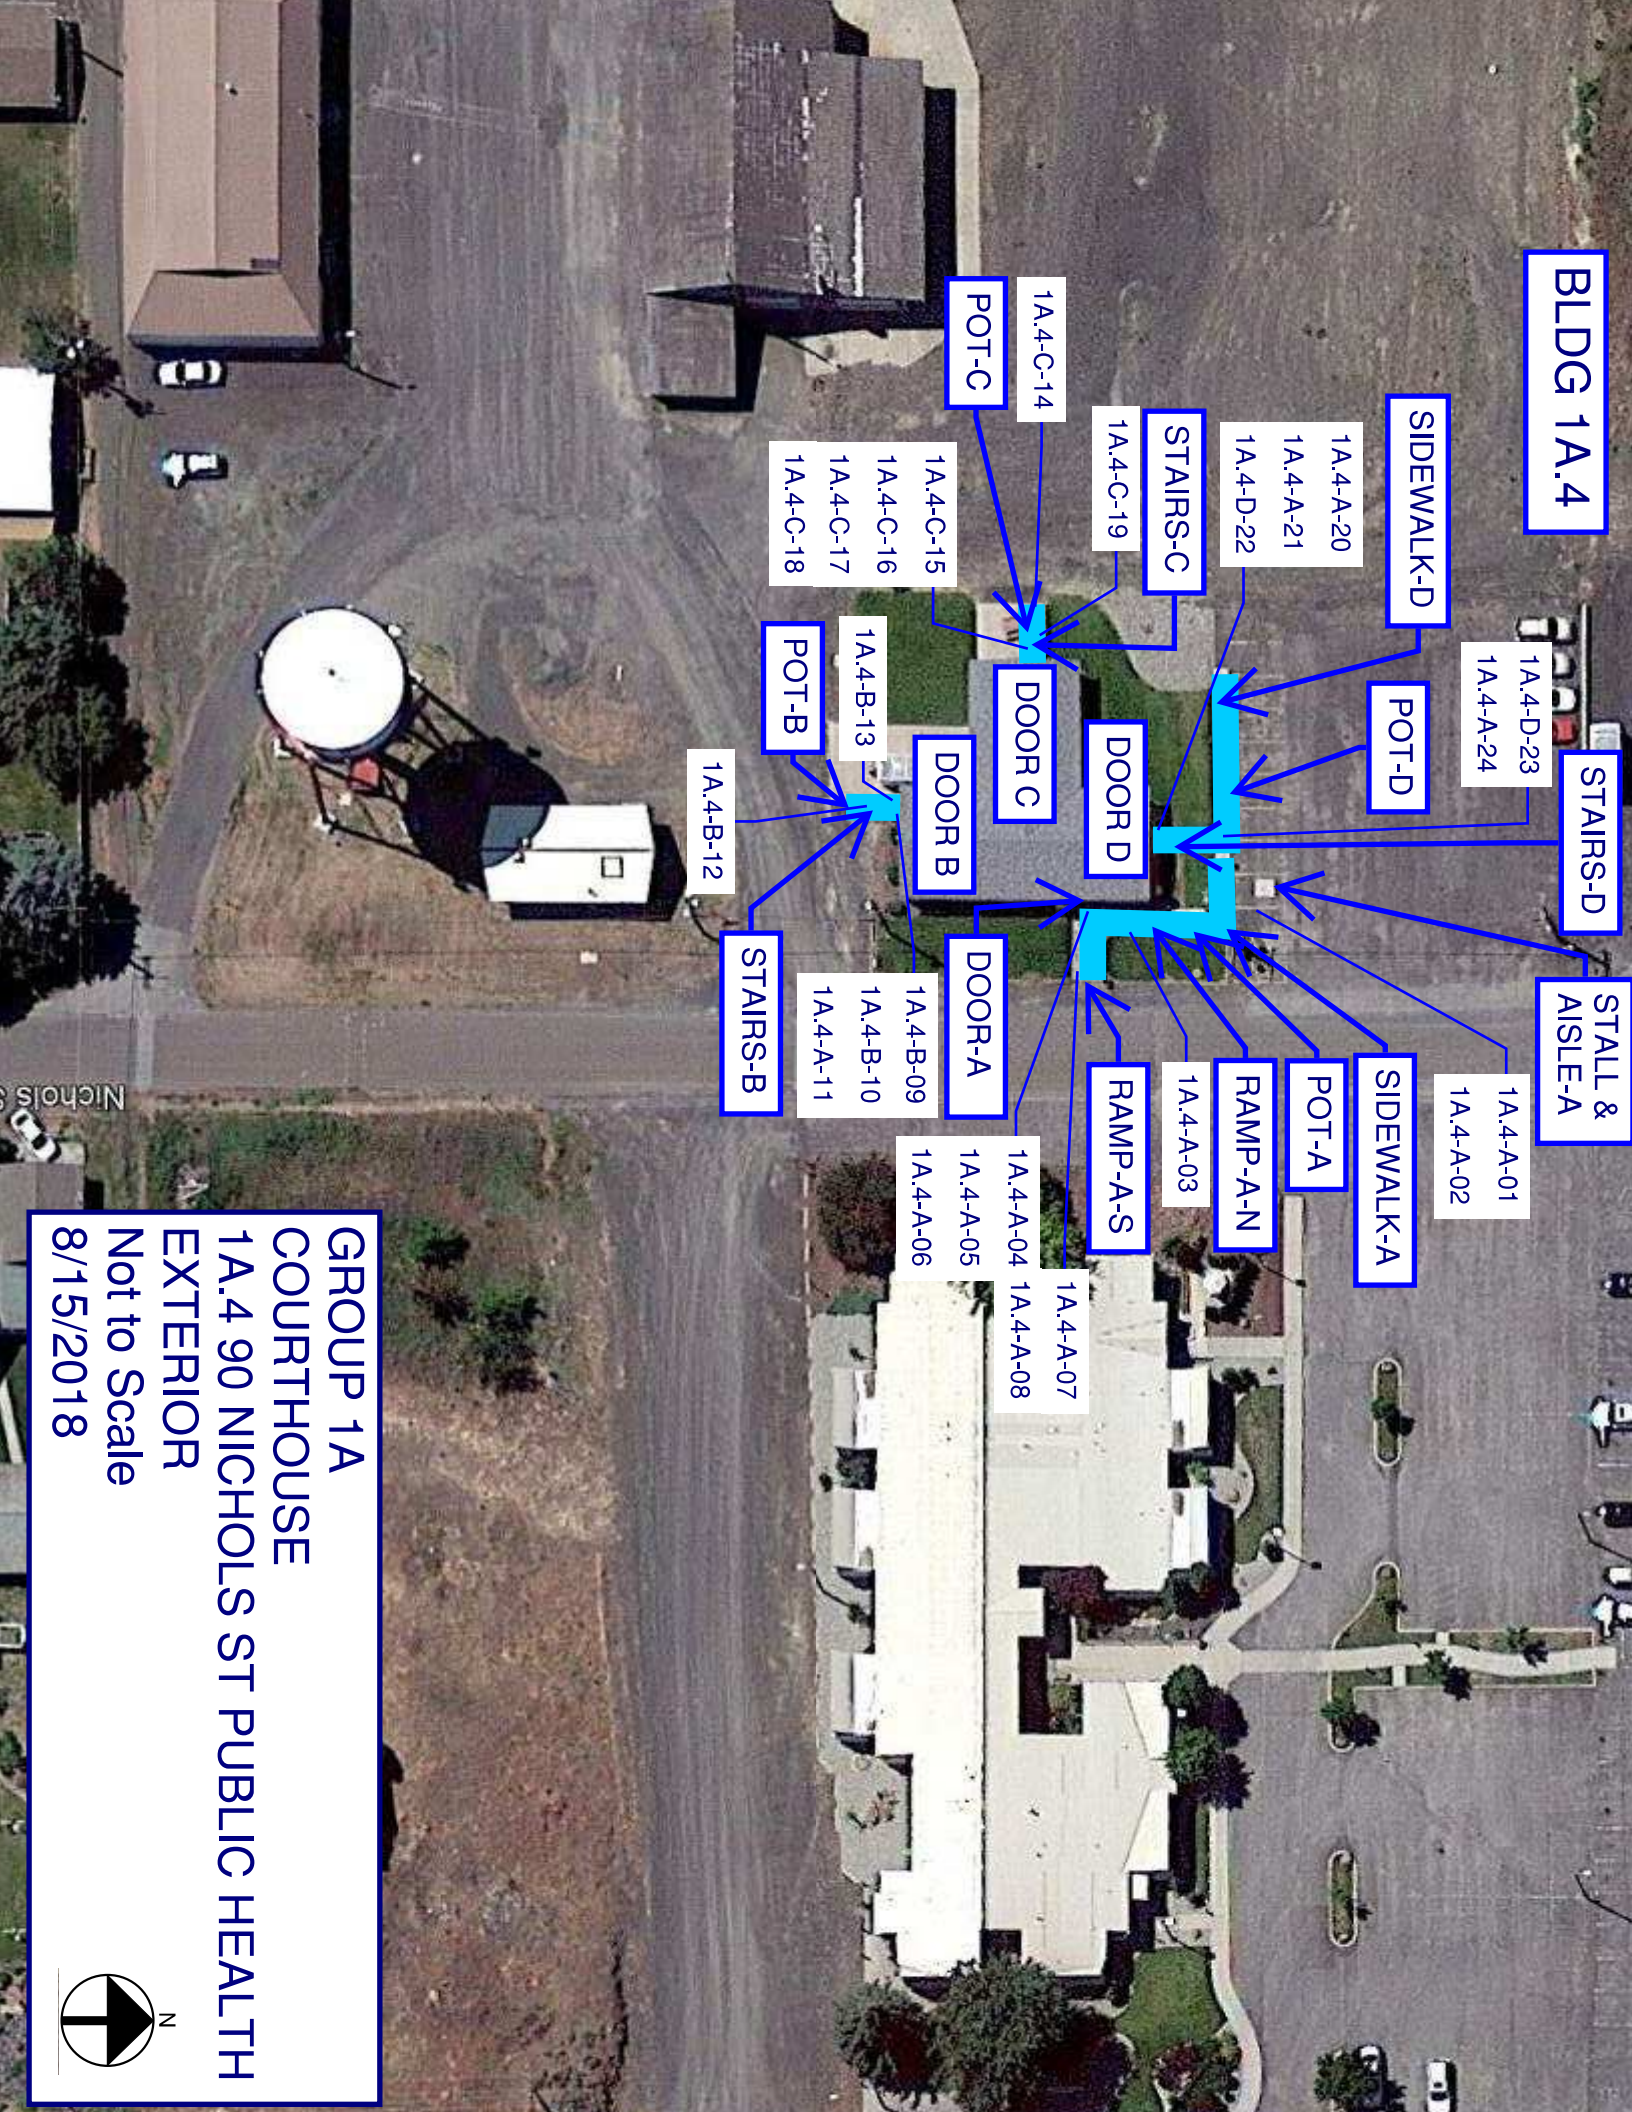
BLDG 1A.4

1A.04 - 1 - 014	Break Room	Soap Dispenser	too high		2010 ADA 308: 48" max above floor, 46" max at obstructed reach ranges	relocate	
1A.04 - 1 - 015	n/a	Windows	operable parts too high		2010 ADA 308: 48" max above floor to operable parts	replace windows or relocate operable hardware to within reach range	
1A.04 - 1 - 016	Corridor	Paper Trays	too high		2010 ADA 308: 48" max	relocate, 48" max to top of items to be removed (depth of contain)	
1A.04 - 1 - 017	Labs	Door	maneuvering clearance too small		2010 ADA 404.2.4: 18" clearance from latch to adjacent surfaces parallel to closed door on pull side of door	relocate casework & refrigerator to provide clearance

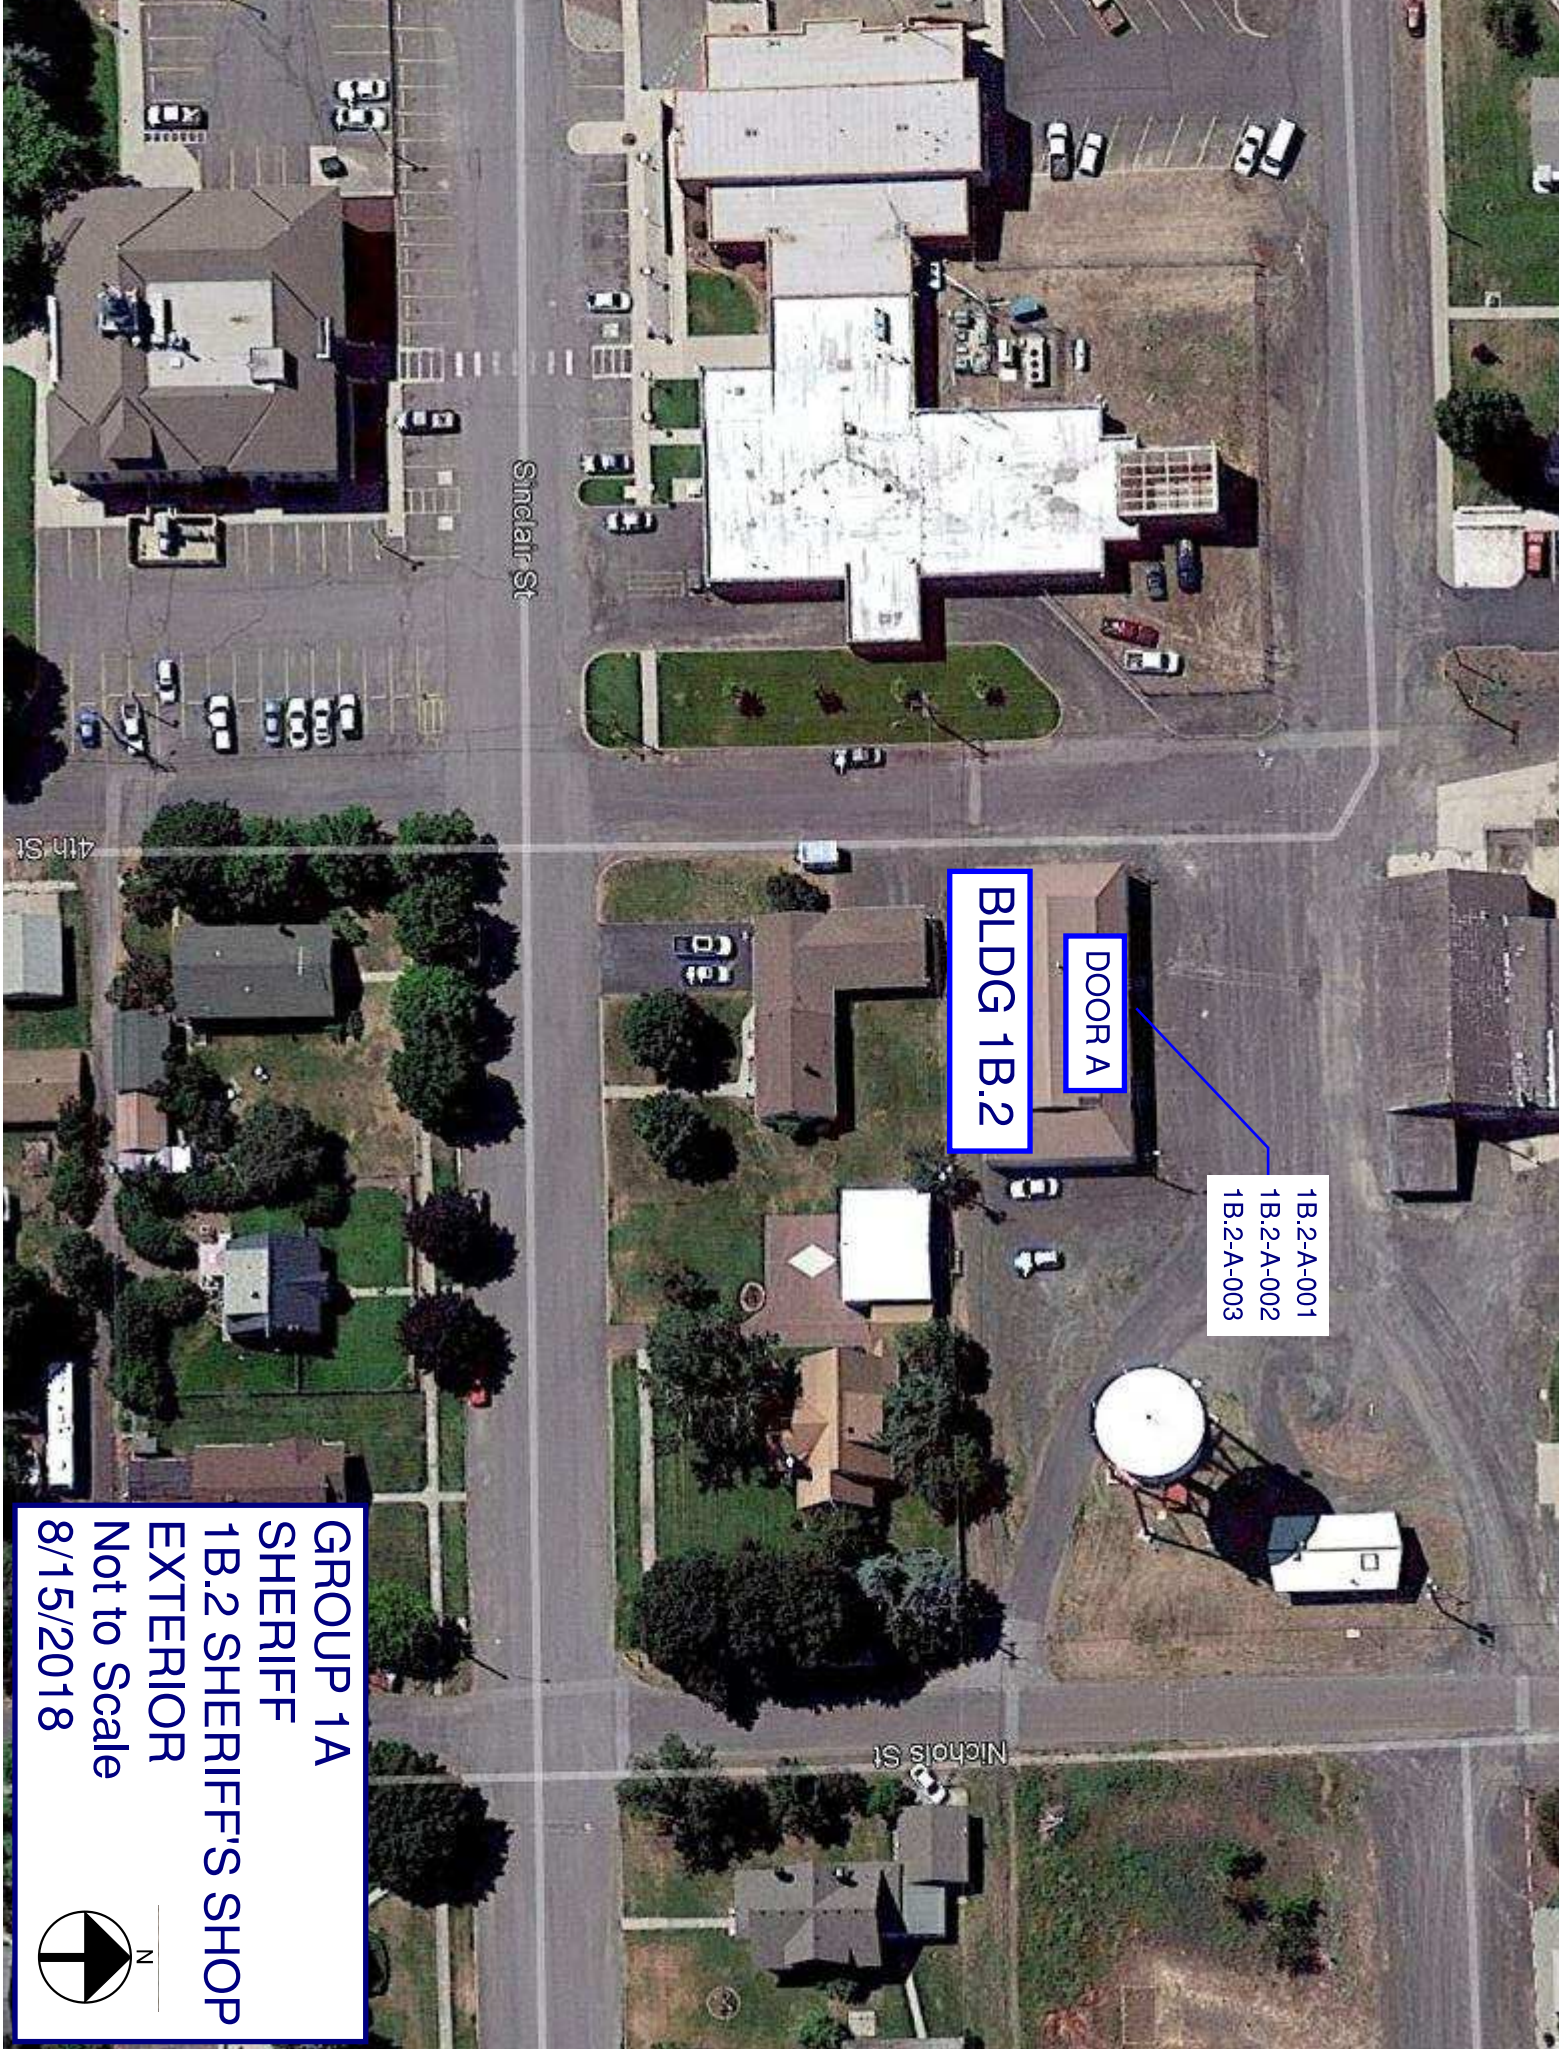
BLDG 1B.2

Item No.	Location	Element	Barrier Description	Photo	Prevailing Code	Recommendation	Comments
1B.02 - 1 - 001	n/a	Receptacles, Switches	too high		2010 ADA 308.2: 48" max	relocate, 48" max to top of device	
1B.02 - 1 - 002	n/a	Fire Extinguisher	too high (mounting brackets only, no fire extinguishers present)		2010 ADA 308.2 & 307: 48" max to handle, 27" max to bottom;	relocate	NFPA 10: 60" max top, 4" min to bottom
1B.02 - 1 - 003	n/a	Door Handle	knob-style handles		2010 ADA 309: no grasping, pinching, or twisting of operable parts	replace knob-style handles with lever-style handles	
1B.02 - 1 - 004	n/a	Threshold	too high		2010 ADA 303: 1/2" max high beveled threshold at accessible routes	remove thresholds or provide ramp	
1B.02 - 1 - 005	n/a	Thermostats	too high		2010 ADA 308.2: 48" max	relocate, 48" max to top of device	
1B.02 - 1 - 006	n/a	Floor	uneven surface		2010 ADA 302.3, 303: 1/2" max openings in floor, 1/4" max vertical change in floor level	replace flooring, 1:48 max slope in both directions, 1/4" max vertical change in elevation at transitions
