Date: January 31, 2014
To: H&H Technical Committee
From: Larry Karpack, Watershed Science & Engineering (WSE)
Cc: Bob Montgomery, Anchor QEA
Re: Chehalis Basin Strategy: Reducing Flood Damage and Enhancing Aquatic Species - Peer Review of December 2007 Peak and Hydrograph at Doty Gaging Station

INDIRECT MEASUREMENT SUMMARY

CHEHALIS RIVER NEAR DOTY, WASH.
CHEHALIS RIVER BASIN
STATION NUMBER 12020000

FLOOD OF DECEMBER 3, 2007

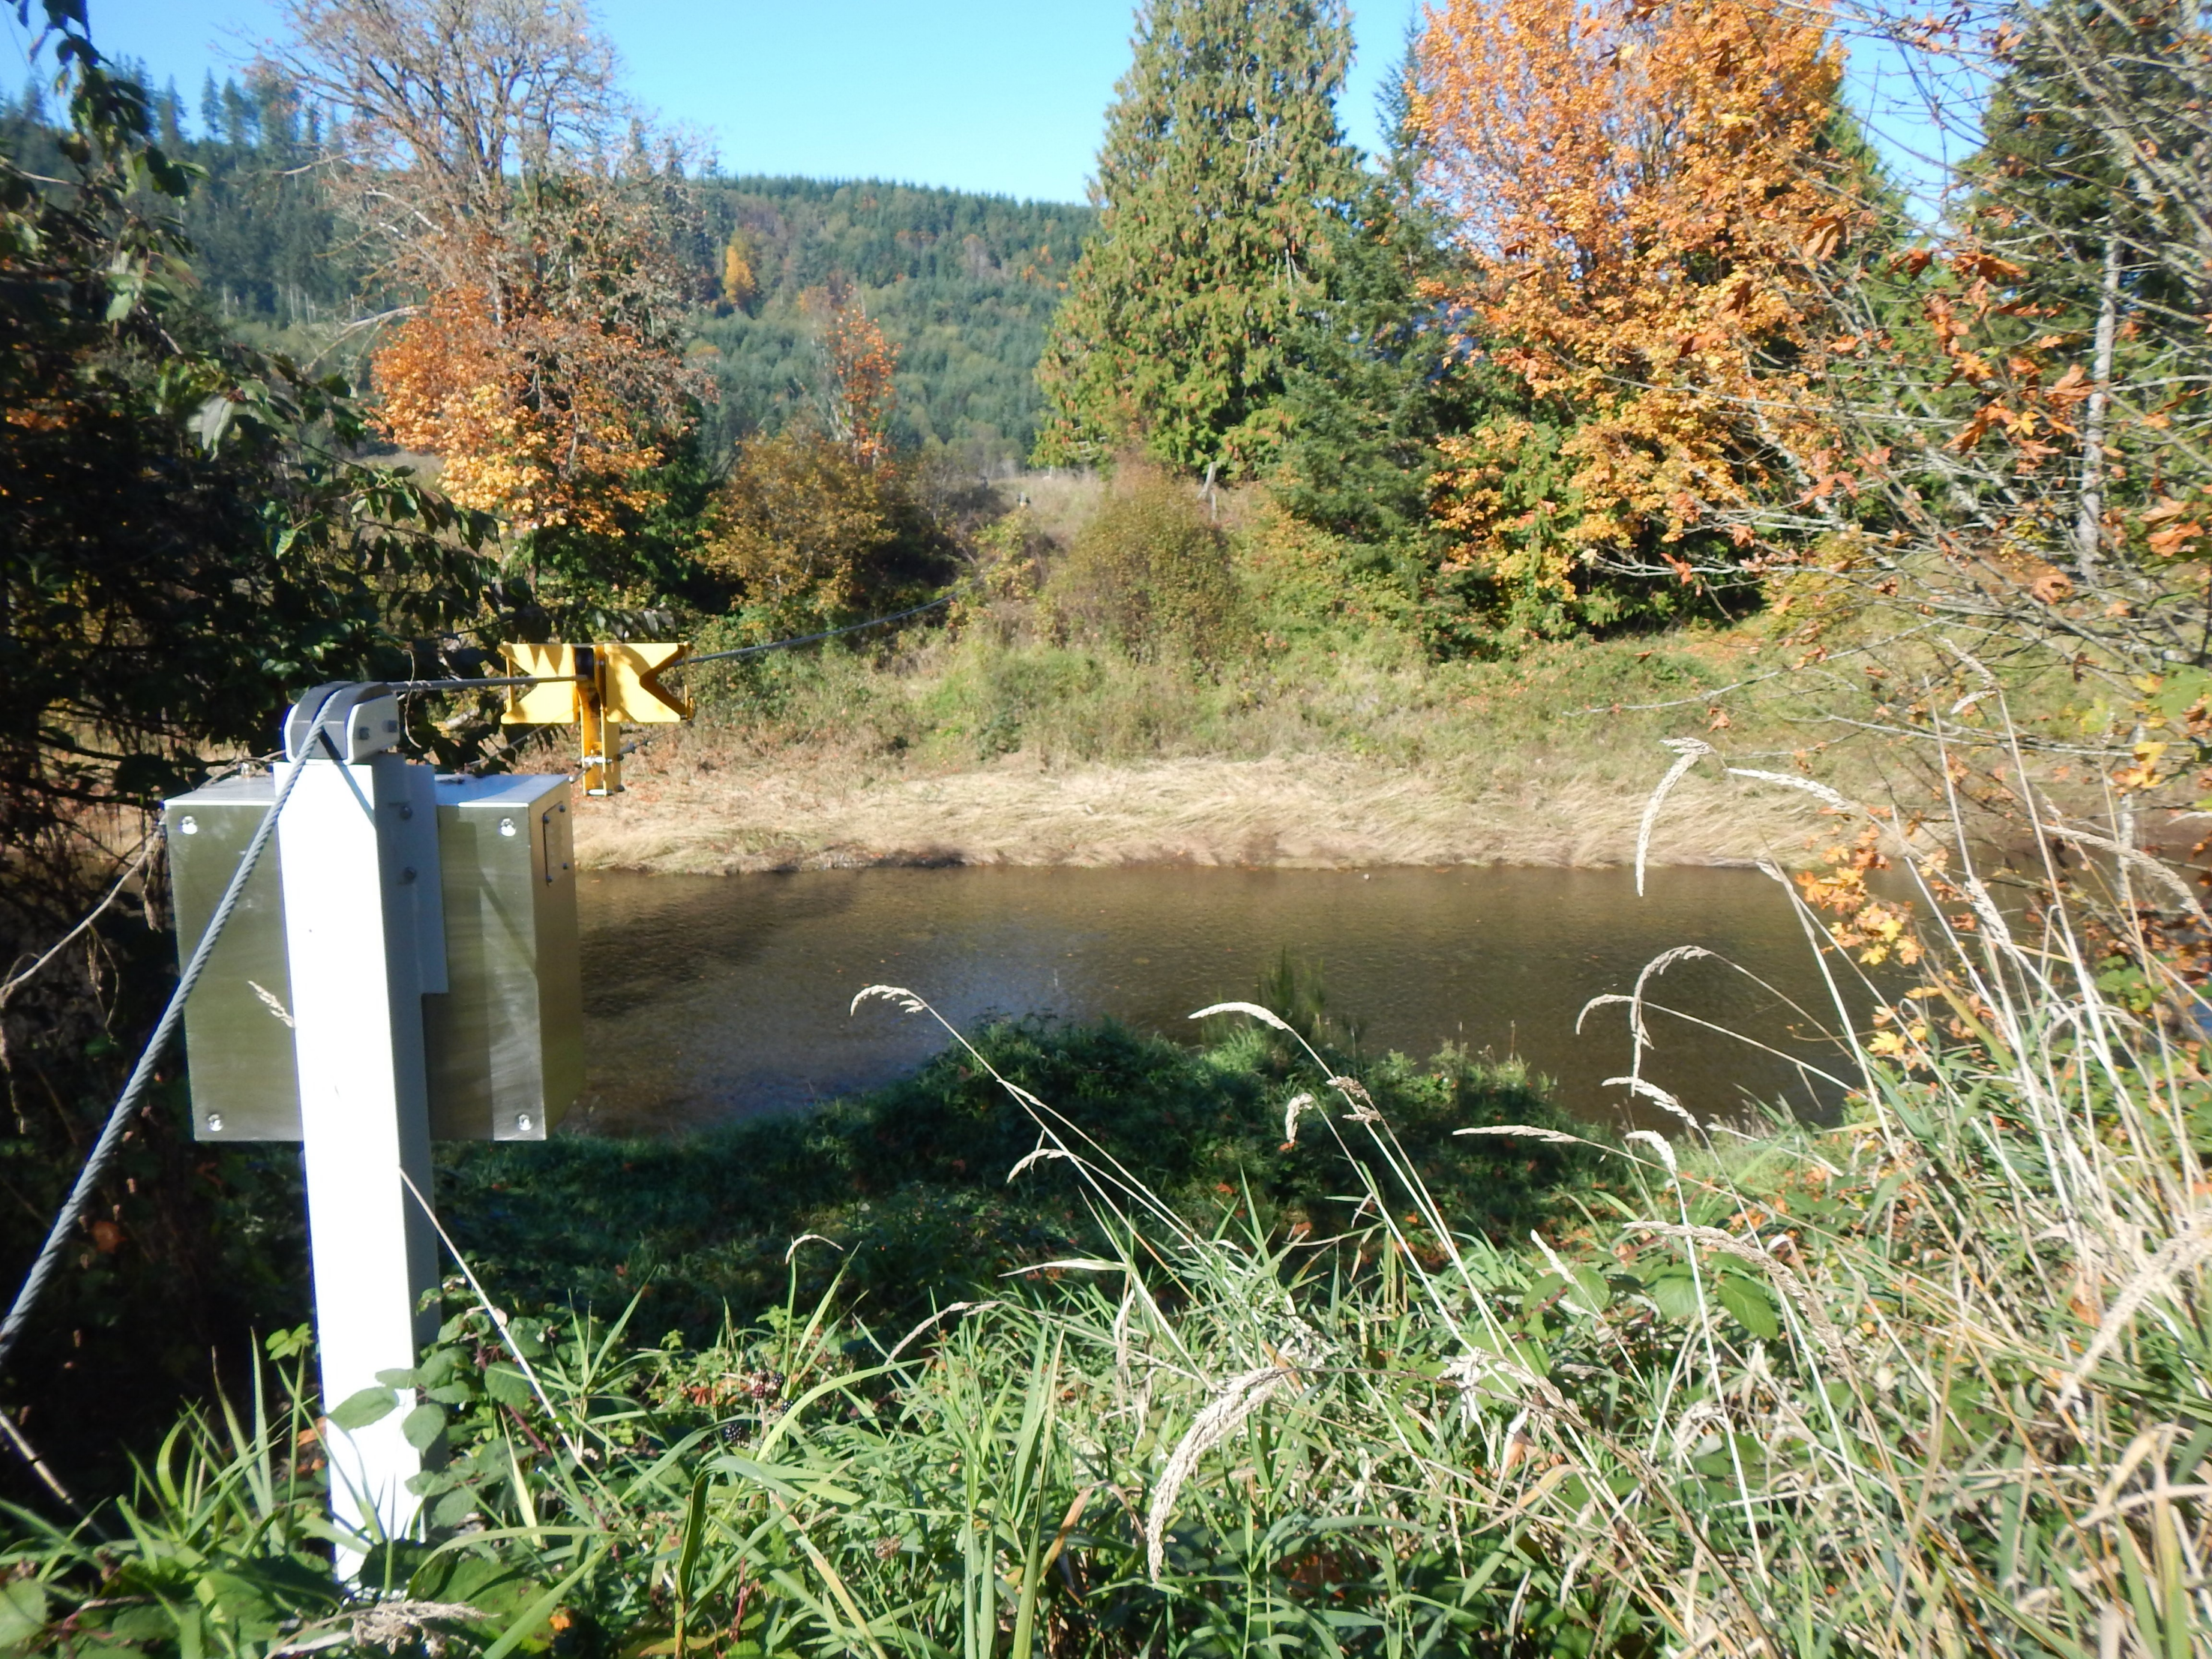
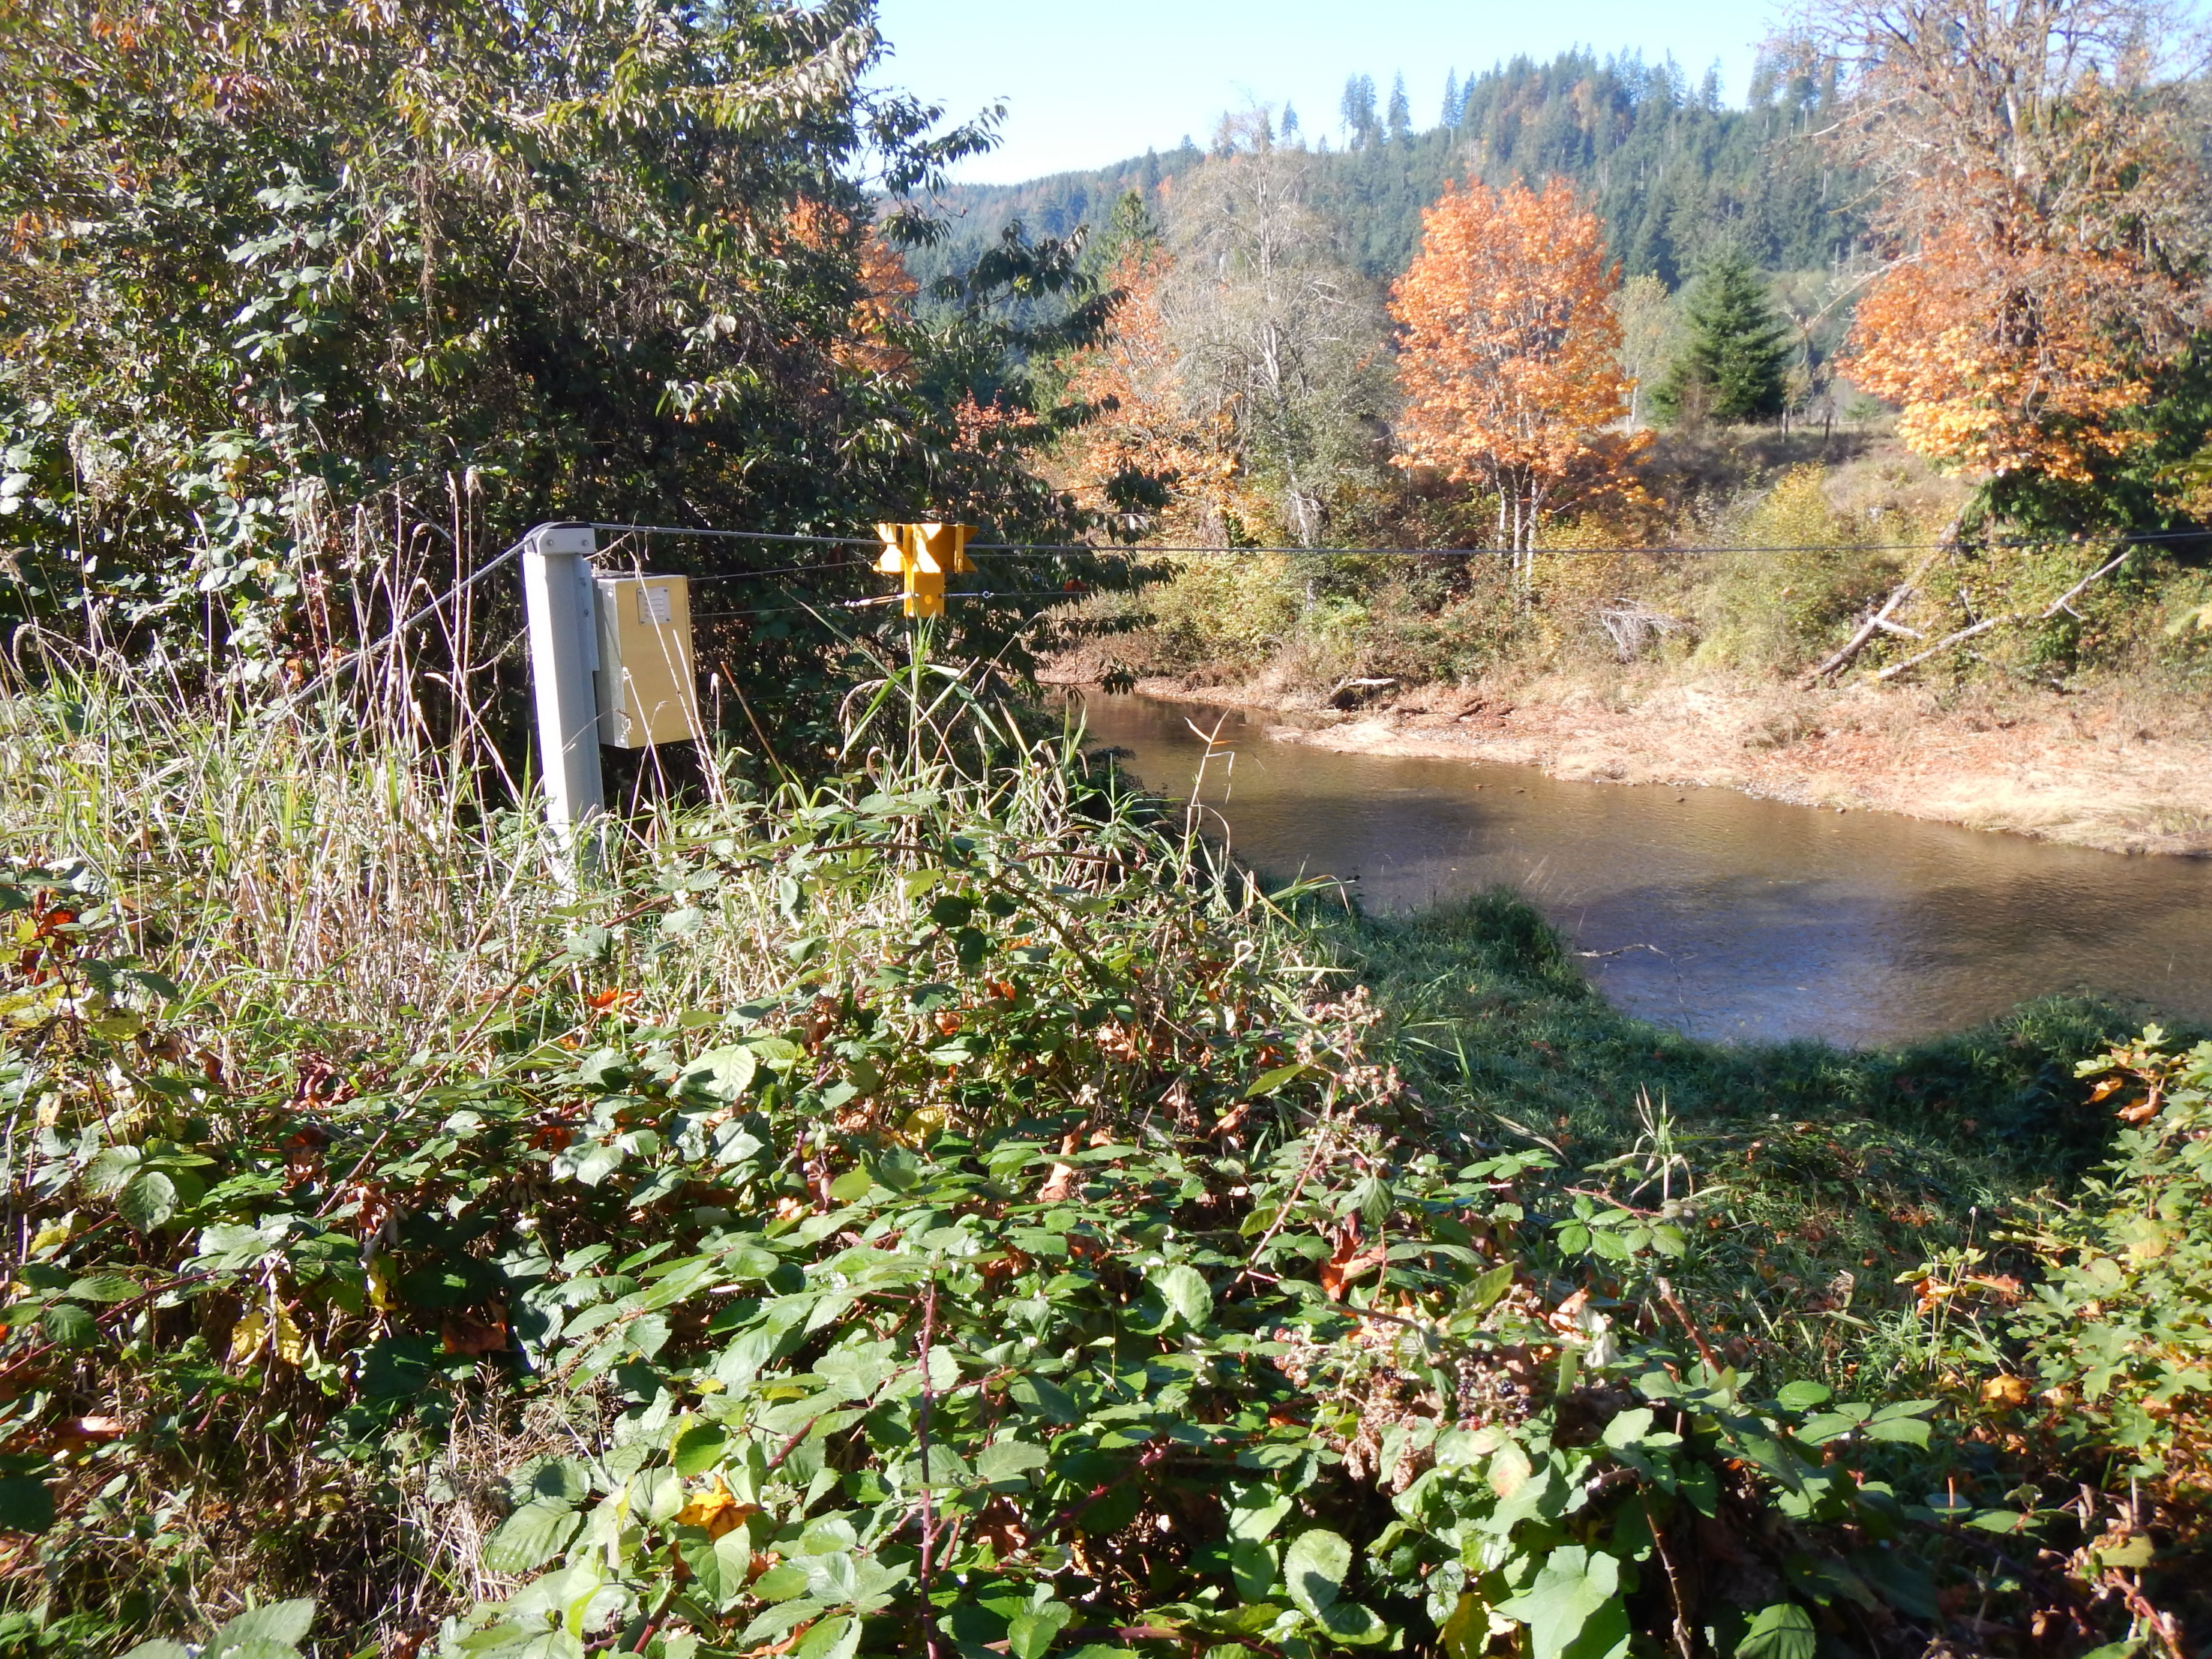
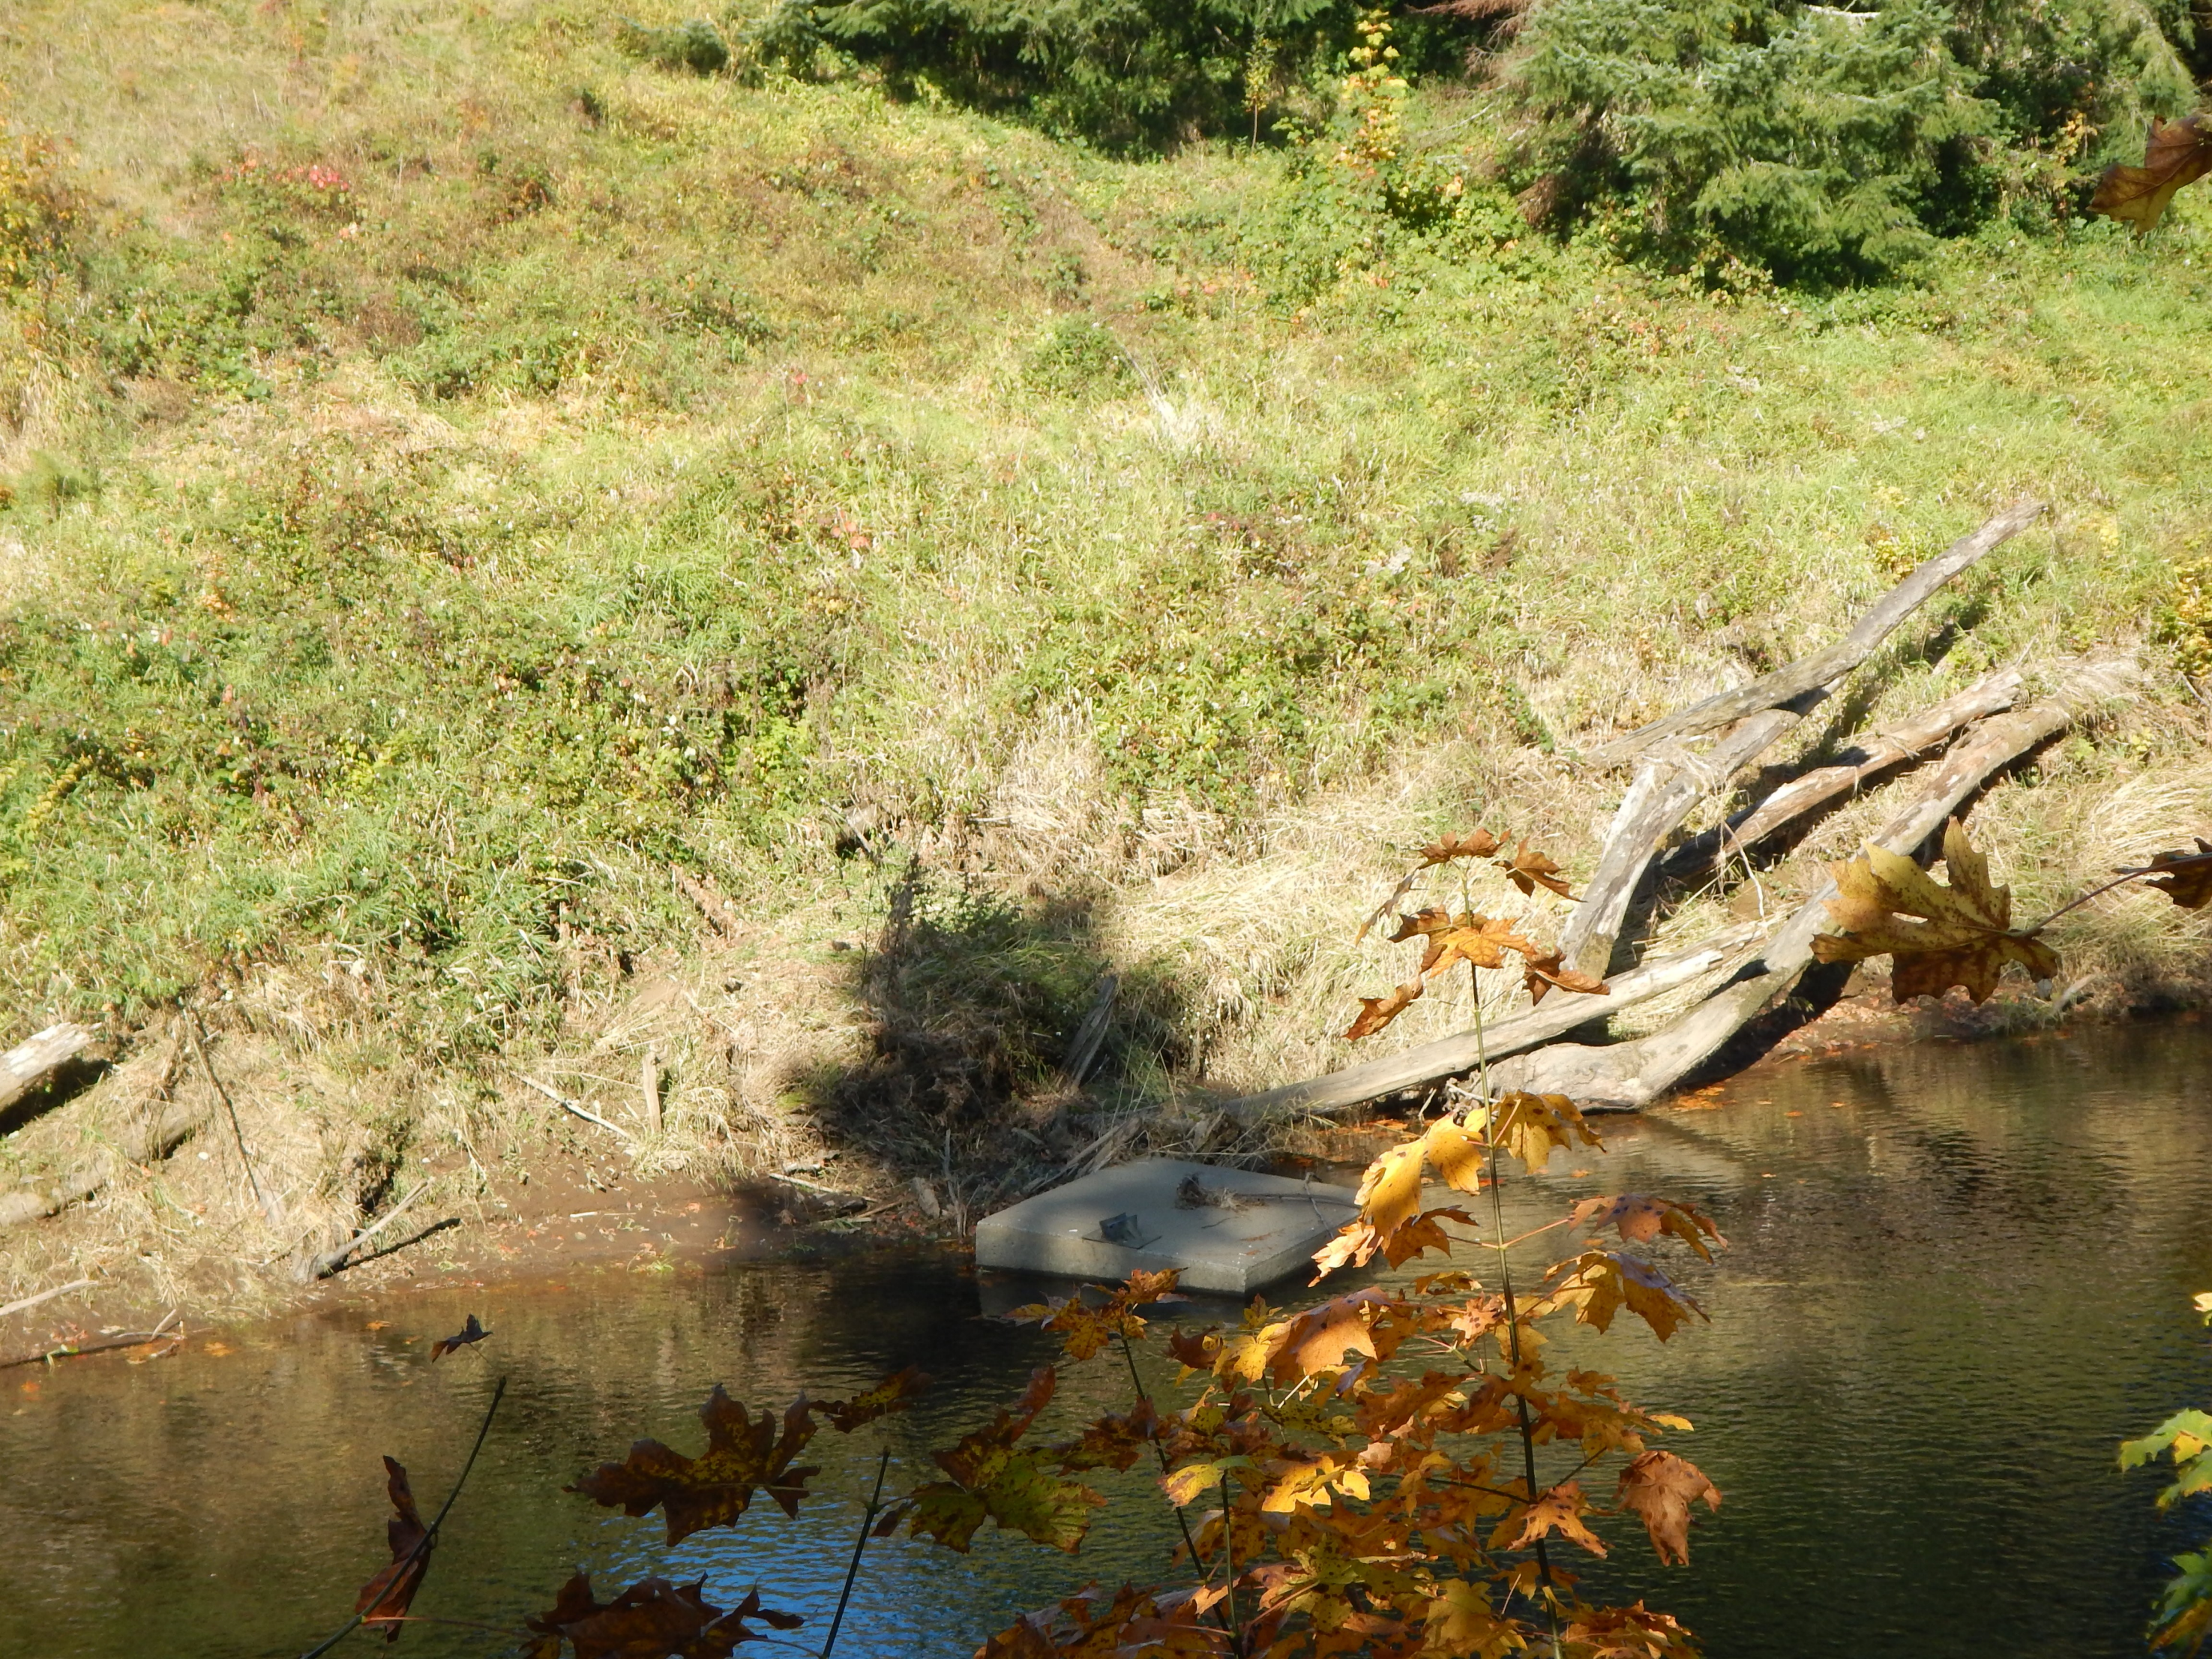
When you are out at the site you can go back to the gage (see attached picture) and think about what it looked like with water up to the level of the gage house. If you are on the bank look downstream about 250 feet and across the river and you should be able to see a huge concrete block which was part of the gage that was wiped out in 2007. The water level in 2007 reached the back room (river side) of the owners house which is just south of the creamery and was well up the side of the building that sits on the river bank right by the gage. Water did not come over the bank by the creamery.

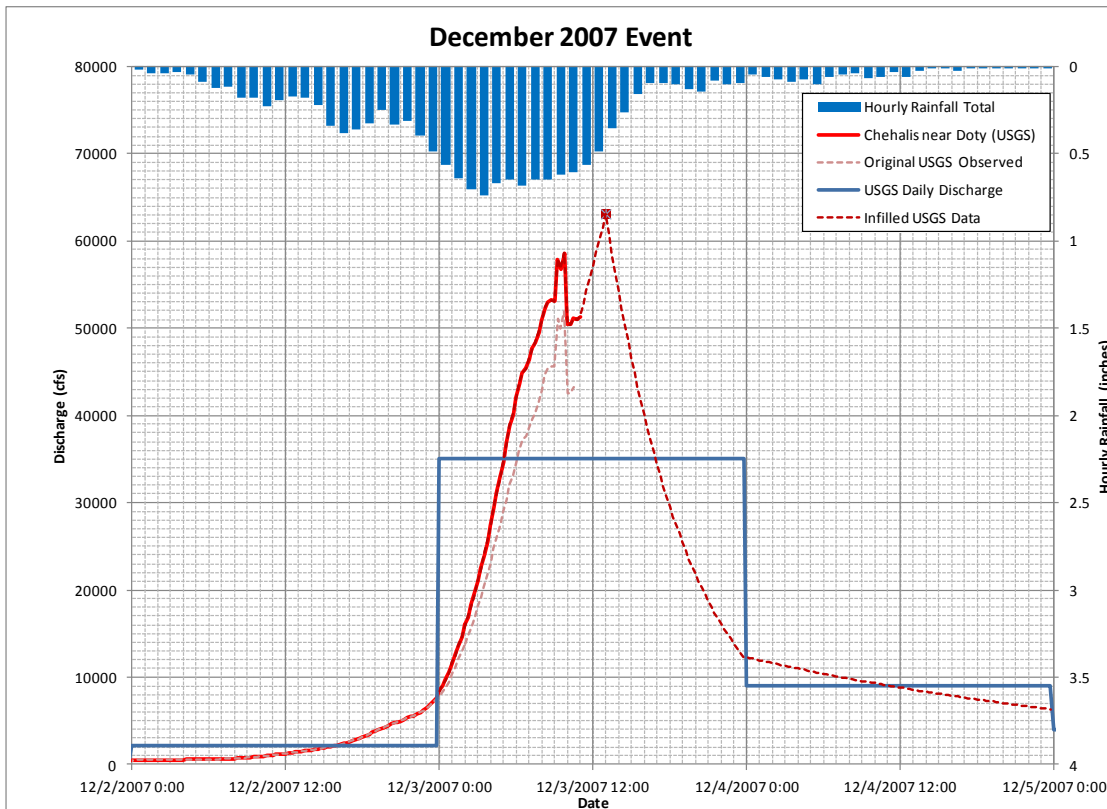
Figure 2: USGS estimated flows for Chehalis River near Doty

Using the indirect peak discharge the USGS updated and extended their rating curve for the Doty gage and used the new rating curve to recompute flows up until the time at which the gage failed. Figure 2 shows the USGS estimated flows using the original rating curve, in place at the time of the December 2007 flood event, and the final (updated and extended) rating curve. The USGS also created a hydrograph for the flood and used that hydrograph to estimate mean daily flows for the event (as shown in Figure 2).

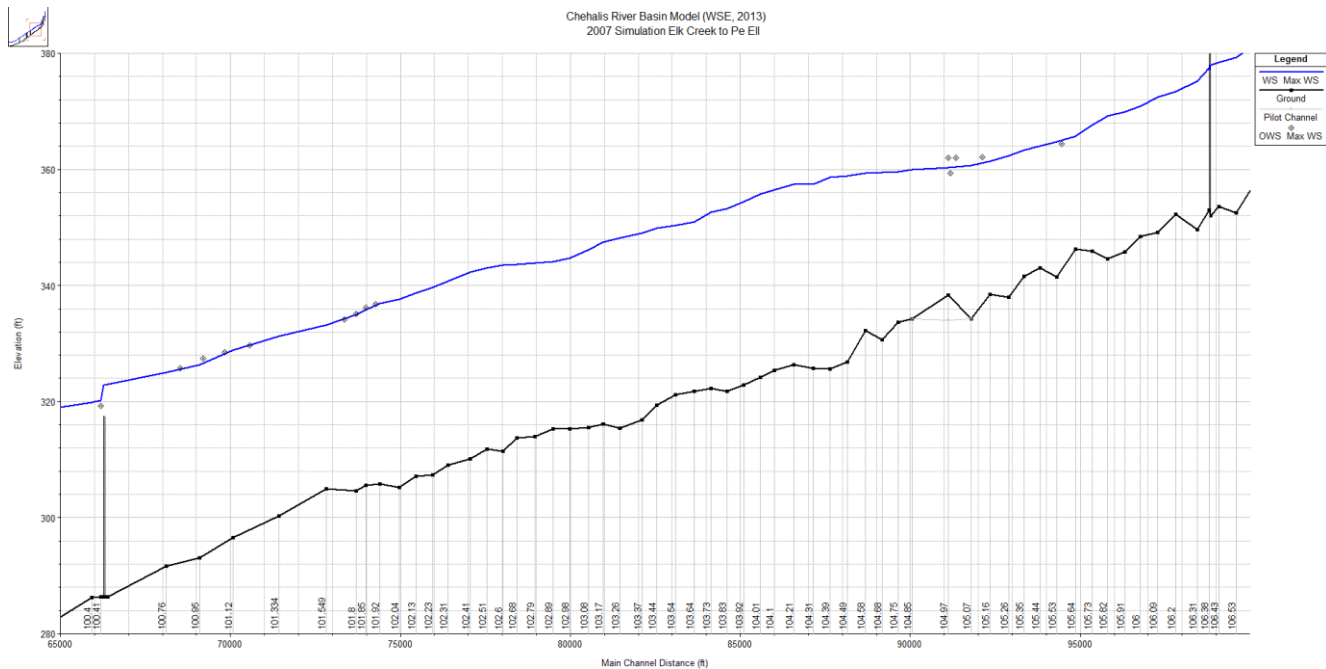
Figure 3: HEC-RAS Model Profile and Observed High Water Marks for December 2007 Flood Event

Using the HEC-RAS model with a Manning's n value of 0.050 (the same value that was used in the recent FEMA study) WSE estimated the peak discharge for the December 2007 flood event to be about 52,600 cfs. This flow and Manning's n value combination provided good calibration results for high water marks throughout the upper Chehalis River (see Figure 3). The one exception is the reach immediately downstream of Pe Ell where a debris jam was reported. This reach is discussed in greater detail in the following section.

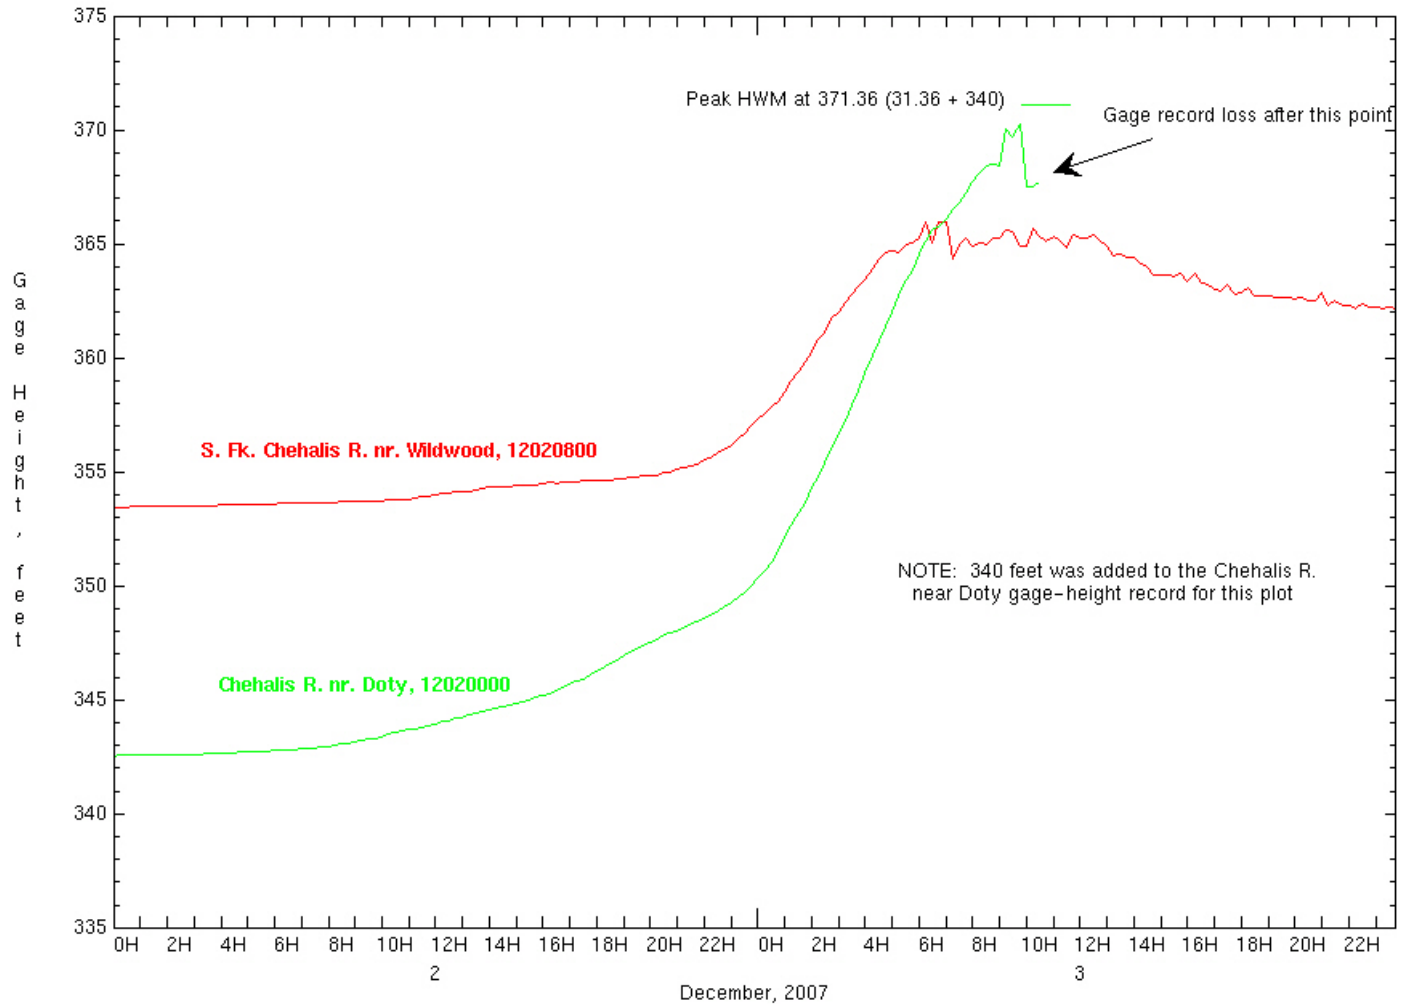
Figure 2. Gage-height record for December 2-3, 2007, at the Chehalis River near Doty and South Fork Chehalis River near Wildwood stream gages, Washington.

DISCHARGE AND GAGE-HEIGHT.—63,100 ft³/s was the computed peak discharge for this indirect measurement; no gage height record was available at the peak and the peak exceeded the highest CSG. The gage height record showed a sudden rise and quick fall before becoming inoperable (fig. 2), which may have coincided with the time when the cableway began to catch

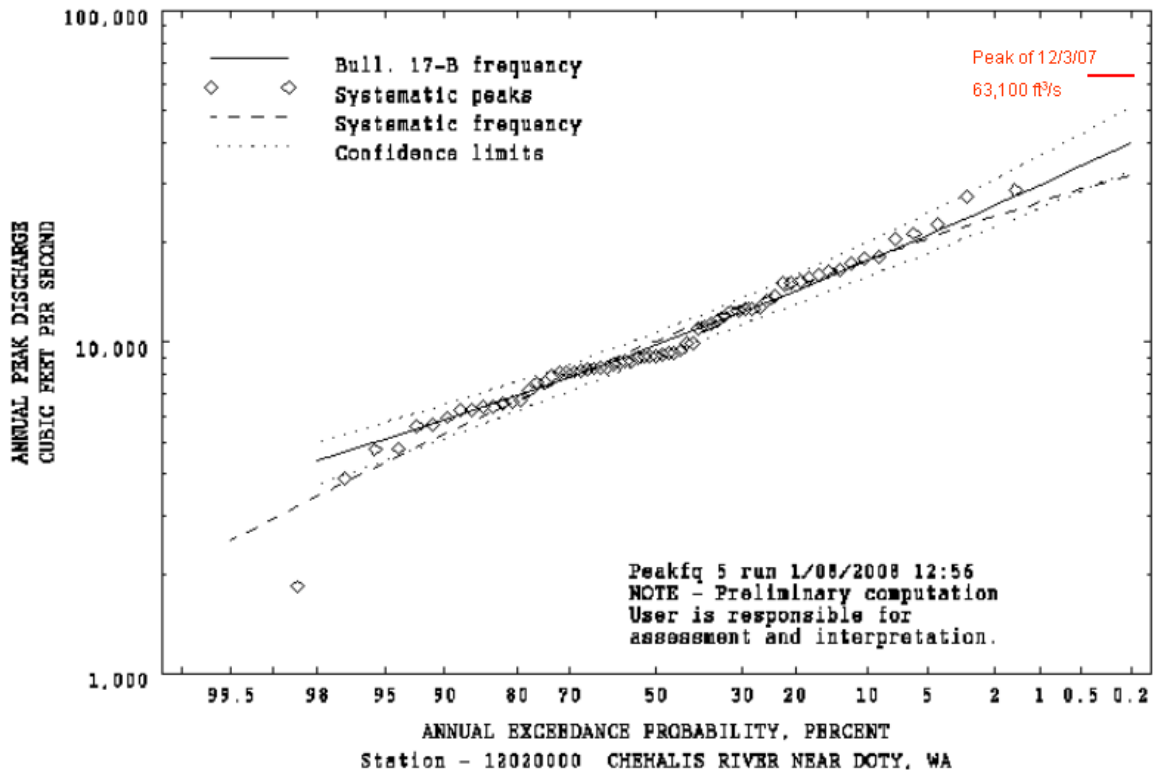
Figure 3. Annual exceedance probability plot of annual peaks at Chehalis River near Doty, Washington for water years 1940 through 2006. (The plot was generated using the PKFQWin program, version 5.2.0.)
