Chehalis River Flood Warning System Master Plan Update

David C. Curtis, PhD
Scott Boettcher
January 19, 2023

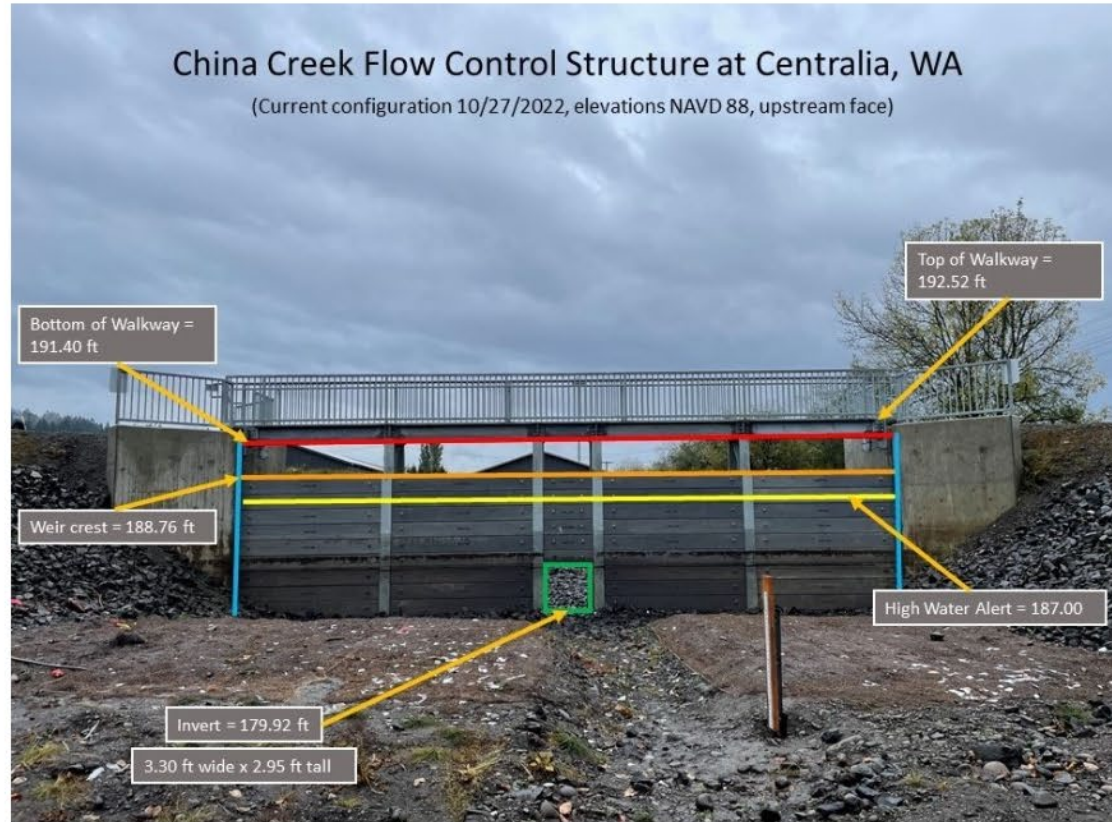
China Creek at Flow Control Structure

CHINA CREEK ABOVE FCS AT CEI

Stage (HG)

184.31 ft

Battery (VB)

12.7 V

Rain Increment (PC_INC)

0.14 in
