Reservoir Slope Stability, Vegetation Management, and Dam Material Sources

May 7, 2014

Outline

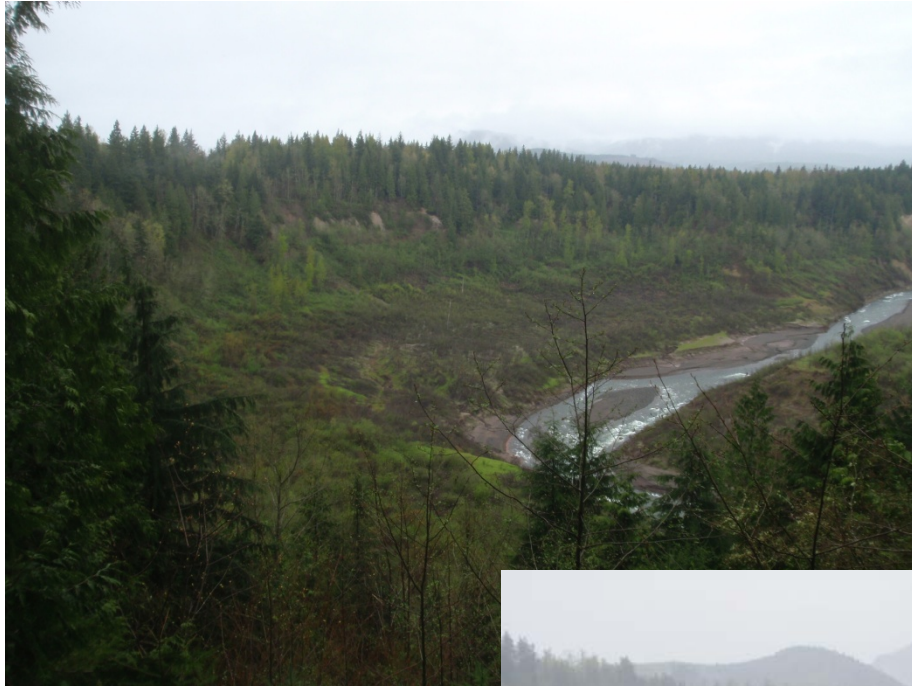
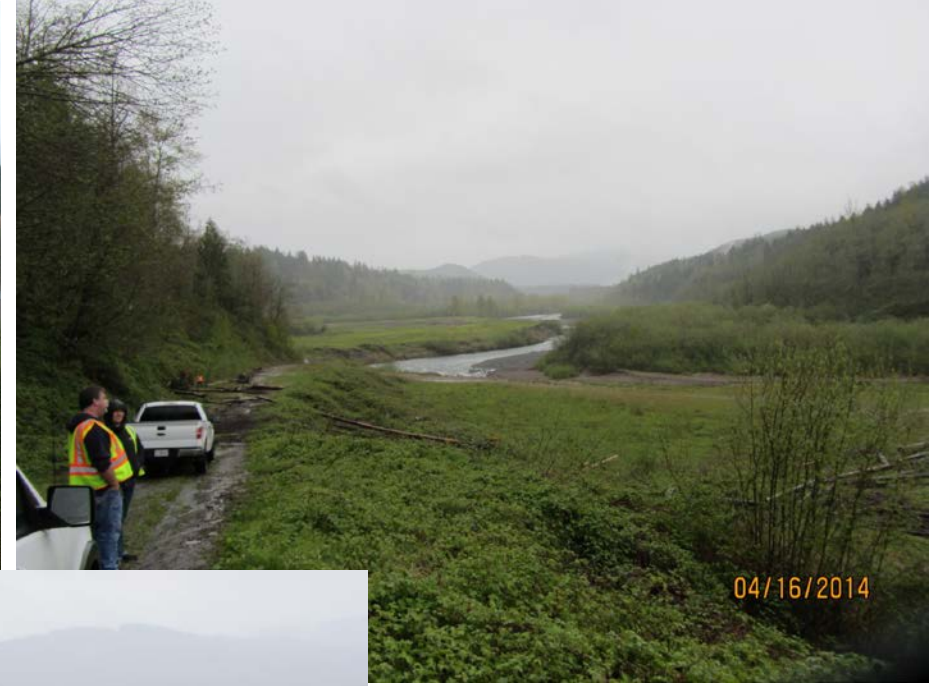
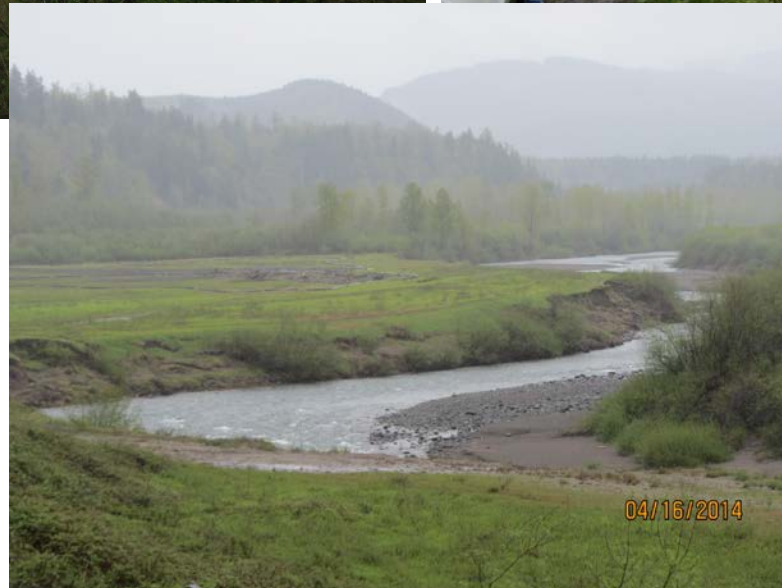
Mud Mountain Dam – Vegetation Mgt

- Initially logged; little vegetation management
- Vegetation and trees not cut or removed
- Log storage areas are cleared
- During flood LWD (from upstream sources) can be backed up for miles
- Floating booms to collect LWD
- Let LWD pass through outlet if possible
- 18 inch opening on bar rack

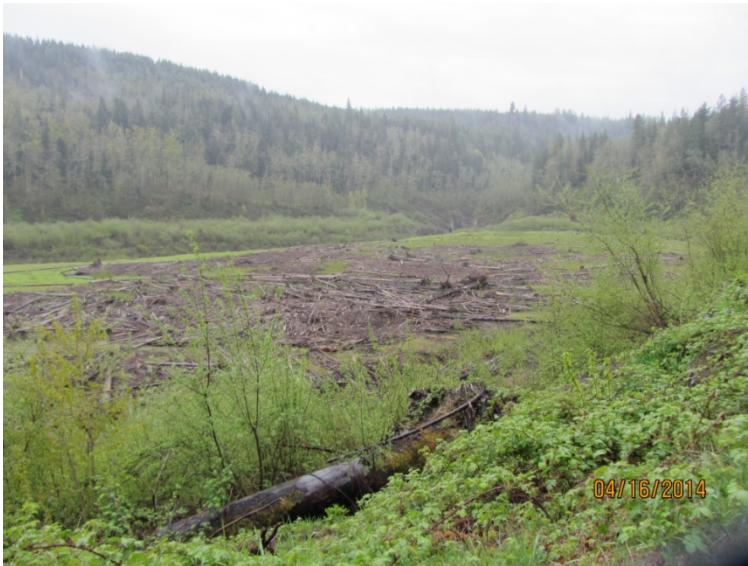
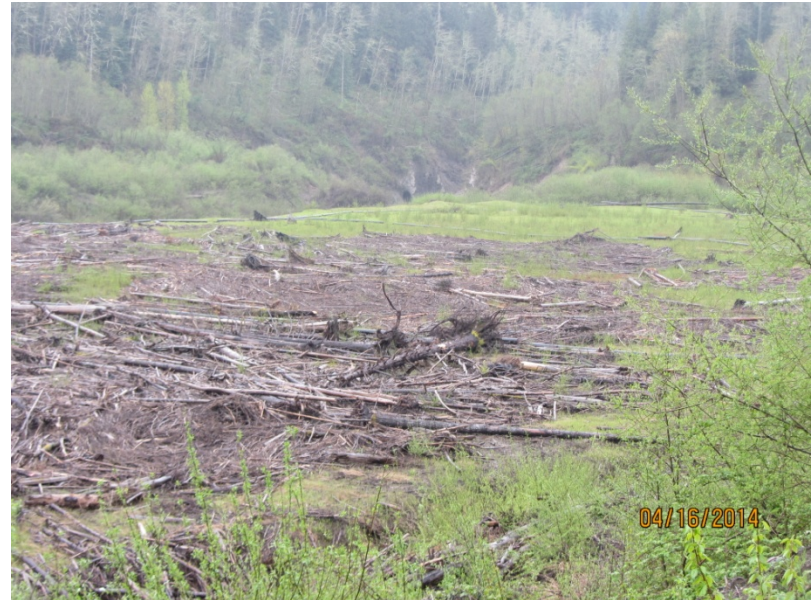
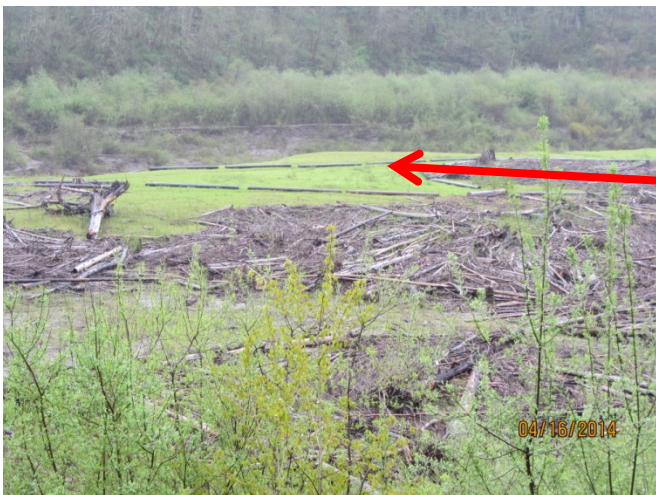
Mud Mountain Dam – Debris Mgt

Log boom

- Lowering pool may be delayed for days or weeks following flood events that deliver large amounts of LWD
- LWD is made available to various stakeholders
- Excess LWD temporarily stored in reservoir
- Use boats to gather and haul LWD to storage areas
- USACE developing management plan to address LWD management, including disposal

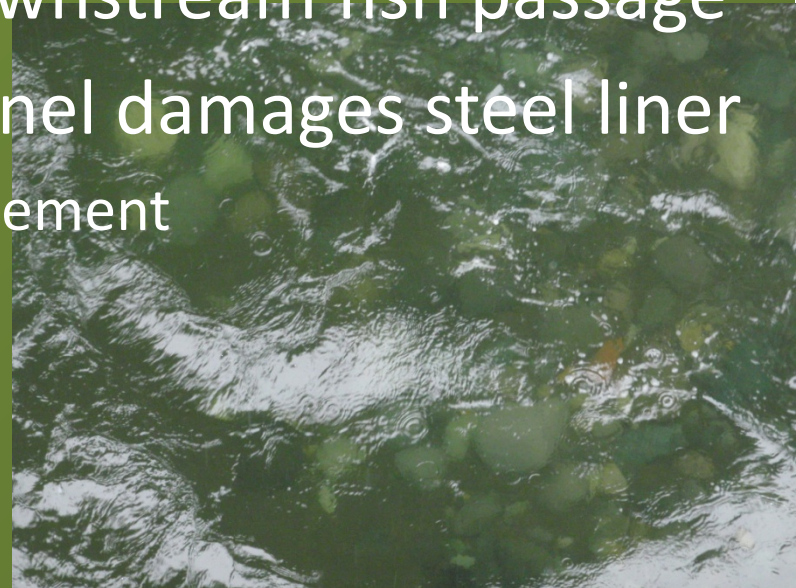
- Soil, gravel, cobbles, and boulders flushed through low elevation tunnel through dam
- Recently, USACE passing additional flow through higher tunnel to facilitate downstream fish passage
- Material carried through tunnel damages steel liner
 - Liner replaced and due for replacement
 - Used to have rails in invert
 - Full steel liner now
 - Lower strength steel lasts longer

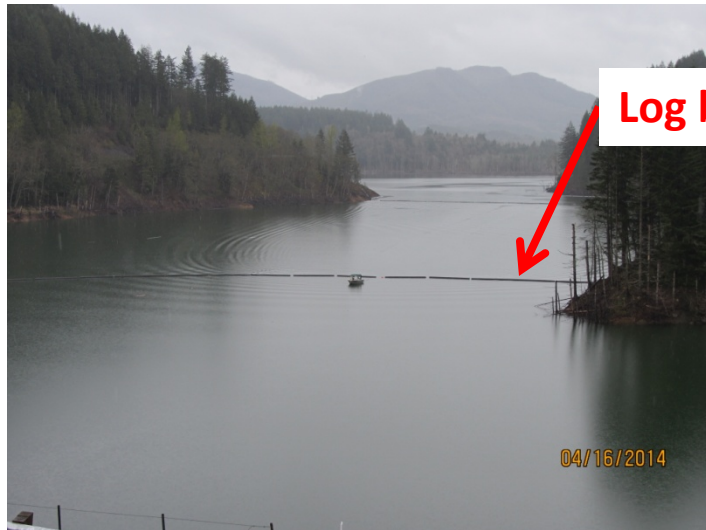
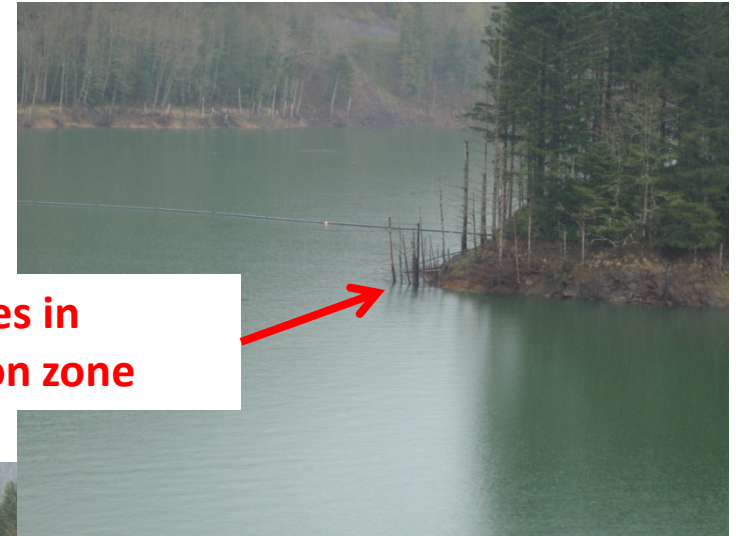
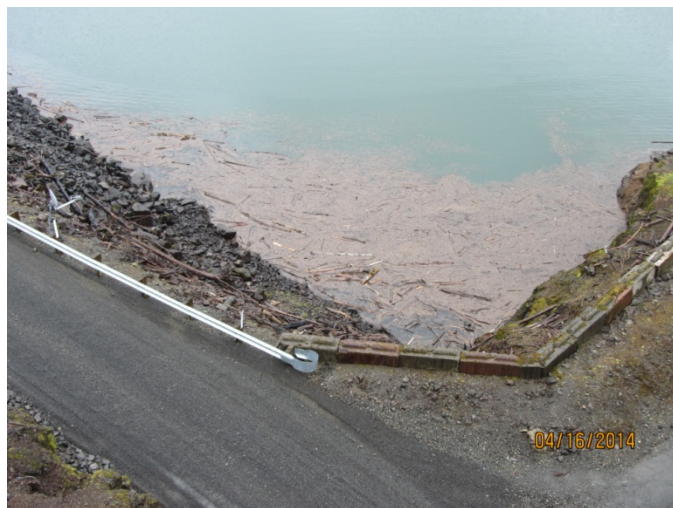
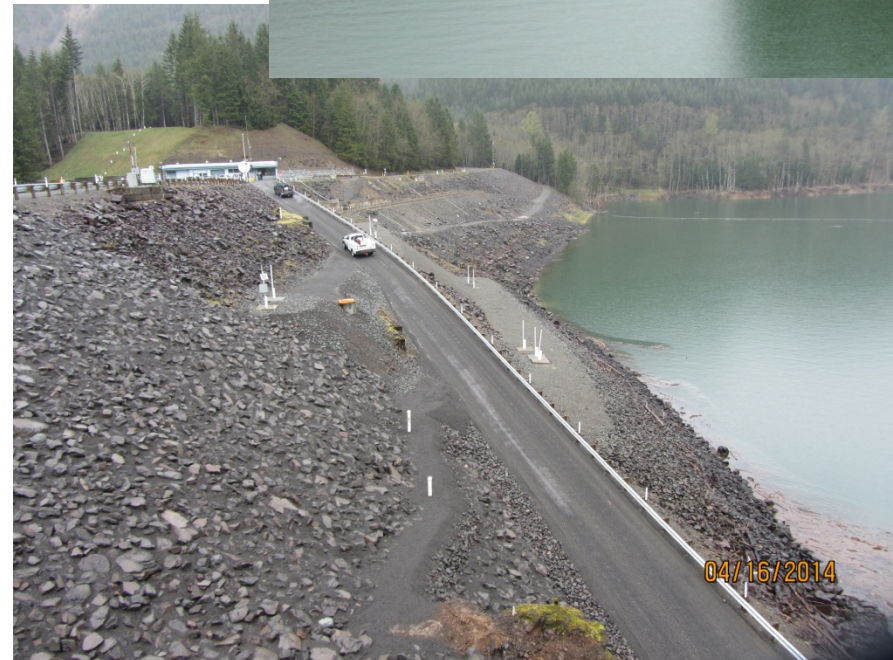
Howard Hanson Dam – Debris Mgt

- Little vegetation management
- Vegetation and trees not cut or removed
- LWD cannot pass through the dam
- More LWD during big floods
- Floating booms to collect LWD
- Booms anchored at multiple elevations
- Use boats to gather and haul LWD to storage areas

- 50% LWD reintroduced to river downstream
- Other LWD is available to various stakeholders
- Excess LWD stored in reservoir to decompose

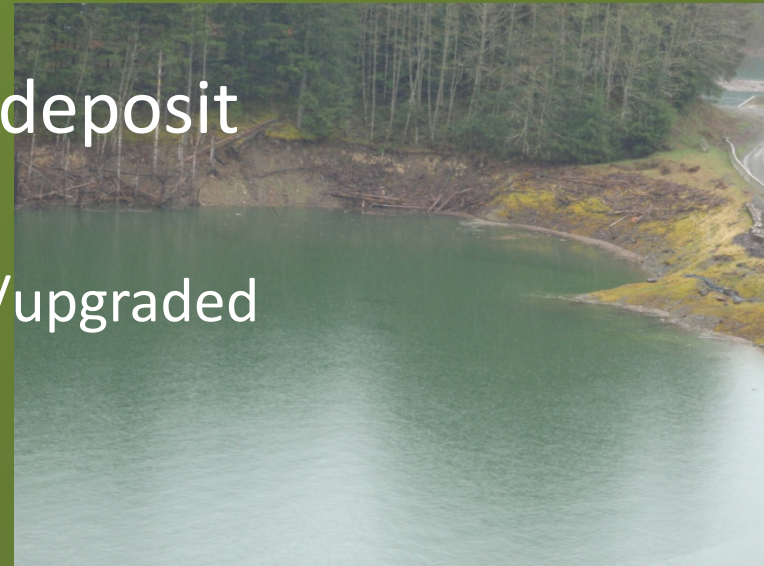
- USACE takes no actions to prevent landslides
- Has no procedures limiting drawdown rate for potential reservoir slope instability
- Yearly reconnaissance
- Right abutment is a landslide deposit
 - Has been seepage problem
 - Drainage tunnel recently installed/upgraded
