Bioretention Hydrologic Performance Study Phase II

Assessment of Facilities Designed Using WWHM 2012

Final Report

Date: December 22, 2020

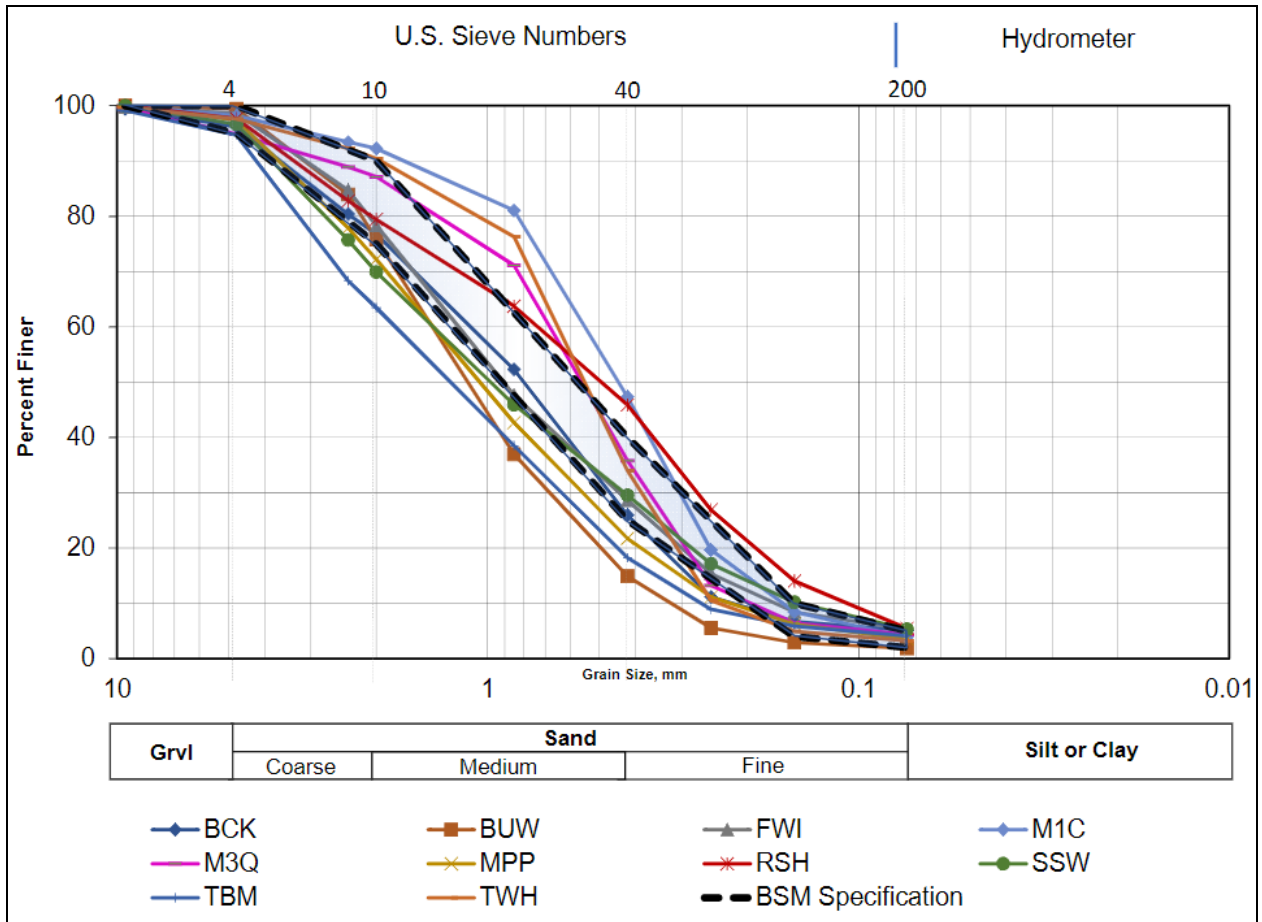
Figure 2. Graphical Representation of the Grain-Size Composition of BSM Samples Collected at Each of the Ten Facilities Studied. “BSM Specification” illustrates recommended gradation in the 2014 SWMMWW.

The BSM infiltration rate exceeded the facility design rate in all cases except in BCK and RSH. In cell BCK, this may be due to the higher than recommended percentage of bioretention soil passing the #200 sieve. In cell RSH, we noted some compaction of the bioretention soil during soil probing, which may have limited the infiltration rate. Based on our qualitative assessment of compaction, we also observed an area of compacted bioretention soil in cell SSW; however, the compacted area comprised only a portion of the cell base and, although it may have reduced the infiltration rate in that portion of the cell base, the overall infiltration rate remained higher than the design rate. We interpret that the bioretention soil was generally in a loose condition in all other cells, and that excessive compaction did not otherwise limit infiltration rates through the bioretention soil.

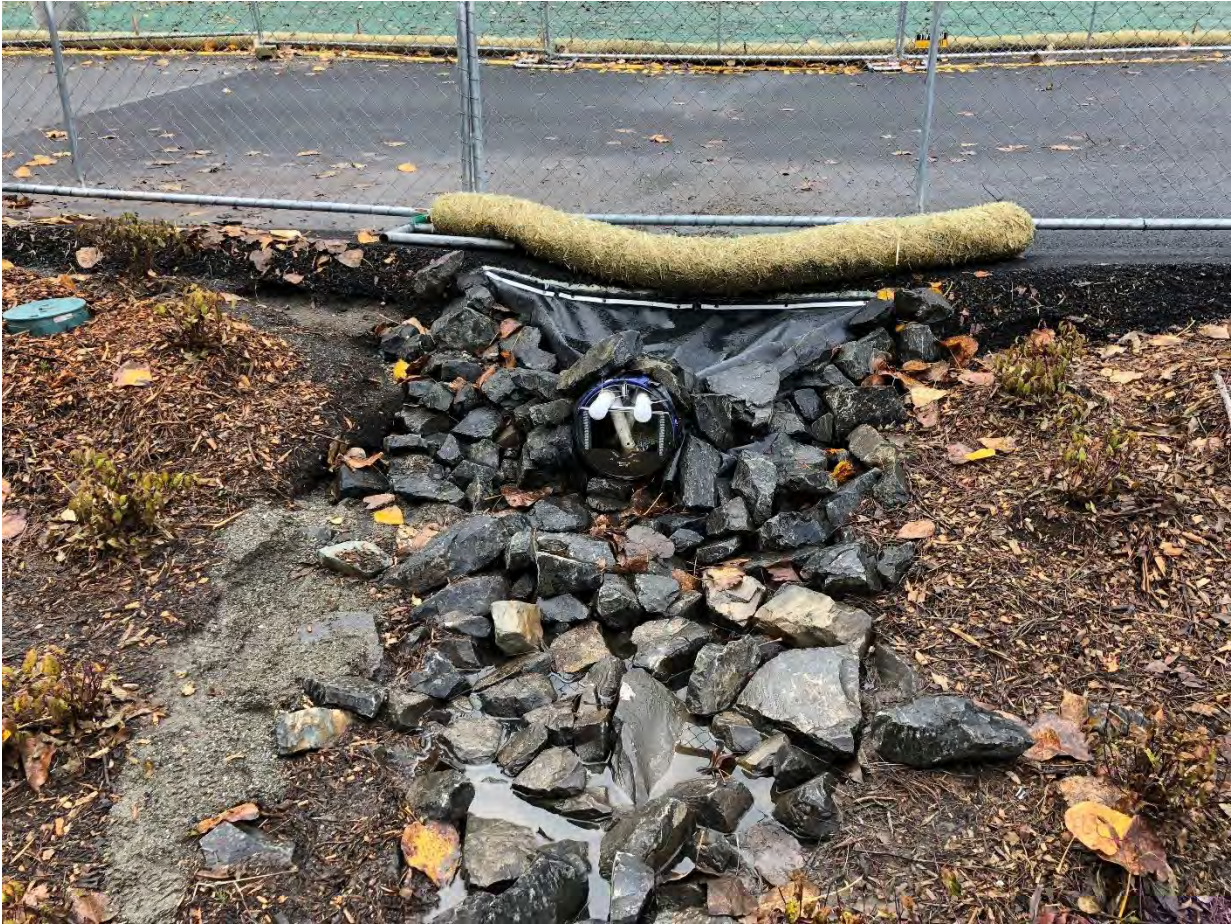
Figure 16. SSW_IN with Construction Wattle on November 6, 2018

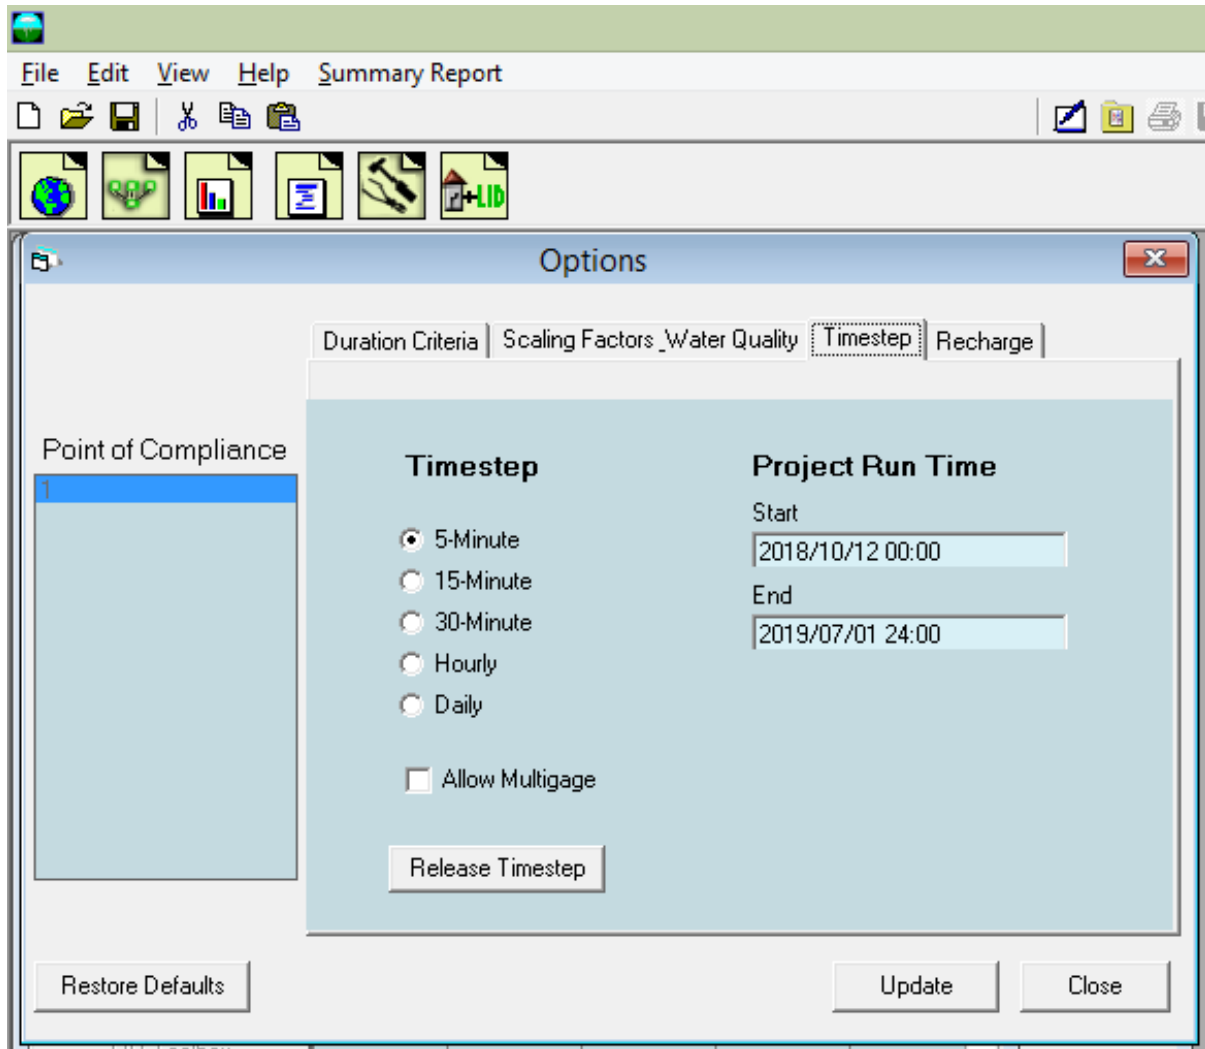
Figure 3. WWHM2012 Simulation Time Step and Start and End Dates (for TBM)
