Appendices

1. Bioretention Hydrologic Performance (BHP) Study Site Selection Process and List of Selected Sites Technical Memo - Deliverables 2.2 and 2.3 Combined. Taylor Aquatic Science. 10/23/15

Bioretention Hydrologic Performance (BHP) Study Site Selection Process and List of Selected Sites Technical Memo - Deliverables 2.2 and 2.3 Combined. Taylor Aquatic Science. 10/23/15

Technical Memo

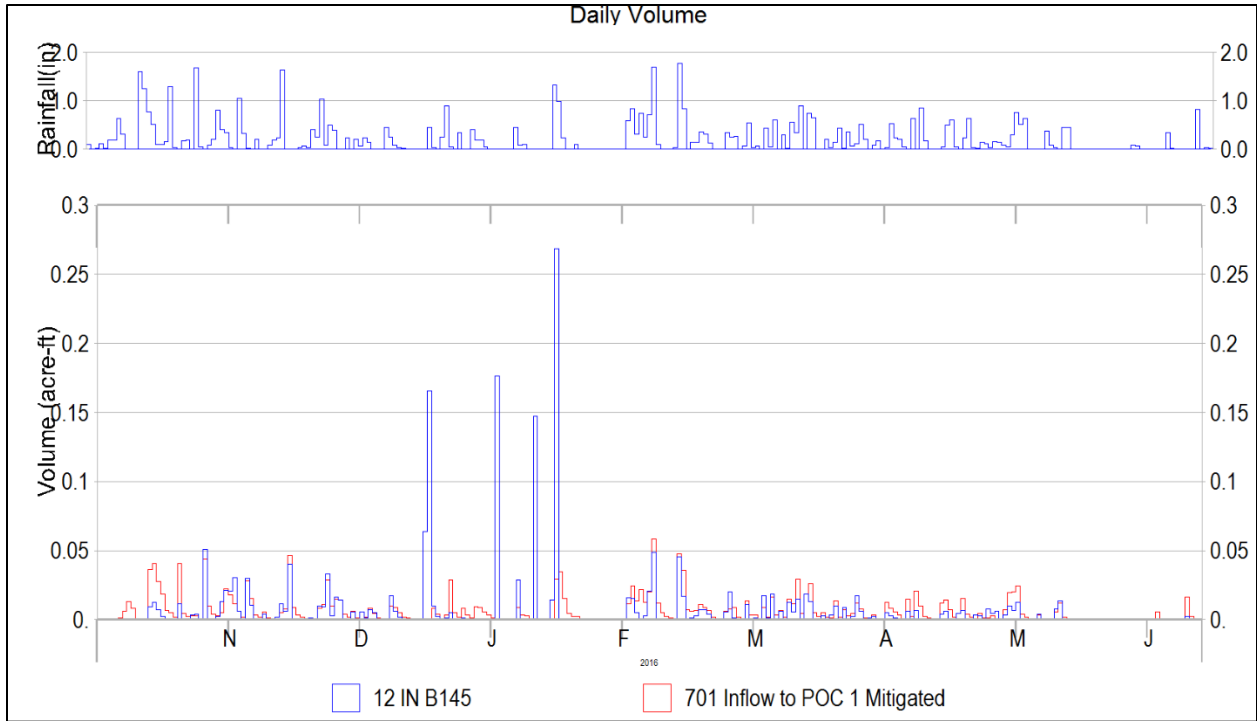
Figure B145-1. B145 Daily Inflow Volumes

Figure B145-1 shows the simulated (red) and recorded (blue) daily inflow volumes and, along the top of the figure, the B145 site monitored daily rainfall data. The simulated and recorded daily inflow volumes match well, except for winter periods (January and February 2017) where snow and freezing conditions affected the recorded values.
