Quality Assurance Project Plan

Clark County Clean Water Program Stormwater Flow Reduction Strategy Monitoring

Project Name:	LID Permeable Pavers Effectiveness Study
Project Code:	TOYLID
Agency Name:	Clark County
Agency Contact Name:	Ian Wigger
Department:	Environmental Services Clean Water Program

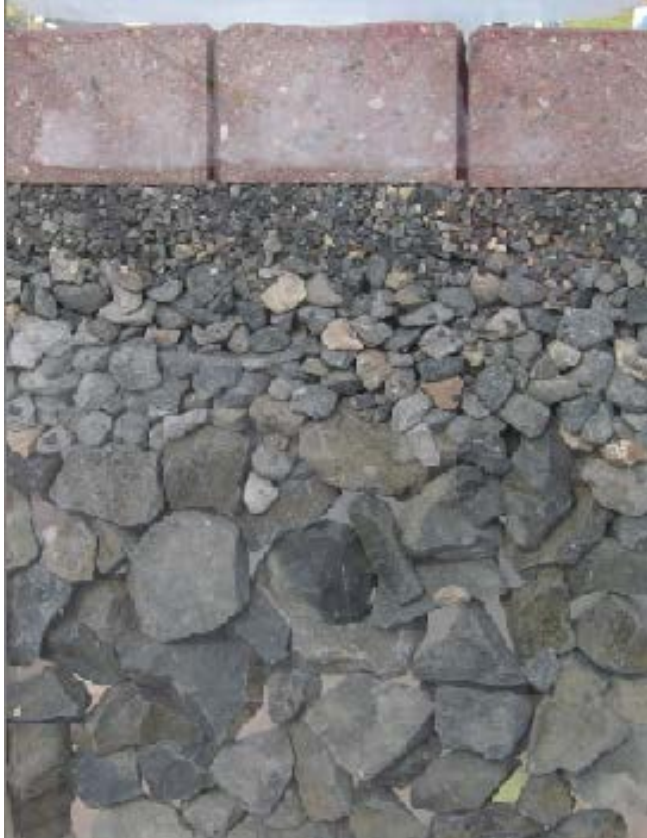
Figure 5. Cross section of permeable concrete pavers and underlying base course

Stormwater runoff from the building rain harvesting overflow, parking lot, and the landscaped area are infiltrated onsite using Eco-Loc Permeable Concrete Pavers. Stormwater is treated by means of infiltration through the base course and the underlying imported sandy soils (Figures 5 and 6).

The term permeable pavement, or pervious pavement, is used to describe pavements that allow stormwater to infiltrate into base course below the pavement surface. The base material provides temporary storage of stormwater before it infiltrates into the subgrade. Pervious pavement in this study refers to modular interlocking concrete block pavers (figure 5 and 6).

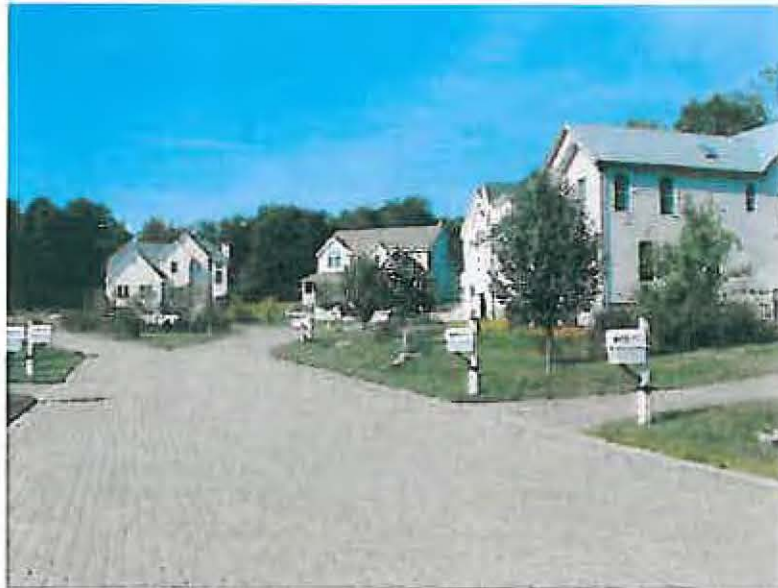
Figure 6.3.1 The residential access road at Jordan Cove Urban Monitoring Project in Connecticut is paved entirely with permeable pavers.

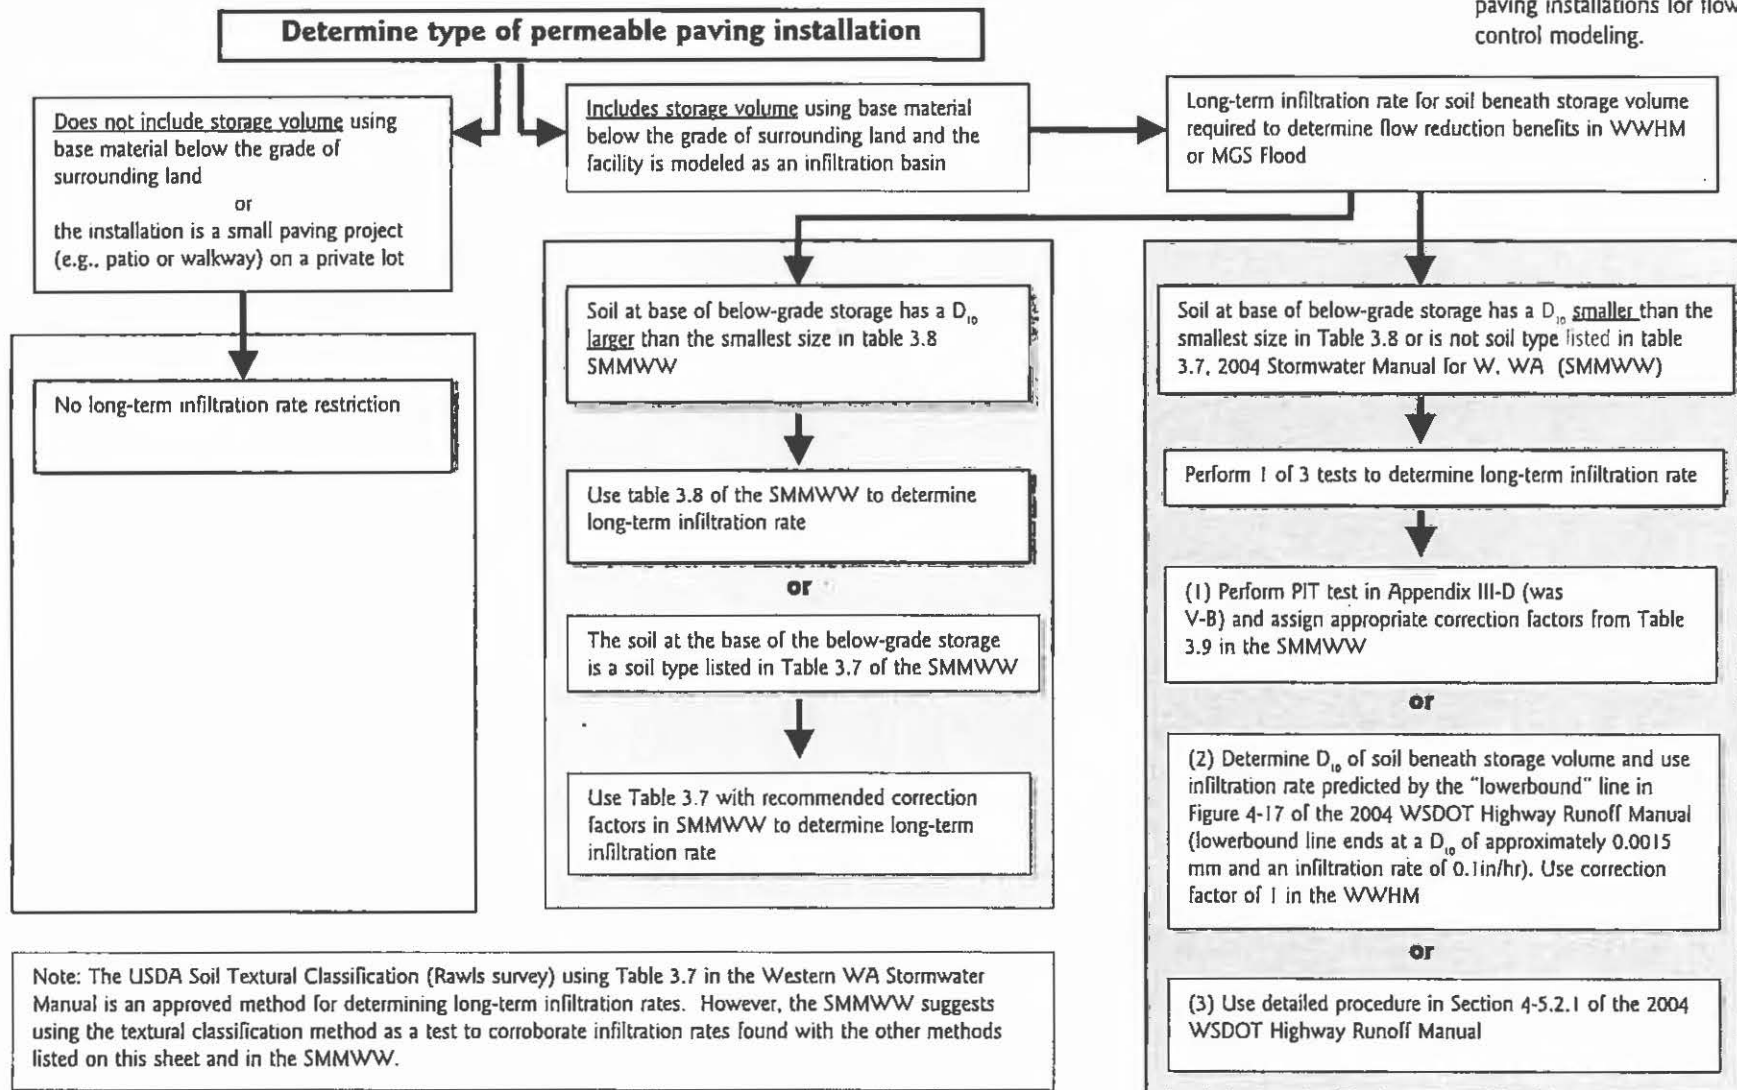
Figure 6.3.2 Determining long-term infiltration rates in soils under permeable paving installations for flow control modeling.

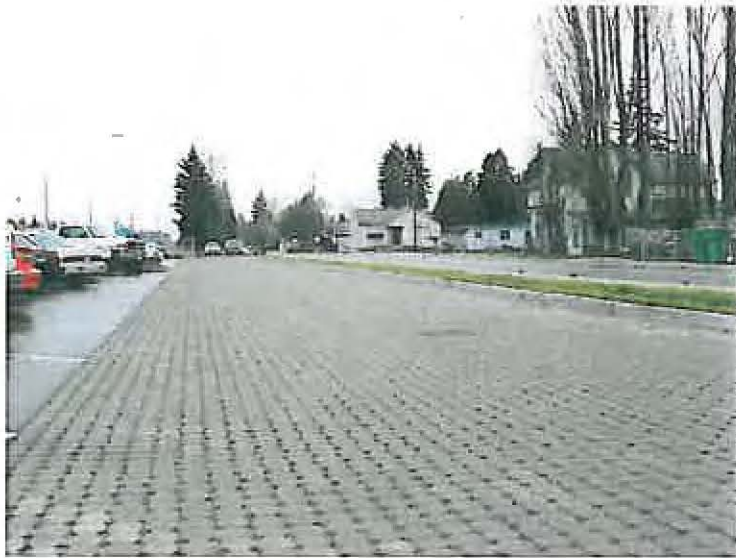
Figure 6.3.3 Permeable pavers were installed at this Marysville parking lot for infiltration. Organic material was mixed with sand as part of the sub-base to enhance treatment.

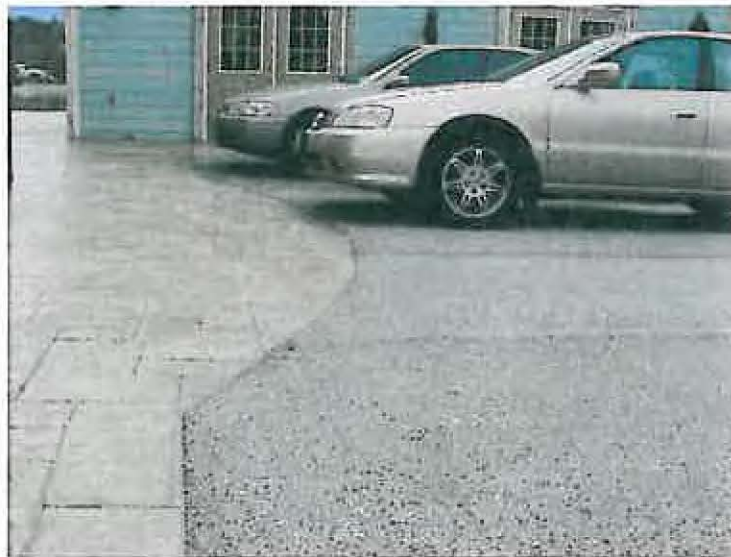
Figure 6.3.6 Permeable concrete adjacent to stamped concrete in Des Moines.

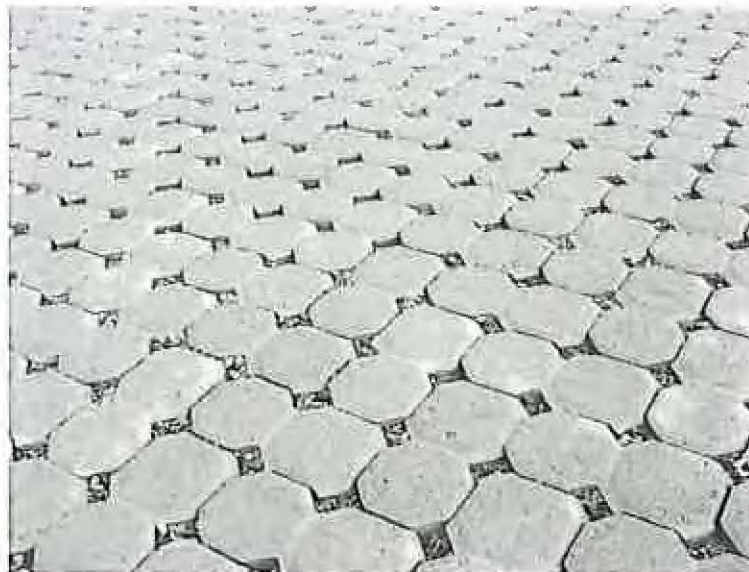
Figure 6.3.8 Close-up view of permeable pavers.

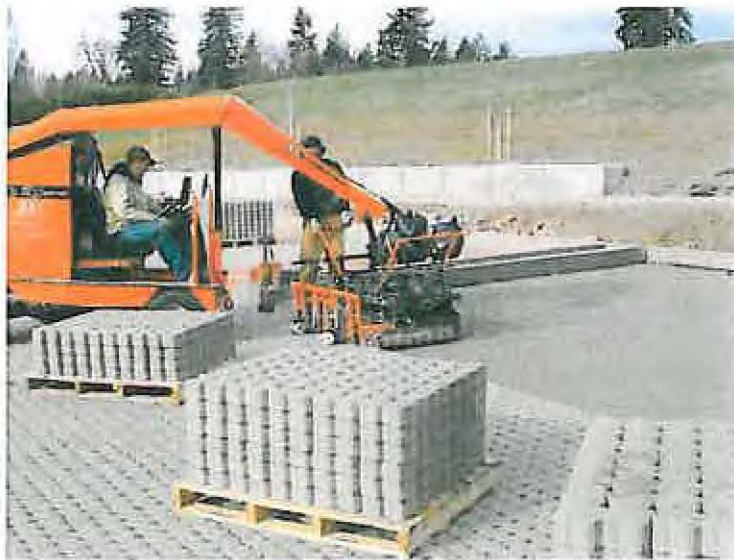
Figure 6.3.9 Mechanical installation of Eco-Stone pavers.
