Technical Memorandum

| | | Project Name: | Long Term Bioretention Monitoring Study, Phase III |
| Subject: | Task 3.2 Geotechnical and Hydrogeologic Data/Report, City of Olympia Contract Agreement Number: C2300003 | | |

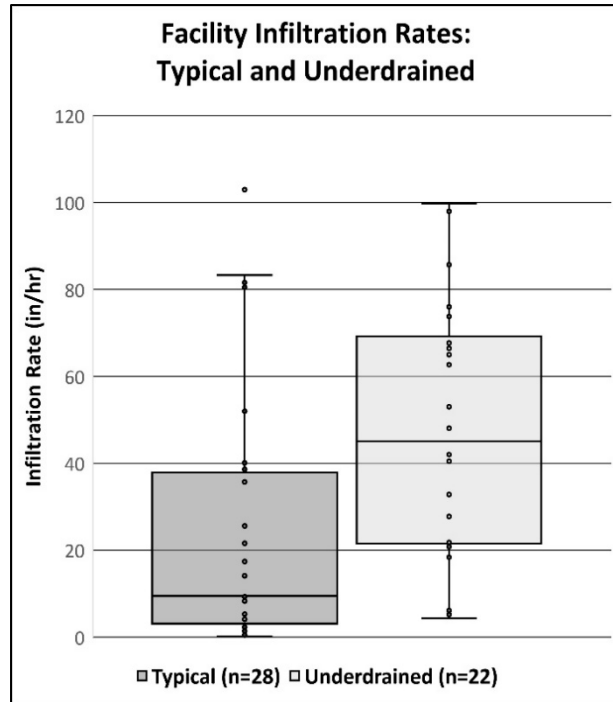
Chart 1. Boxplot of Facility infiltration rates for typical and underdrained facilities. For this plot, facilities with a large storage sump were grouped with underdrained. The plot used an exclusive median.

For this study, the native soil was the limiting layer for most of the typical infiltrating sites.

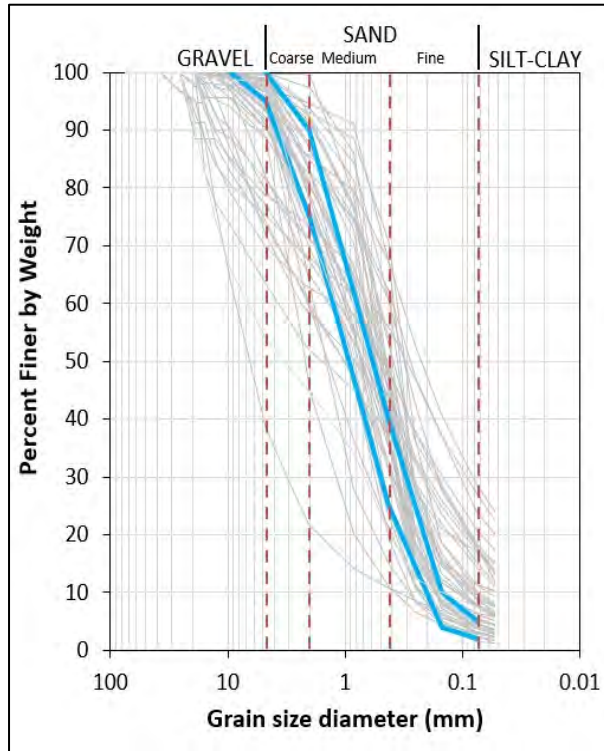
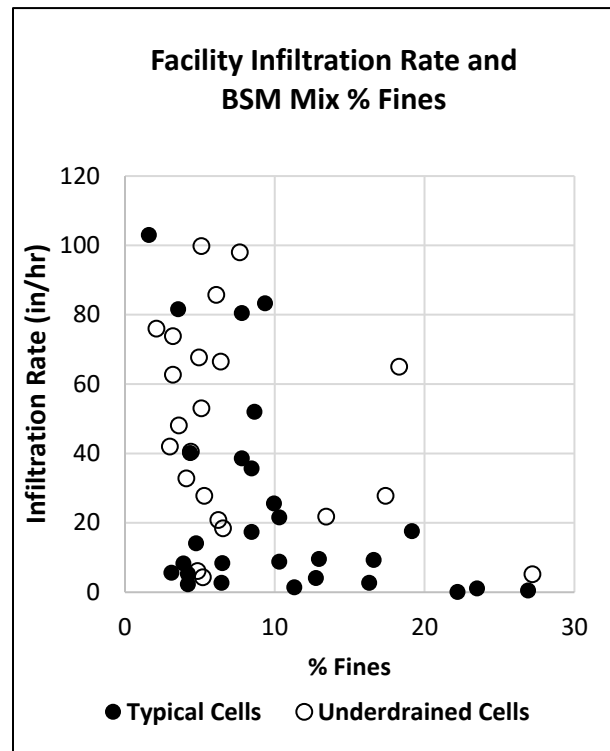
Chart 3 (left). Bioretention soil grain size distribution curve. The light blue lines illustrate the current specification guidelines for the 60:40 bioretention soil mix.

- Most soil was finer than the current gradation on the silt, fine sand and medium sand fractions.
- Most sites contained more gravel than the current gradation
- 9 sites had 15+% silt/clay
- Wide range of organic matter content, 2 to 29% by weight

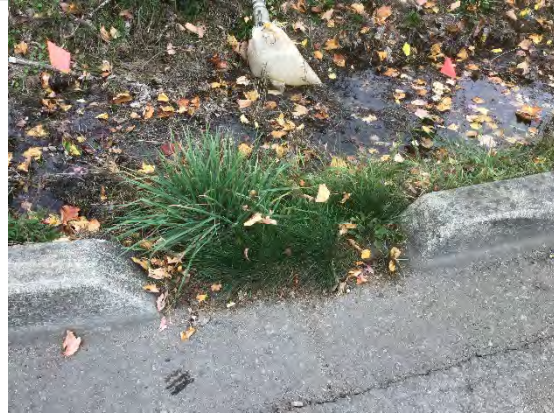
FA_INphoto-20231009-192612.jpg

Additional Details: Grass and soil built up around curb cut inlet. Evidence of ponding along curb due to fines deposition.

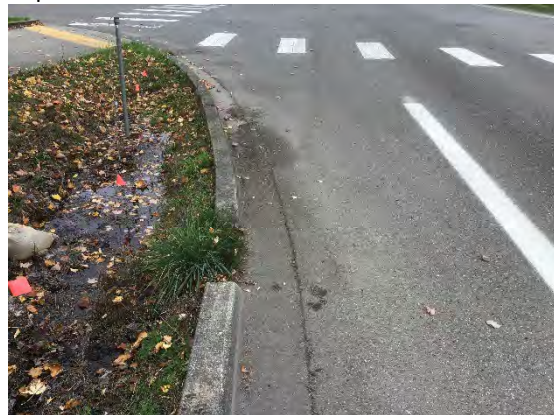
FA_INBLPhoto-20231009-192554.jpg

Additional Details: Quarry spalls noted in plans buried by sediment and organic debris.

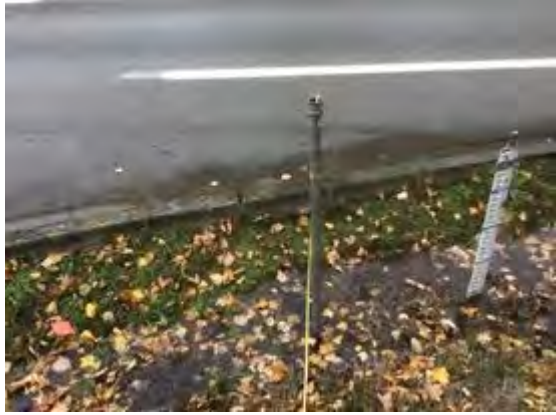
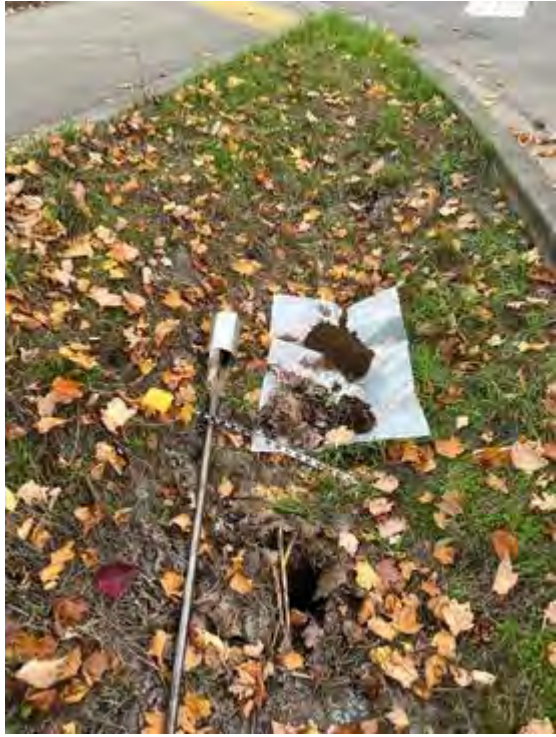
| HA-1WP | | <p>FA_FPhoto-20231009-210838.jpg</p> <p>IMG_0724.jpg</p> |

| Rain/Garden Mix Soil Texture: Slightly moist, loose, dark brown, fine to medium SAND, some gravel, some silt, abundant organics (SW-SM). Native Soil Texture: Slightly moist, medium dense, light brown fine to medium SAND, some gravel, trace silt. (SP) | | |

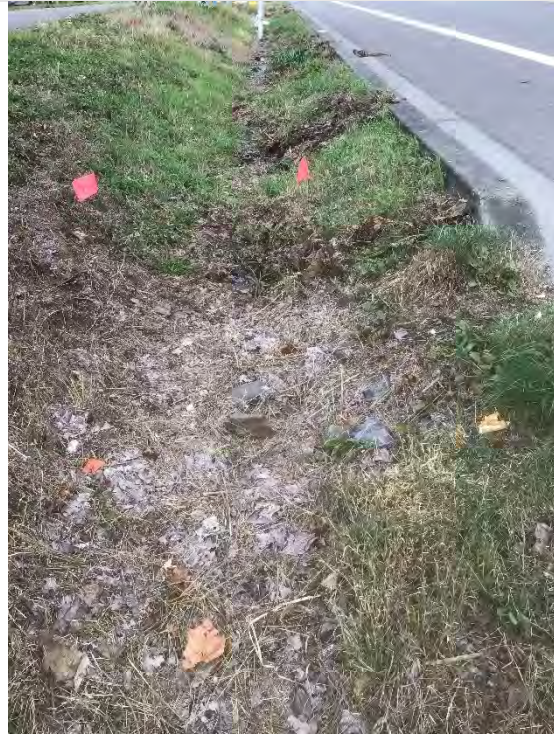
FA_INphoto-20230919-173520.jpg

Additional Details: Grass and sand built up.

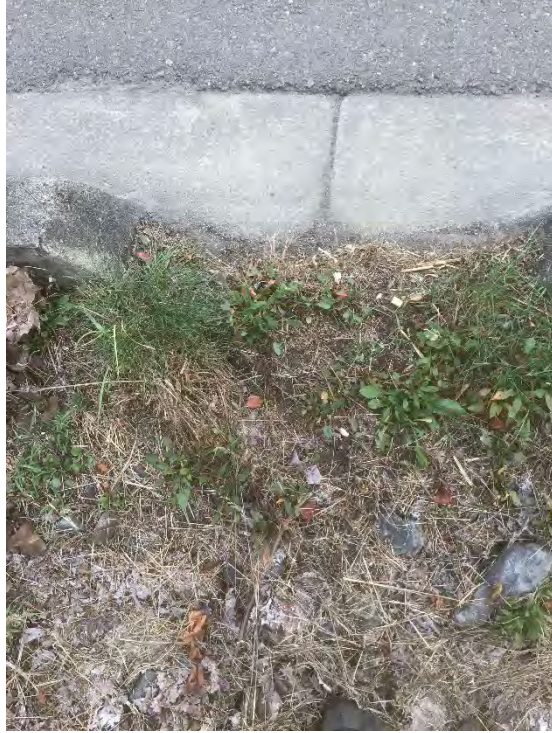
FA_INBLPhoto-20230919-184219.jpg

Additional Details: Some angular cobbles exposed beneath mat of grasses and vegetative debris.

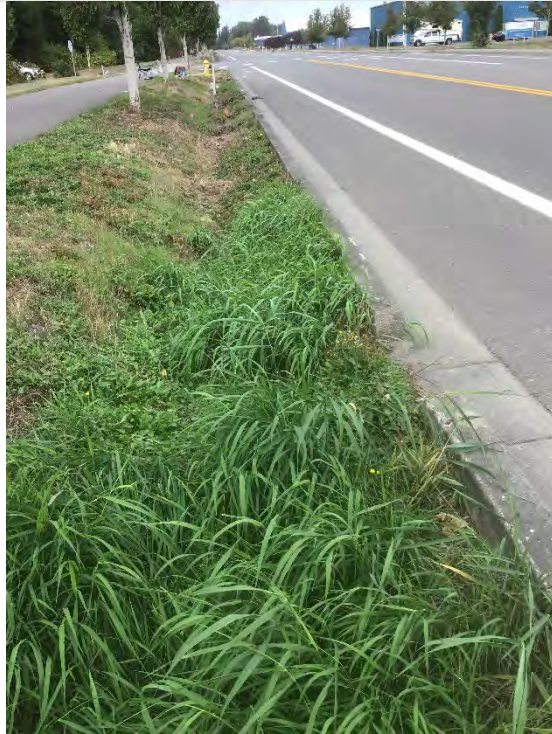
FA_INphoto-20230919-173854.jpg

Additional Details: Large weed growth with organic material piled against it.

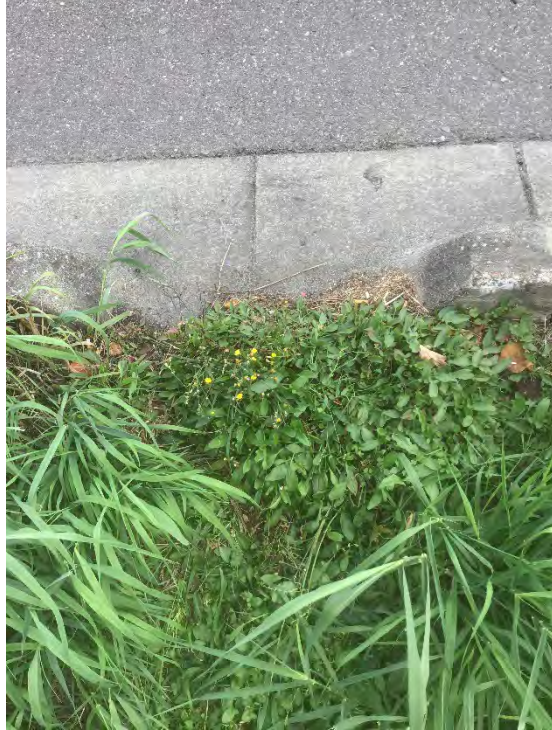
FA_INBLPhoto-20230919-173841.jpg

Additional Details: In comparison to adjacent inlets, more vegetative growth and taller grasses surrounds inlet 3.

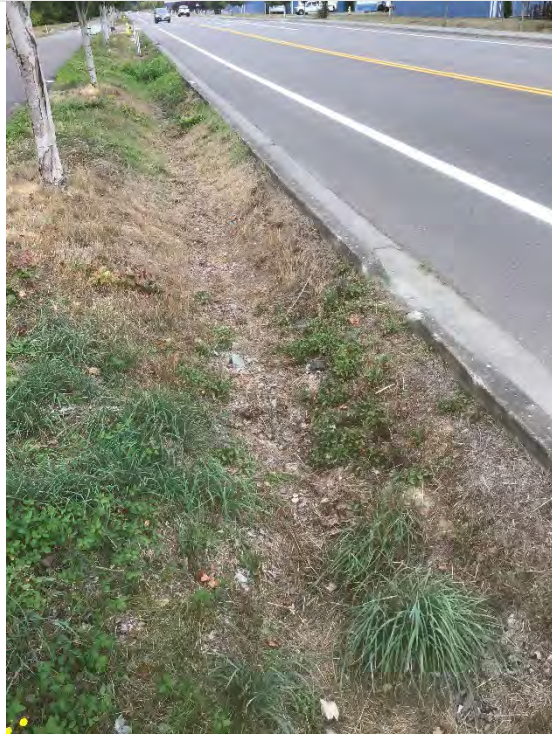
FA_INphoto-20230919-183827.jpg

Additional Details: Blockages fills entire inlet but not impervious.

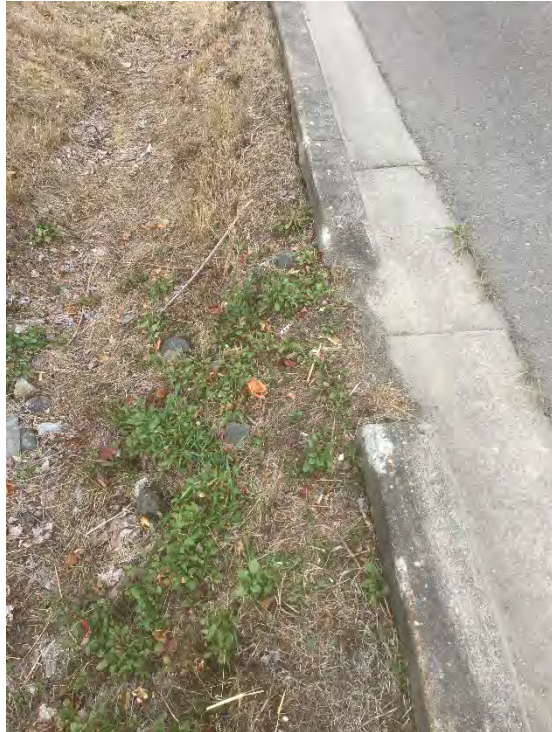
FA_INBLPhoto-20230919-183546.jpg

Additional Details: Some angular cobbles exposed though most are buried under grass cuttings.

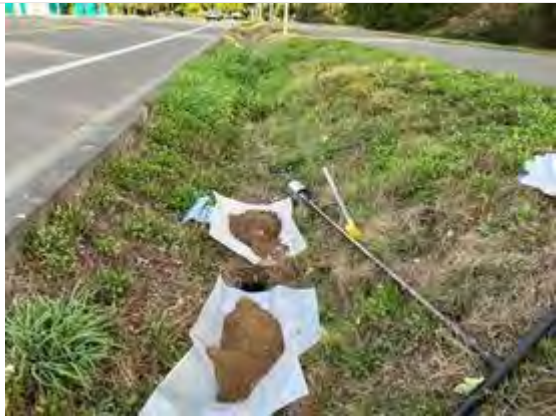
| IMG_0610.jpg | |

| Rain/Garden Mix Soil Texture: Loose, slightly moist, dark brown, gravelly, fine to medium SAND, some silt, abundant organics (SW-SM). Native Soil Texture: | |
| Liner Present: <input type="checkbox"/> Yes <input checked="" type="checkbox"/> No | Filter Fabric Present: <input checked="" type="checkbox"/> Yes <input type="checkbox"/> No Filter fabric at 1.7' |

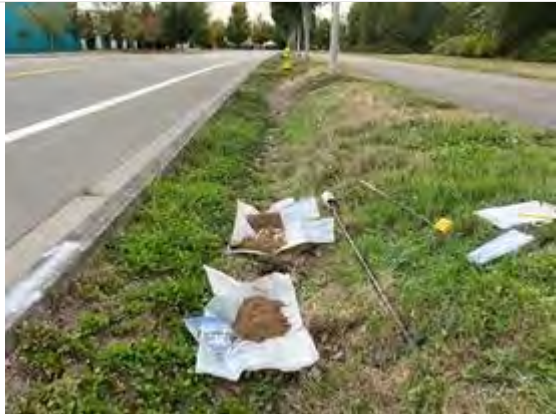
| IMG_0617.jpg | |

| Rain/Garden Mix Soil Texture: Loose, slightly moist, dark brown, gravelly, fine to medium SAND, some silt, abundant organics (SW-SM). Native Soil Texture: | |
| Liner Present: <input type="checkbox"/> Yes <input checked="" type="checkbox"/> No | Filter Fabric Present: <input checked="" type="checkbox"/> Yes <input type="checkbox"/> No Filter fabric at 1.8' |

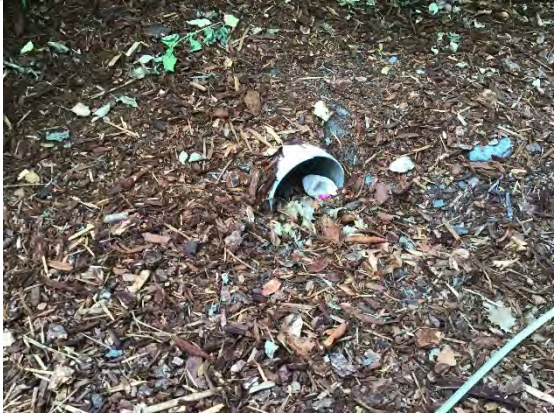
| <p>Erosion Present? <input type="checkbox"/> Yes <input checked="" type="checkbox"/> No</p> | <p>Blockage Present? <input checked="" type="checkbox"/> Yes <input type="checkbox"/> No Approximately 30% blocked</p> <p>Types: <input type="checkbox"/> Sediment <input type="checkbox"/> Organic <input type="checkbox"/> Rock <input checked="" type="checkbox"/> Trash <input type="checkbox"/> Vegetation</p> <p>Additional Details: Pipe blocked in leaf litter, trash, beauty bark.</p> |
| <p>Additional Details: Buried stream cobbles under 0.3 feet of sedimentation.</p> | |

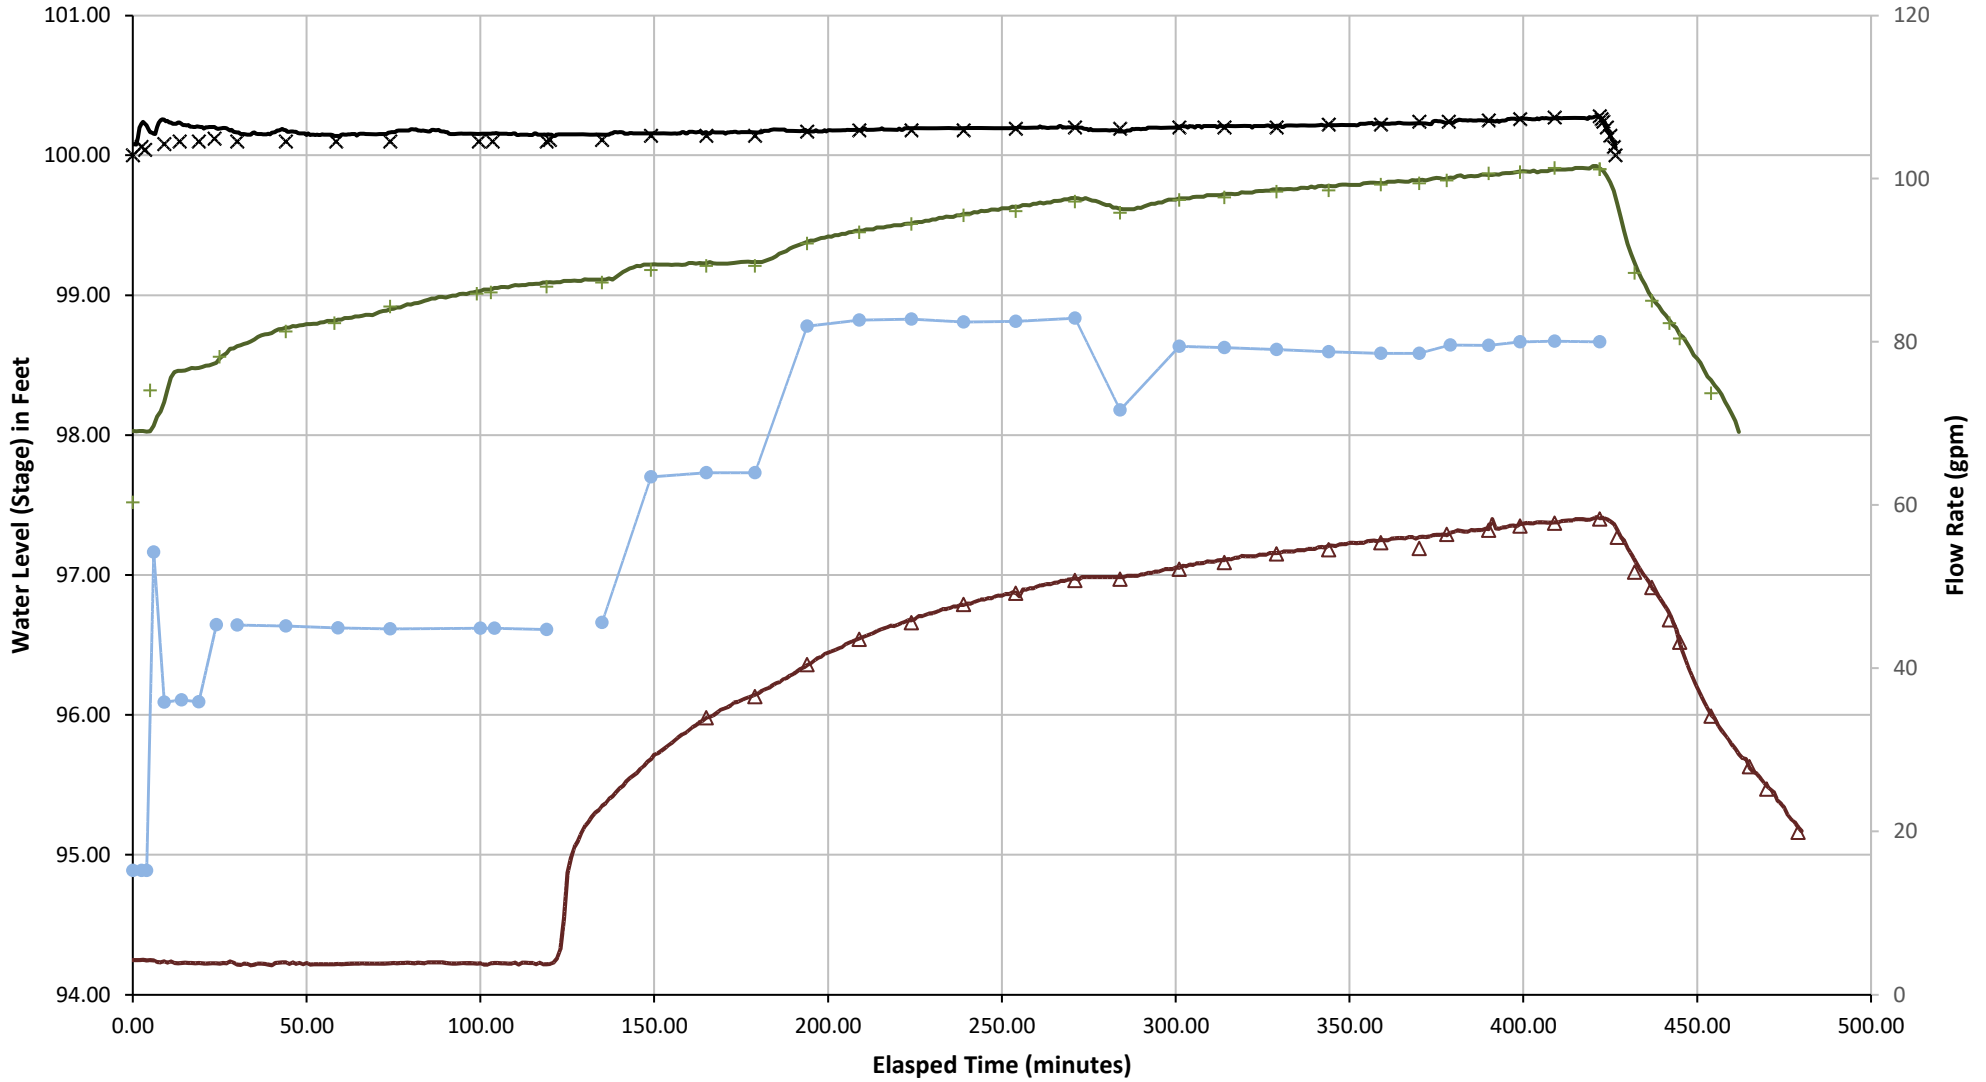
Stage (feet) on Left Axis; Flow Rate (gpm) on Right Axis vs Elapsed Time (minutes)

Notes: Elevations are not surveyed and should be used as a relative reference. Elevation 100 represents ground surface. Catch Basin set in native soils

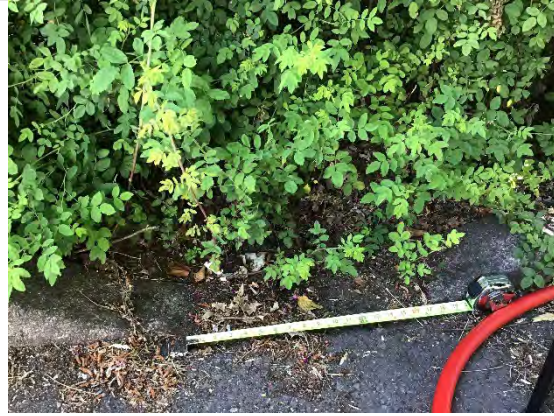
FA_INphoto-20230705-233238.jpg

Additional Details: There is 0.15 feet of sediment buildup on the downhill, eastern, edge of curb cut. Trace amounts of sediment buildup was observed along the cell bottom. Deposition of sediment and matted organic material was observed behind the inlet.

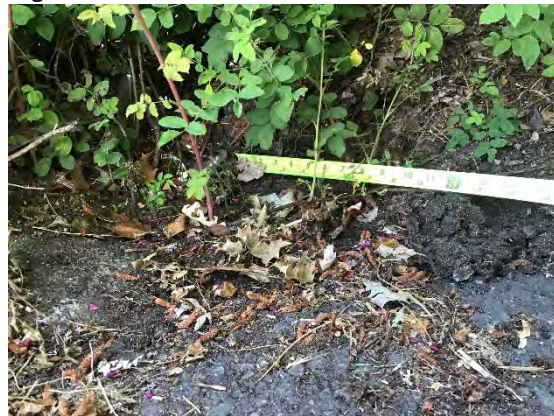
FA_INBLPhoto-20230705-233552.jpg

Additional Details: No energy dissipation was observed.

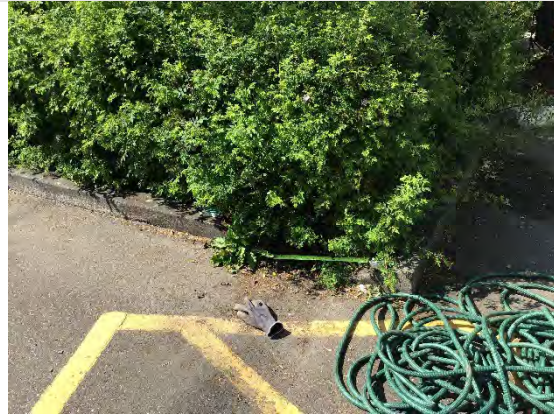
FA_INphoto-20230705-234001.jpg

Additional Details: Sediment accumulation was observed on the downhill, southern, side if inlet. Matted leaves fixed to the sides of plants adjacent to the inlet up to 0.7' above ground. A plant was observed growing in the organic buildup on the inlet.

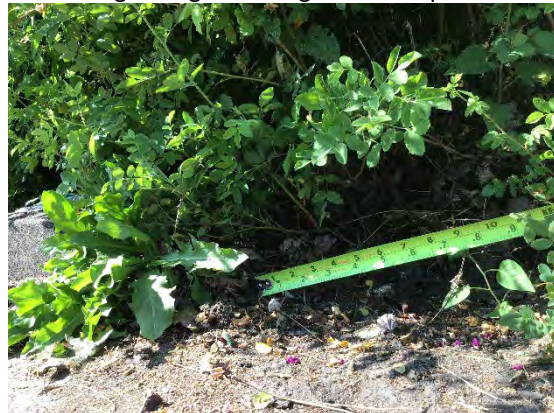
FA_INBLPhoto-20230705-233949.jpg

Additional Details: No energy dissipation was observed.

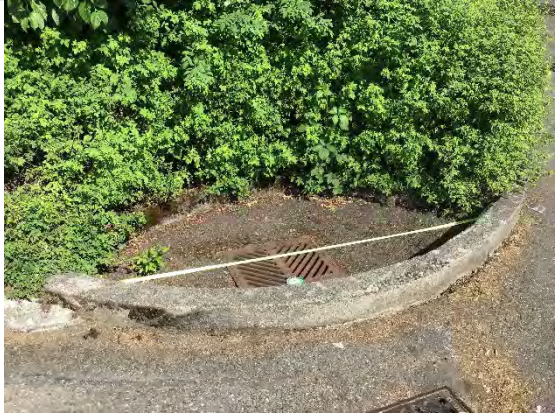
| Stickup (ft) From Ground: 0.5 Relative from staff gauge: 0.3 | FA_DOPhoto-20230705-234423.jpg |

| Shape: <input type="checkbox"/> Round <input type="checkbox"/> Rectangular <input checked="" type="checkbox"/> Other: Semicircle Additional Details: The overflow is a 9.5' diameter semicircle which divides the bioretention cell from the overflow catch basin at ground level. | Dimensions: |

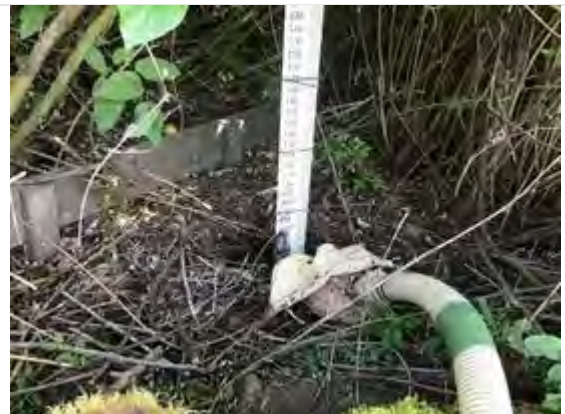
IT_Photo-20230705-235400.jpg

| Three infiltration tests were performed. Test statistics above came from IT-1, with the total gallons being the sum of all three tests. IT-1 had the diffuser located closest to inlets 1 & 2. IT-2 had the diffuser located in the middle of the cell, close to Wellpoint. IT-3 had the diffuser located in | |

NE edge of the cell, closer to the outlet. Additional test details can be found in the executive summary.

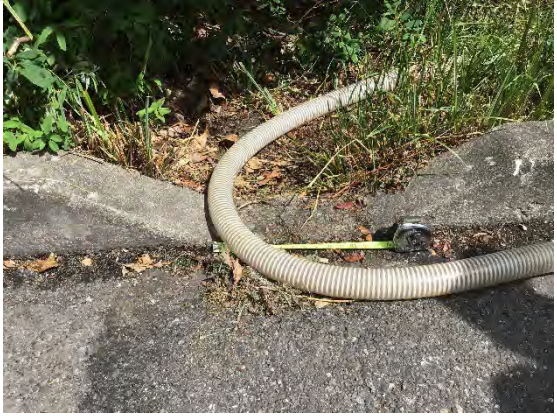
| <input checked="" type="checkbox"/> Curb cut <input type="checkbox"/> Sheet Flow <input type="checkbox"/> Dispersed Flow <input type="checkbox"/> Pipe <input type="checkbox"/> Other: Width: 1.1' Energy Dissipation Angular Rock: n/a Stream Cobble: n/a Water Wheel: n/a Splash Block: n/a Concrete Apron: n/a | FA_INphoto-20230629-182054.jpg |
| Erosion Present? <input checked="" type="checkbox"/> Yes <input type="checkbox"/> No Severity: Minor There was a 0.2' deep scour observed in a 1.5' diameter zone near the inlet. | Blockage Present? <input type="checkbox"/> Yes <input checked="" type="checkbox"/> No |
| Additional Details: No energy dissipation mechanism was observed. | |

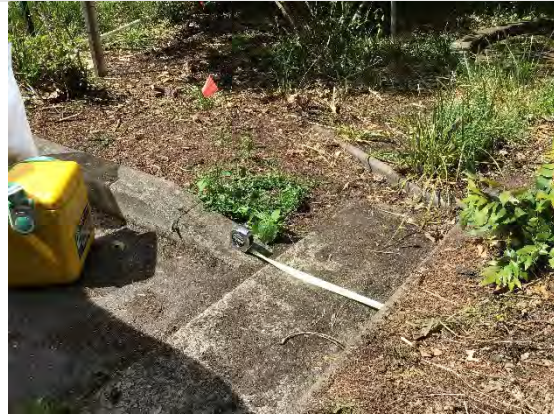
FA_INphoto-20230629-182849.jpg

Additional Details: The inlet is not immediately blocked but there is significant sediment blocking inlet which would prevent low levels of water from actually entering the cell.

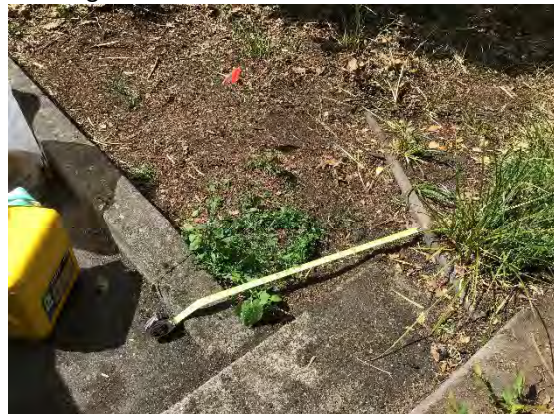
FA_INBLPhoto-20230629-182800.jpg

Additional Details: There is a vertical concrete apron which terminates 6.2' from sidewalk that appears like it was designed to direct water into the center of the cell. However the concrete apron is buried and has created a build up of sediment that partially blocks entry into the cell.

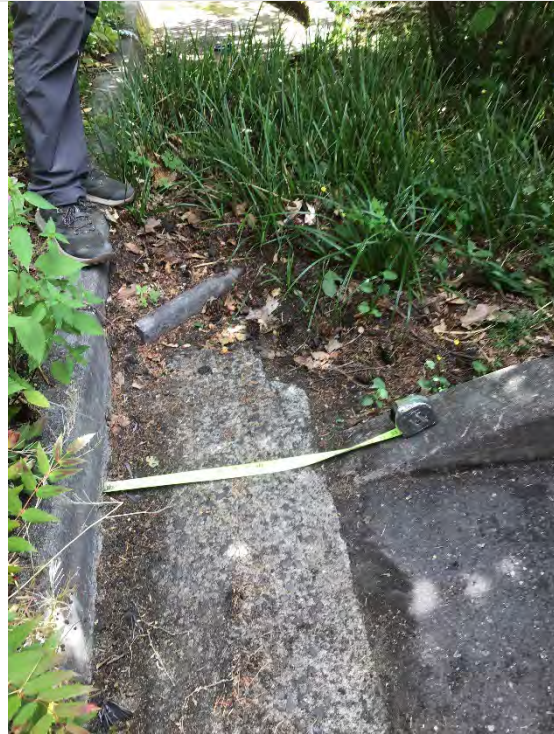
FA_INphoto-20230629-185739.jpg

Additional Details: Sediment and organic debris blocks the the pathway for water to enter the cell.

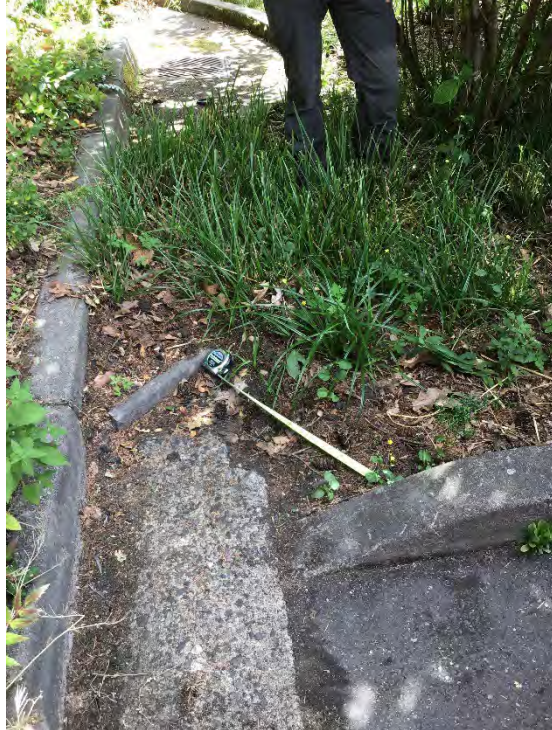
FA_INBLPhoto-20230629-185720.jpg

Additional Details: There is a vertical concrete apron which terminates 6.2' from sidewalk that appears like it was designed to direct water into the center of the cell. However the concrete apron is buried and has created a build up of sediment that significantly blocks run off into the cell.

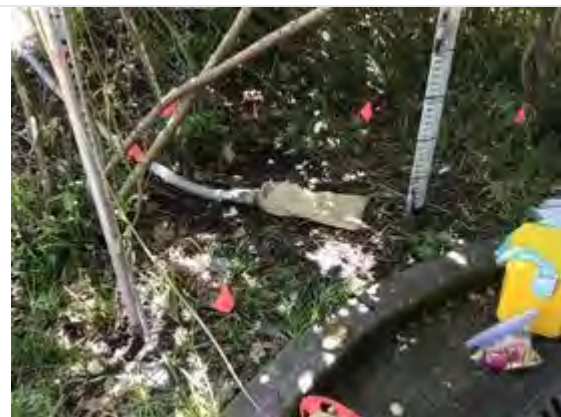
IT_Photo-20230629-215119.jpg

Additional Details:
 Two infiltration tests were performed. The first test was conducted near inlet 1 in the southeast corner. The second test was completed closer to the overflow on the north end of the cell. Additional test details can be found in the executive summary.

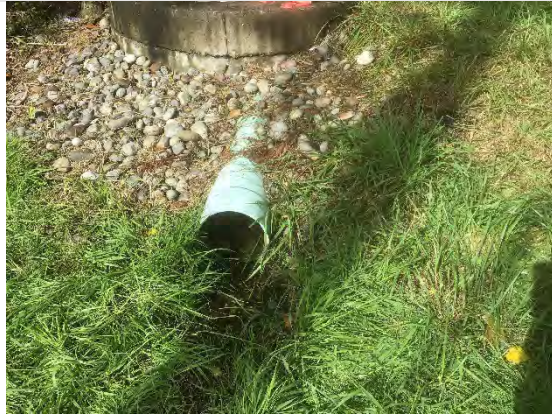
FA_INphoto-20231003-193742.jpg

Additional Details: Minimal blockage of pine needles was observed.

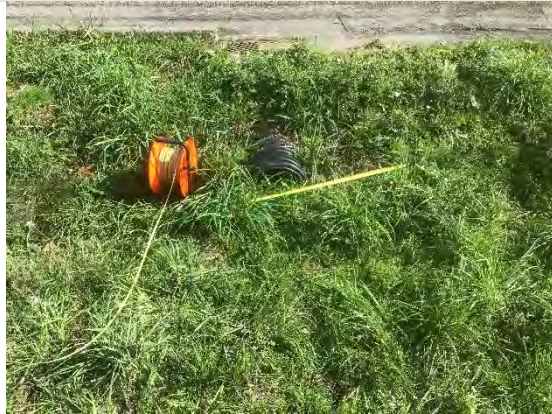
FA_INphoto-20231003-202232.jpg

Additional Details: Outfall of pipe is blocked by build up of sediment and thick grasses.

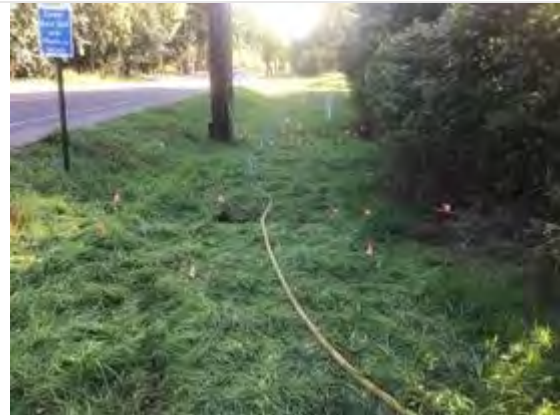
Three infiltration tests were conducted in this facility, the first test includes cells 1 and 2, IT-2 is in cell 3, and IT-3 is in cell 4. Additional test details can be found in the executive summary. Flags in the first image indicate the different ponded areas for each test.

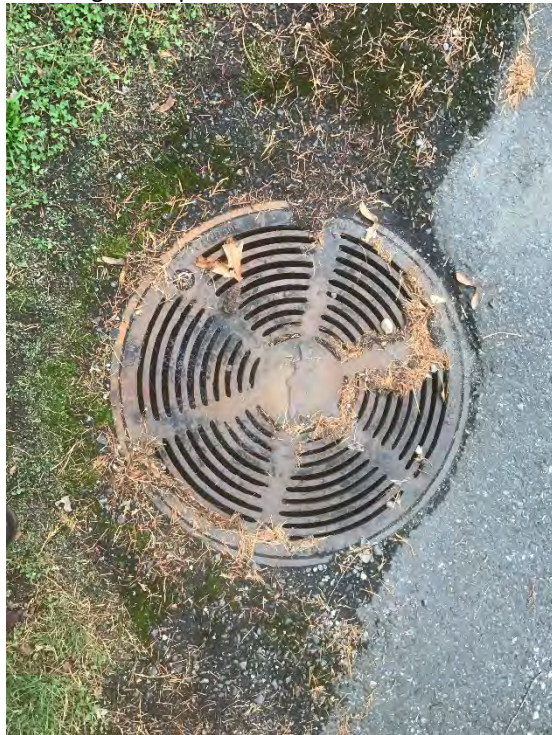
FA_INBLPhoto-20231004-163610.jpg

Additional Details: IN-1 flows into the bioinfiltration swale outfall structure, described previously.

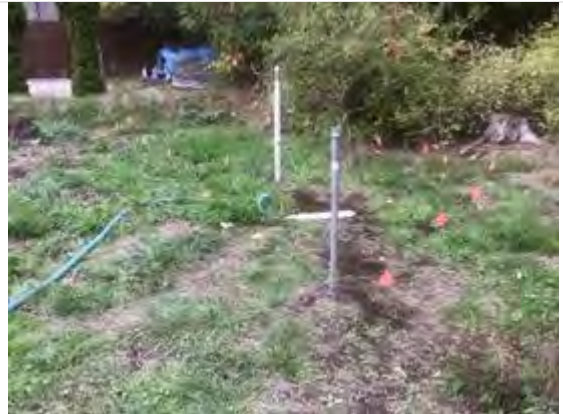
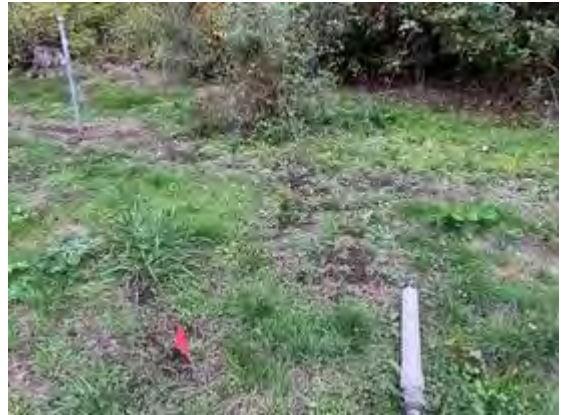
IT_Photo-20231004-204329.jpg

| Additional Details: Two infiltration tests, IT-1 was located centrally in the cell in an area that had some evidence of water flow. IT-2 was located in the northwest of the cell in a zone that shows evidence of past water ponding. IT-2 had a significantly lower infiltration rate, possibly due to accumulation of fines and compaction of soil due to ponding water. | |

Two infiltration tests were conducted, IT-1 (76 in/hr) was located centrally in the cell in an area that had some evidence of past water flow. IT-2 (22.3 in/hr) was located in the northwest of the cell in a zone that showed greater evidence of past water ponding. IT-2 had a significantly lower infiltration rate, likely due to accumulation of fines and compaction of soil due to ponding water.

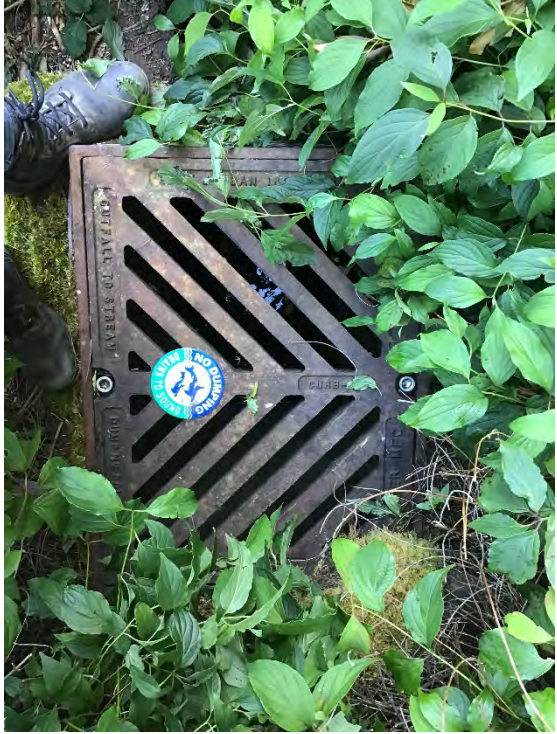
| FA_DOPhoto-20230816-172738.jpg | |

| Overflow Blocked? <input checked="" type="checkbox"/> Yes <input type="checkbox"/> No Approximately 5% blocked Additional Details: Vegetation hinders access, unable to gather relative stick up from staff gauge zero due to brambles | |

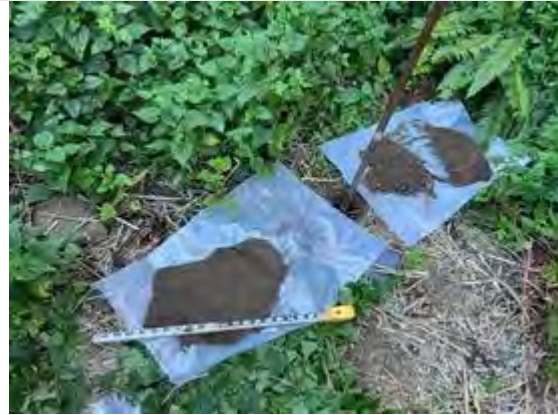
IMG_0463.jpg

| Additional Details Underdrain encountered at 1.5' | |

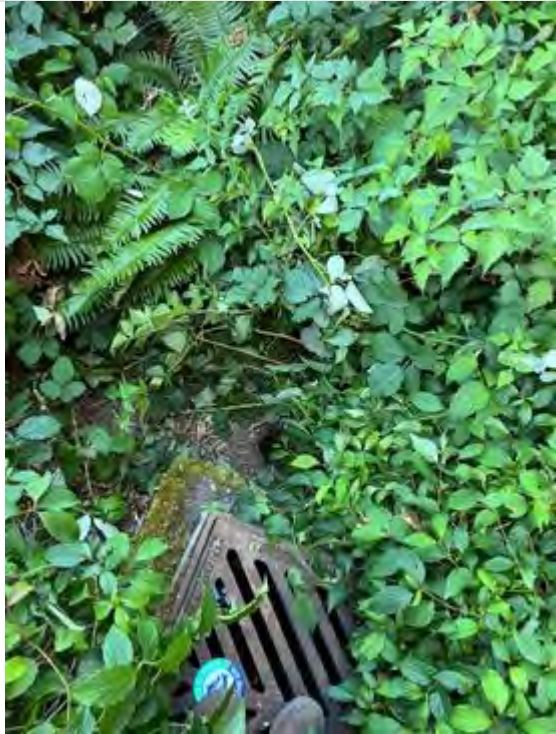
| IMG_0469.jpg | |

| Additional Details 0-0.2 Feet of dead blackberry canes 0.2-1.0 Bioretention soil mix Bottom of hole 1 foot, no returns, blackberries limited access, | |

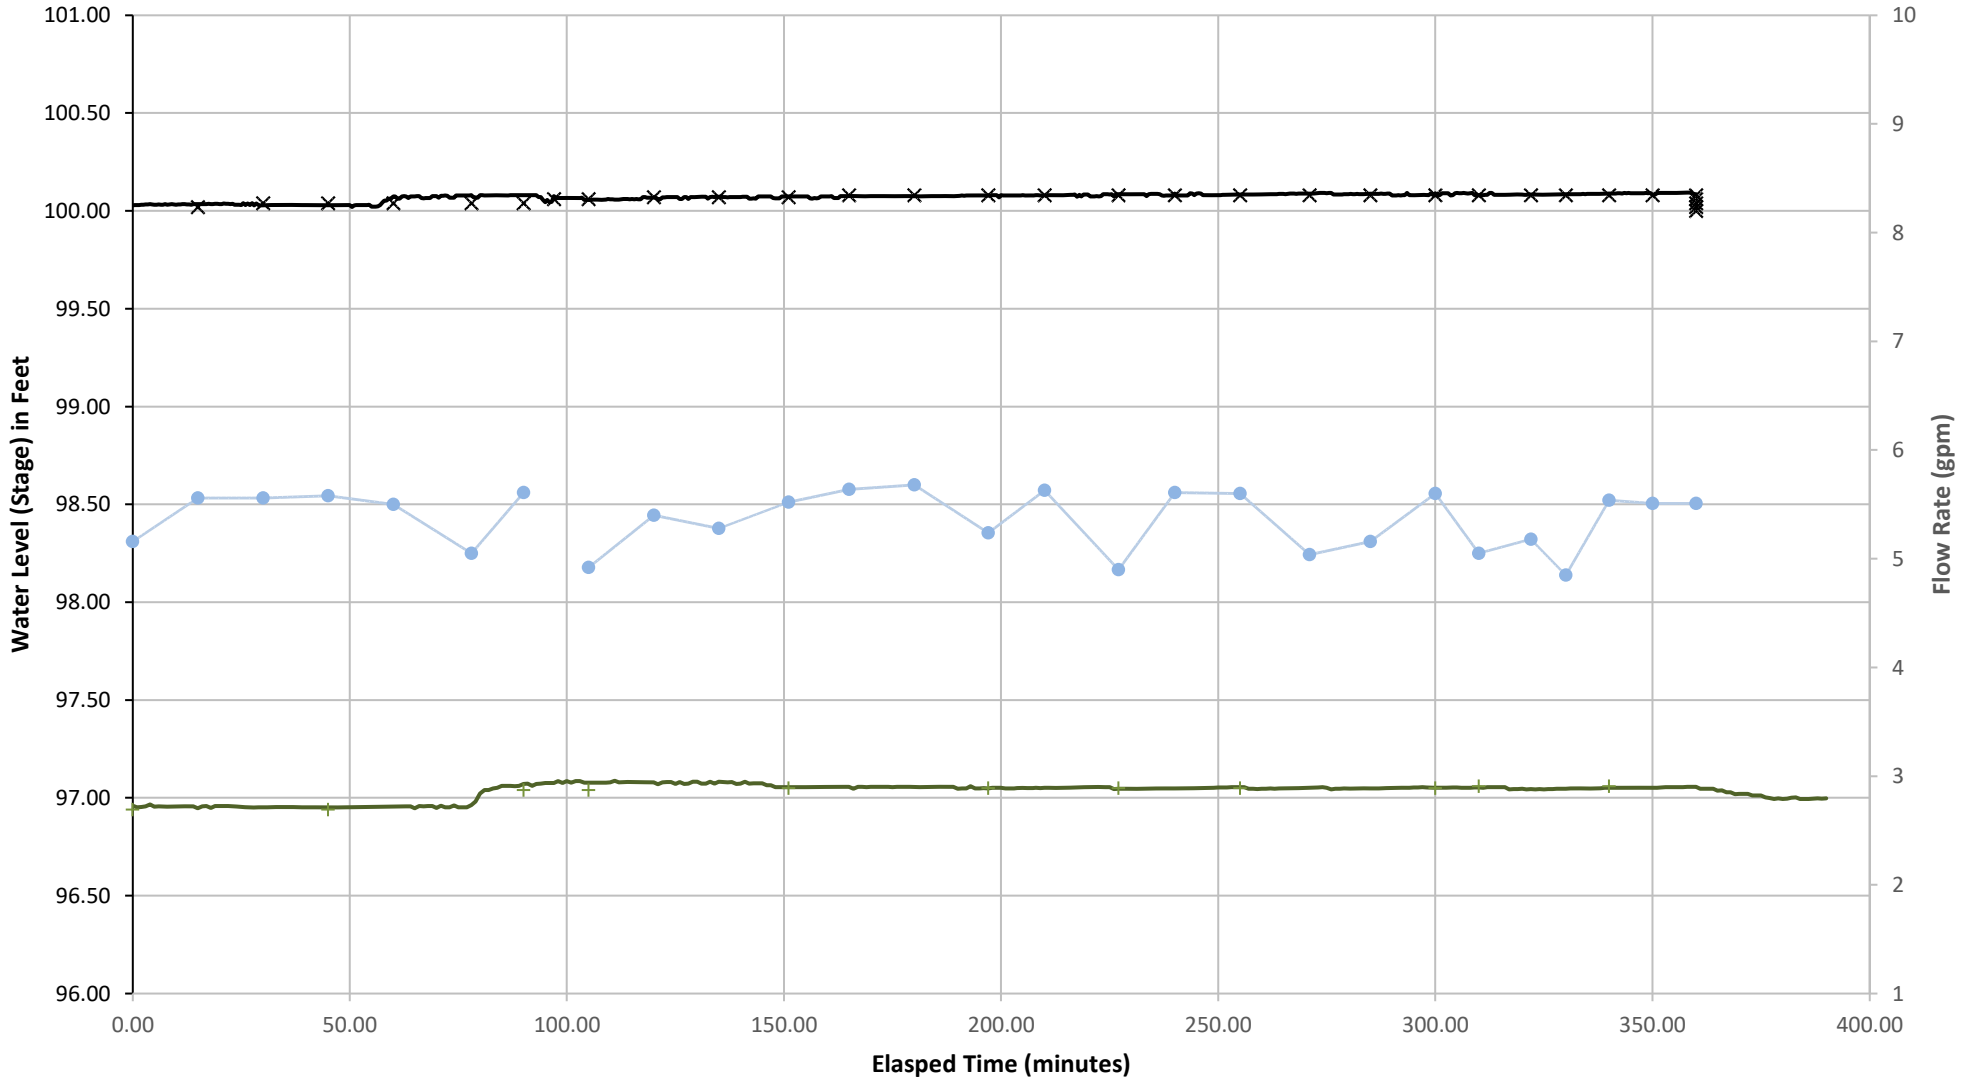
Bainbridge High School-Typ 2 (Roof Cell) (IT-1) Infiltration Test Stage (feet) on Left Axis; Flow Rate (gpm) on Right Axis vs Elapsed Time (minutes)

Notes: Elevations are not surveyed and should be used as a relative reference. Elevation 100 represents ground surface. The wellpoint did not respond to testing.

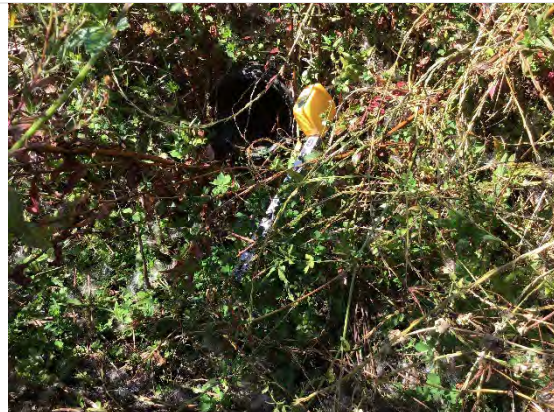
FA_INphoto-20230815-220550.jpg

| Additional Details: If any dissipation method was implemented it has been deeply buried by sediment and organic debris. | |

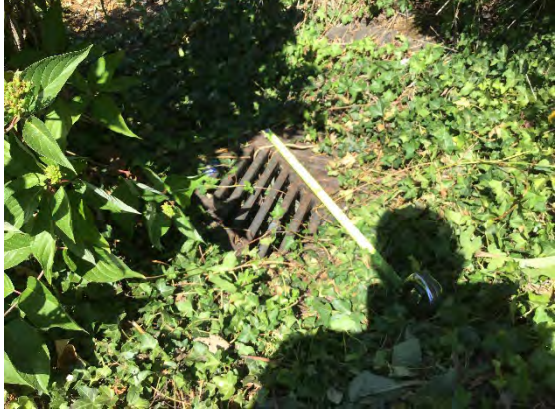
| DO - 1 Shape: <input type="checkbox"/> Round Dimensions: <input checked="" type="checkbox"/> Rectangular Length: 1.75' <input type="checkbox"/> Other Width: 1.4' Additional Details: | | <p>FA_DOPhoto-20230815-215930.jpg</p> |
| Damage Indicators: <input checked="" type="checkbox"/> Yes <input type="checkbox"/> No Vines within catch basin. Relative stick up difficult to measure due to thick vegetation between overflow structure and ponded area. | | |

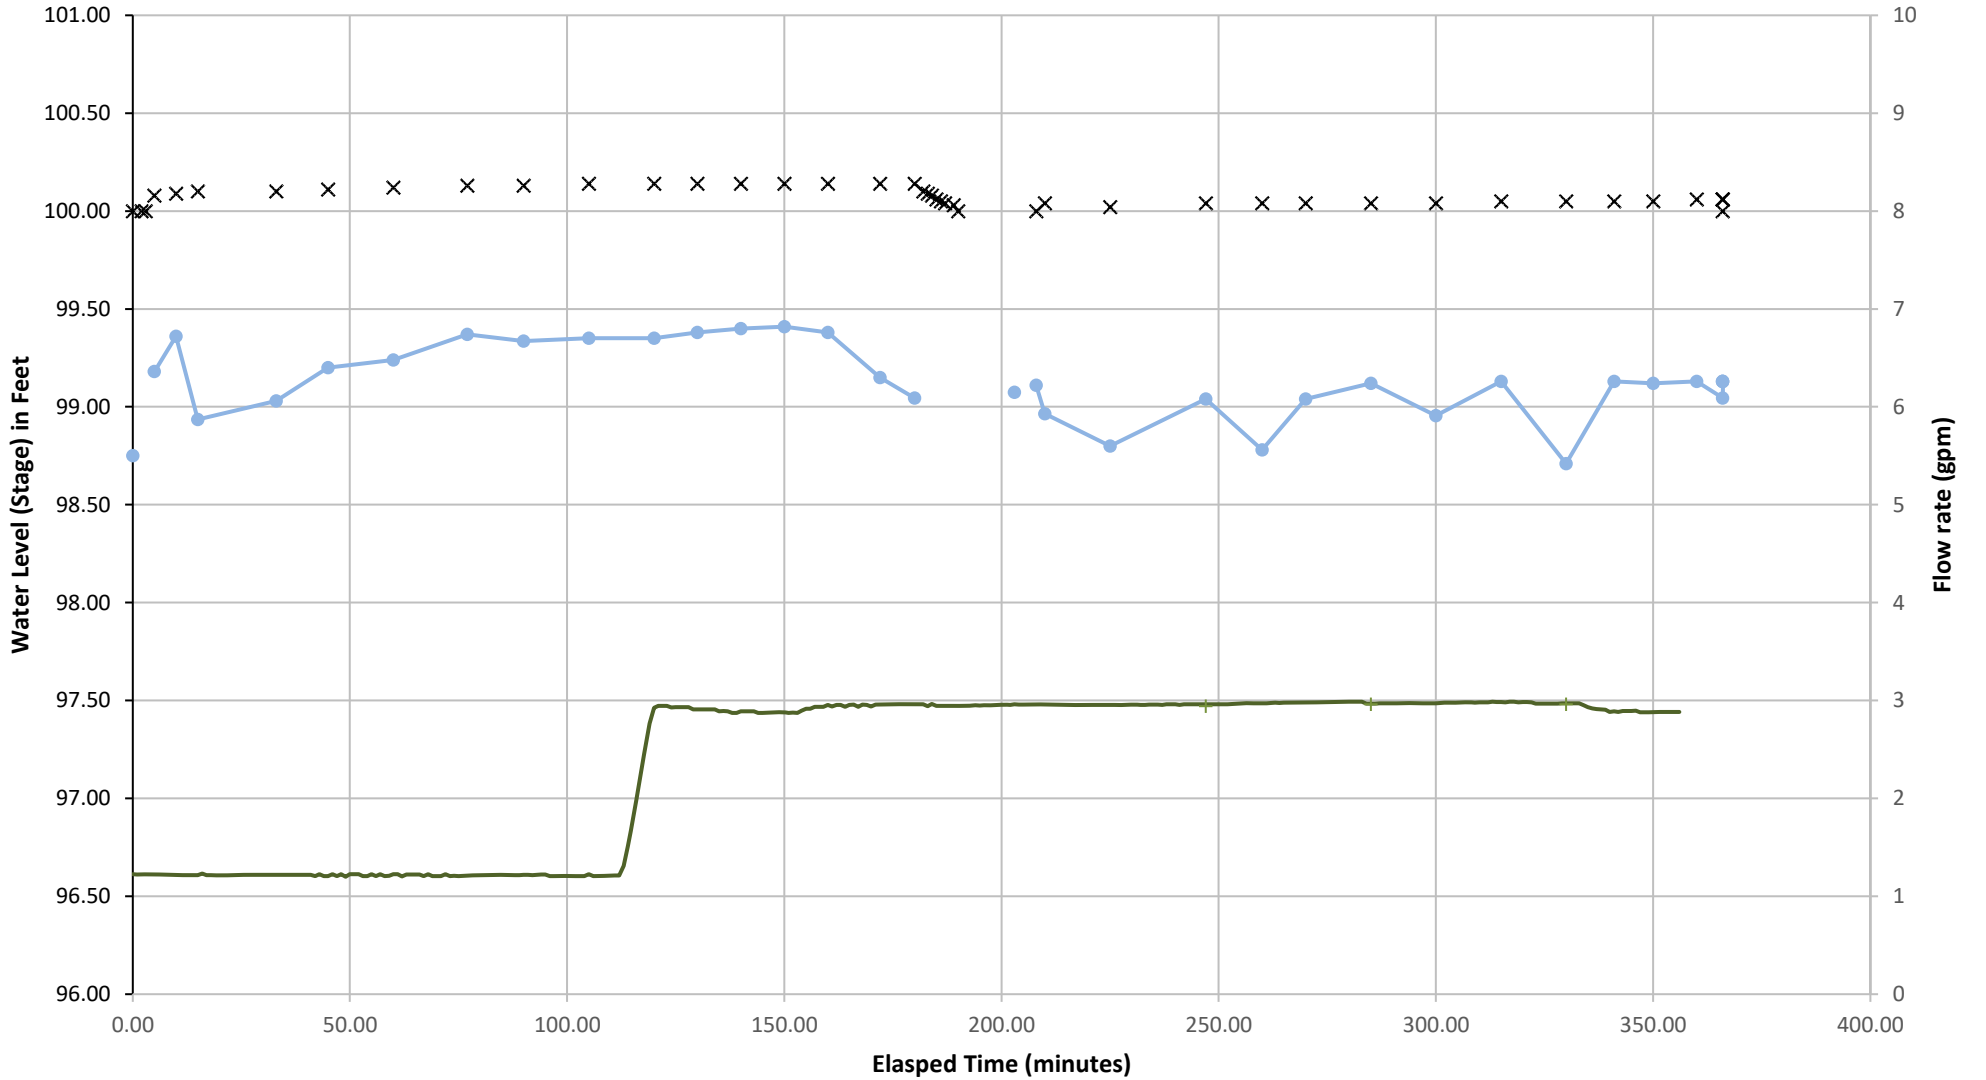
Bainbridge Island High School-Type 5 (Tennis Cell) Infiltration Test Stage (feet) on Left Axis; Flow Rate (gpm) on Right Axis vs Elapsed Time (minutes)

Notes: Elevations not surveyed and should be used as a relative reference. Elevation 100 represents ground surface. Catch Basin logger pulled immediately after test, falling head response not recorded.

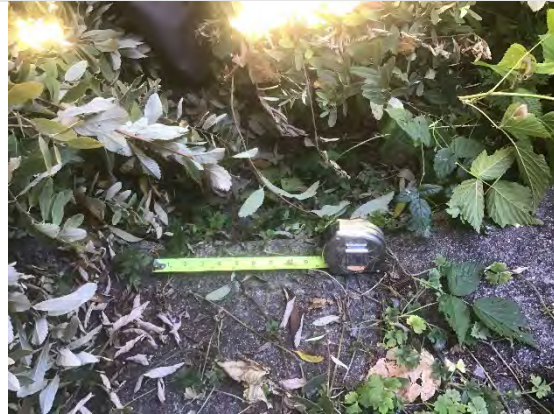
FA_INphoto-20230914-181321.jpg

Additional Details: Vegetation overhanging inlet was observed.

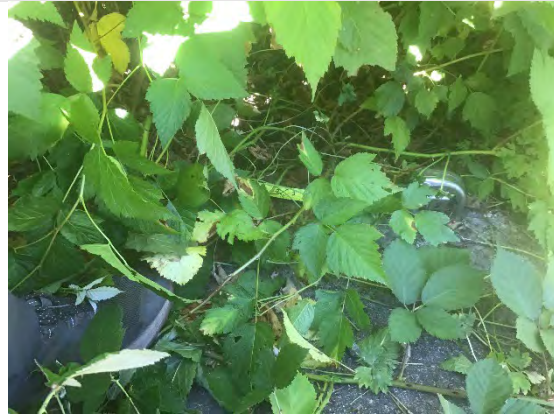
FA_INphoto-20230914-182242.jpg

Additional Details: Blackberry brambles were observed overhanging the curb.

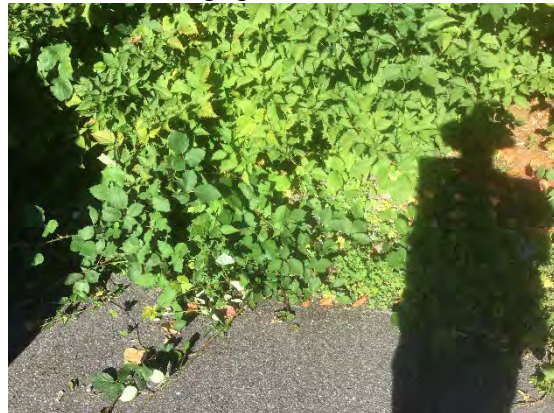
FA_INBLPhoto-20230914-182145.jpg

Additional Details: No energy dissipation was observed.

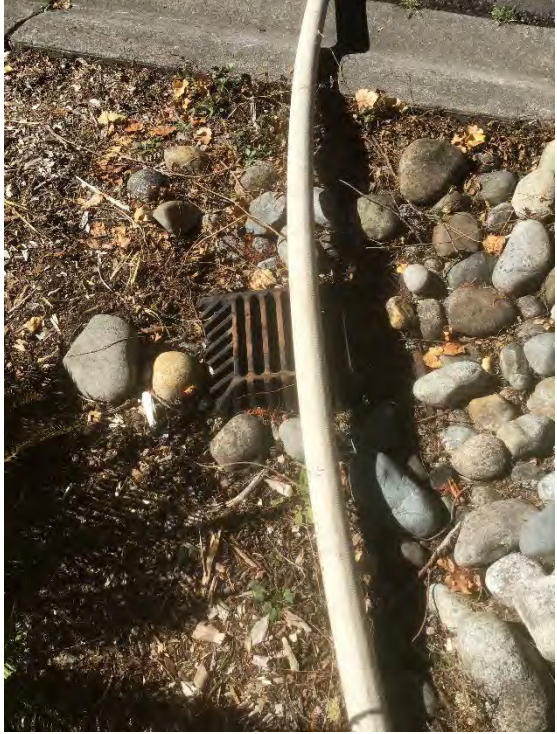
FA_DOPhoto-20230914-183348.jpg

| Overflow Blocked? <input checked="" type="checkbox"/> Yes <input type="checkbox"/> No Approximately 20% blocked Additional Details: Overflow was blocked by stream cobbles and mulch. | |

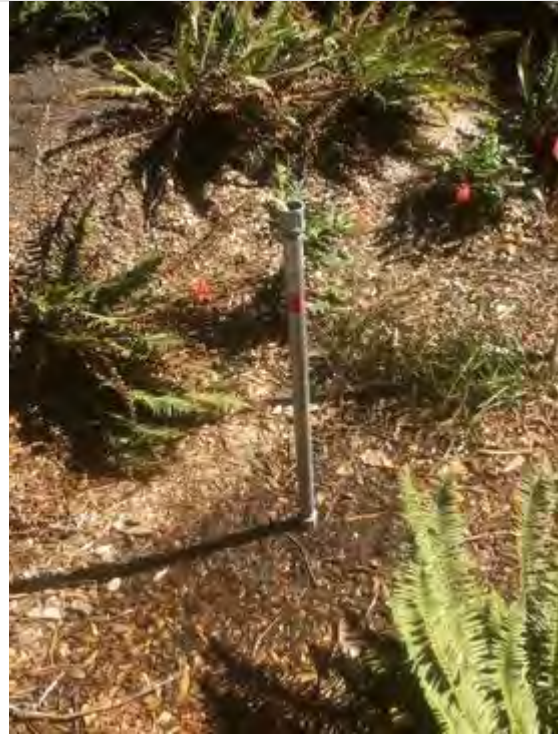
FA_FPhoto-20230914-185128.jpg

| Native sediment had moderate caving and some oxidation. Wellpoint water level rose to same elevation as surface water. | |
