Technical Memorandum

| | | Project Name: | Long Term Bioretention Monitoring Study, Phase III |
| Subject: | Task 3.2 Geotechnical and Hydrogeologic Data/Report, City of Olympia Contract Agreement Number: C2300003 | | |

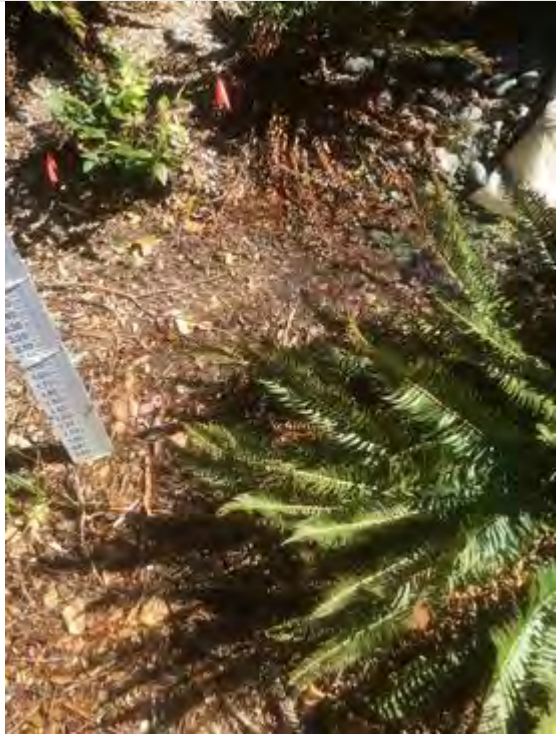
FA_FPhoto-20230914-185357.jpg

| Additional Details roots absent, severe caving from 1.6-2.5' samples mixed with above organics | |

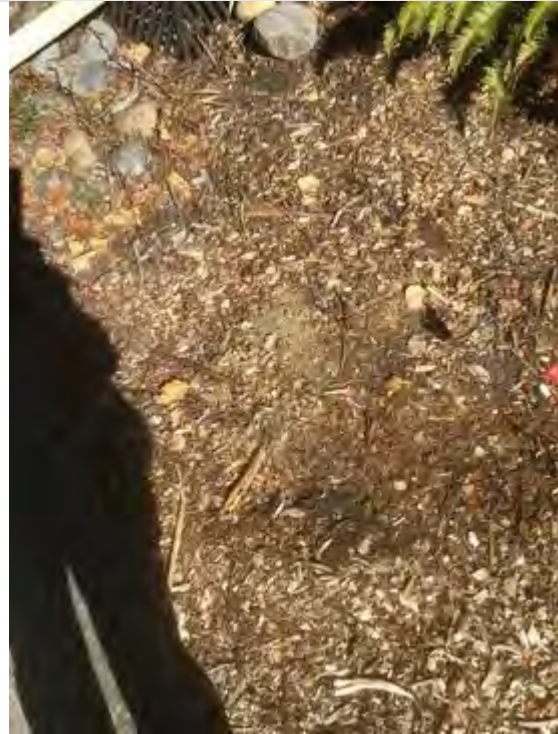
FA_FPhoto-20230914-185449.jpg

Slight oxidation on gravels was observed in the native soil.

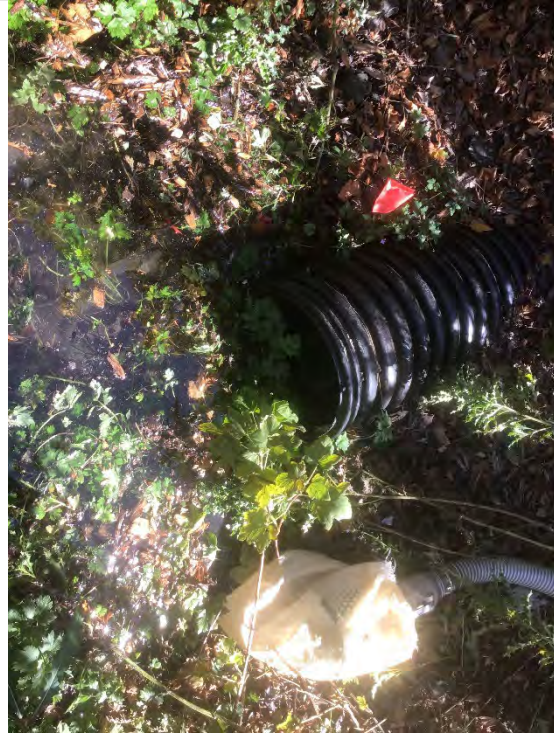
FA_INphoto-20230915-195107.jpg

Additional Details: Some leaf debris was observed on angular rocks.

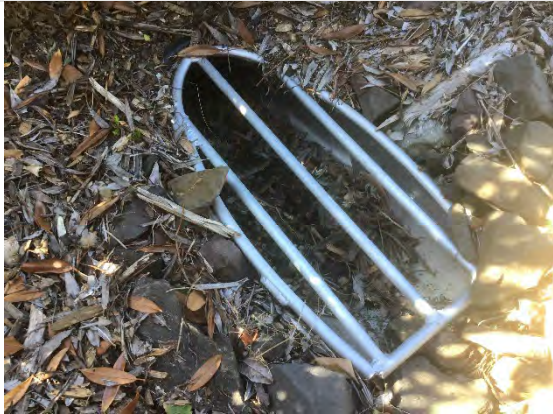
| Shape: <input checked="" type="checkbox"/> Round Dimensions: <input type="checkbox"/> Rectangular Diameter: 1' <input type="checkbox"/> Other | <p>FA_DOPhoto-20230915-201005.jpg</p> |

| Additional Details: Stickup (ft) From Ground: 0.2 Relative from staff gauge: 0.95 | |
| Additional Details: Overflow Blocked? <input checked="" type="checkbox"/> Yes <input type="checkbox"/> No Approximately 40% blocked Additional Details: Leaf debris and sticks were observed in the bottom of the catch basin. | |

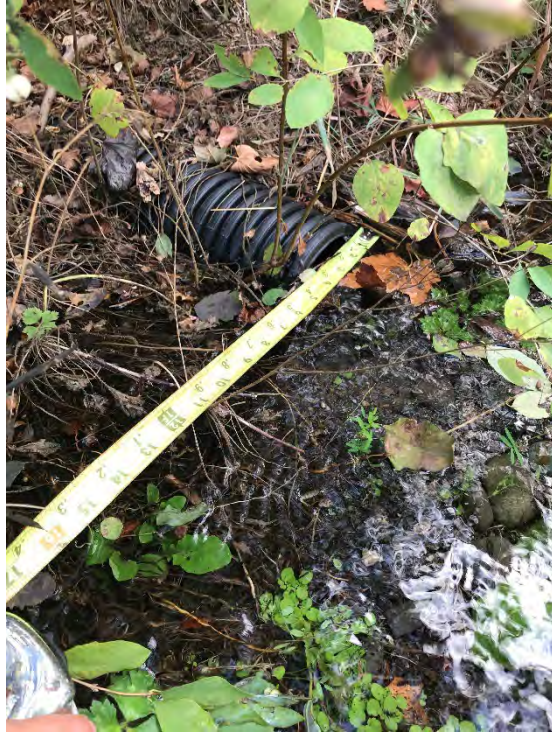
IMG_1797.JPG

Additional Details: Leaf litter and other vegetation covers the base of the inlet pipe

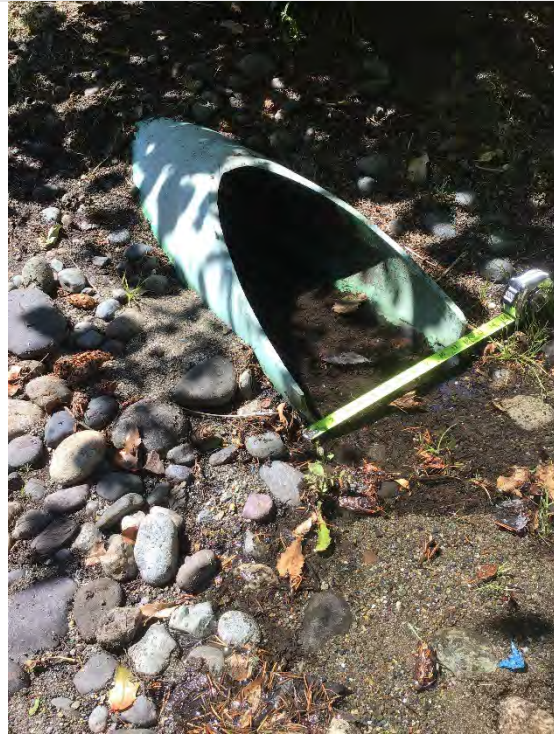
FA_INphoto-20230628-193323.jpg

Additional Details: 0.2' of debris at base of inlet pipe.
Consists of silt, pine needles, organic material.

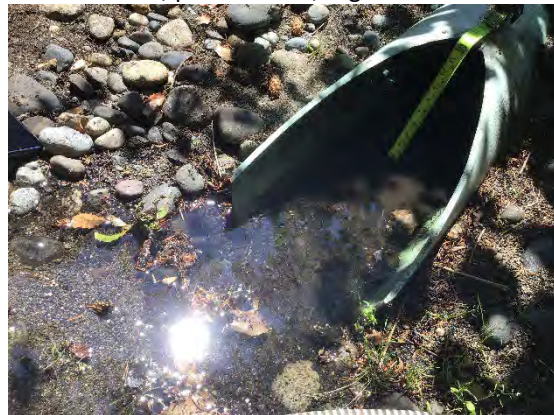
FA_INBLPhoto-20230628-193628.jpg

Additional Details: Stream cobble has been partially buried by sediment and organic debris. Deposition of sediment is dominant over erosion. Street catch basin which inlet connects to is filled with debris.

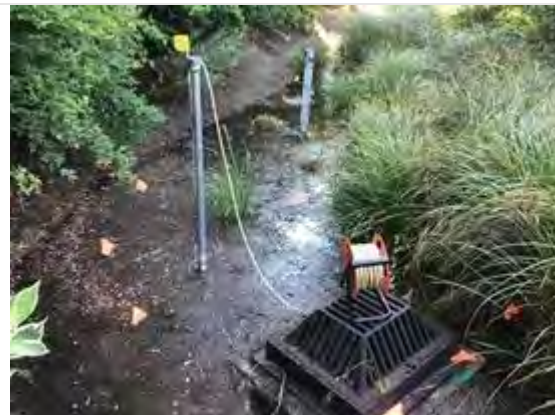
Trace water entering catch basin through joints in concrete.

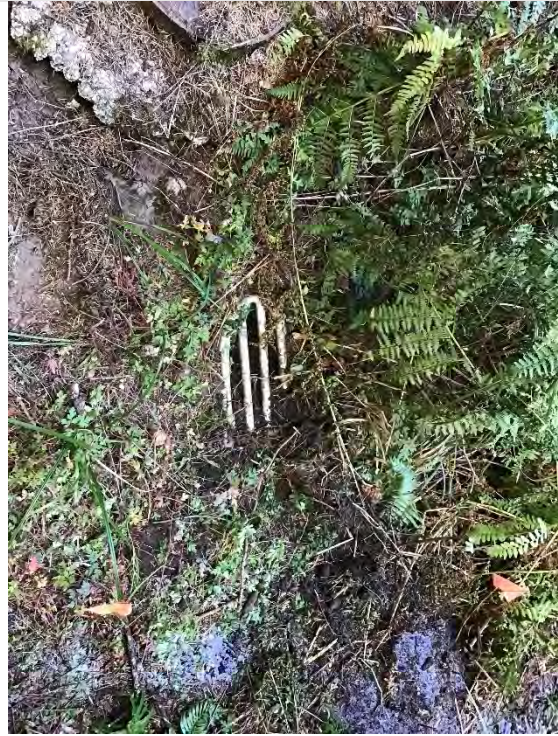
FA_INphoto-20230817-190713.jpg

Additional Details: The blockage fills most of the pipe and had to be dug out to acquire data. There is 3 inches of head from blockage to top of the aluminum pipe.

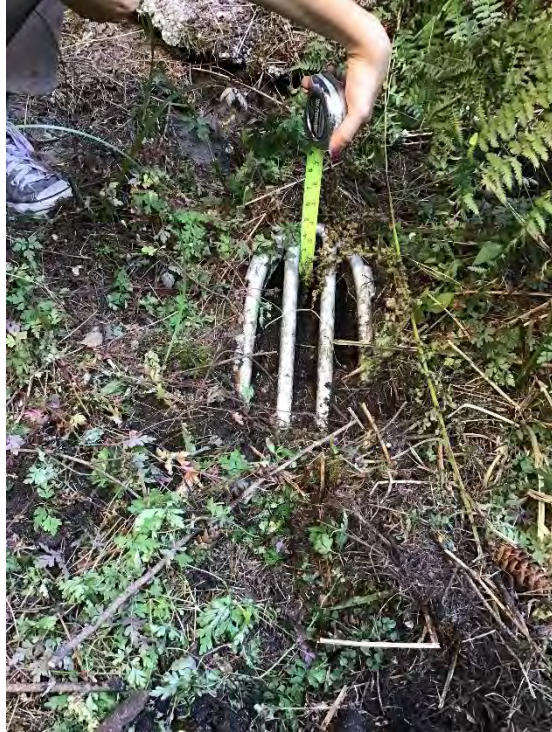
FA_INBLPhoto-20230817-190638.jpg

Additional Details: Angled cut corrugated aluminum pipe with trash rack on top pipe is 50% buried in soils and plant debris. Any energy dissipation would be completely buried. Design notes a 3 foot diameter pad of outfall rock lined with geotextile fabric under each rain garden rock outfall structure.

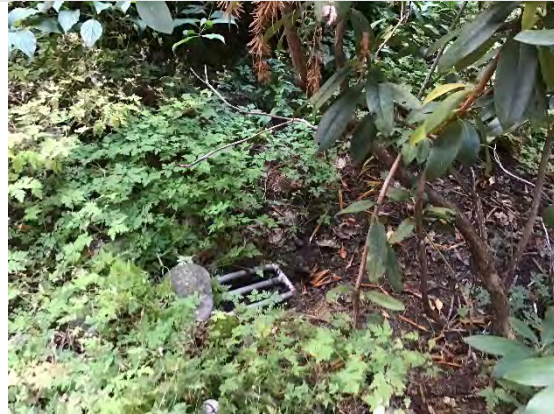
FA_INphoto-20230817-191831.jpg

Additional Details: Soils and plant debris causing some blockage, any energy dissipation is buried.

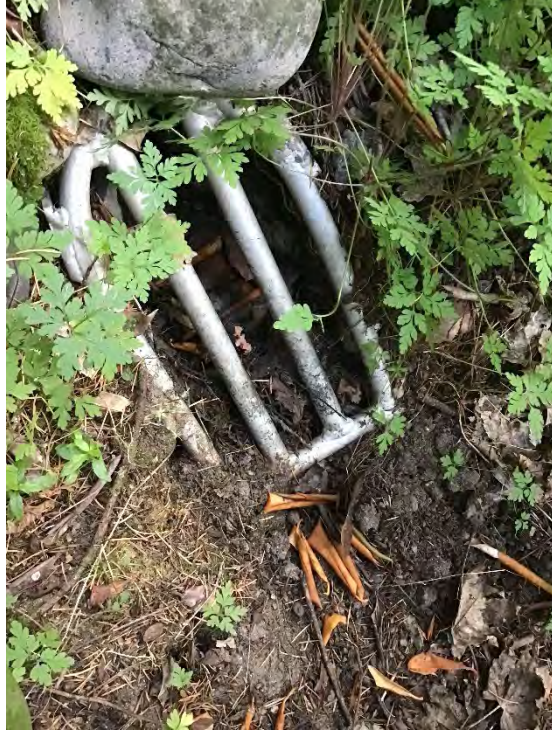
FA_INBLPhoto-20230817-191820.jpg

Additional Details: PVC pipe connected to an angled cut , corrugated aluminum trash rack. Stream cobbles are completely buried. Design notes a 3 foot diameter pad of outfall rock lined with geotextile fabric under each rain garden rock outfall structure.

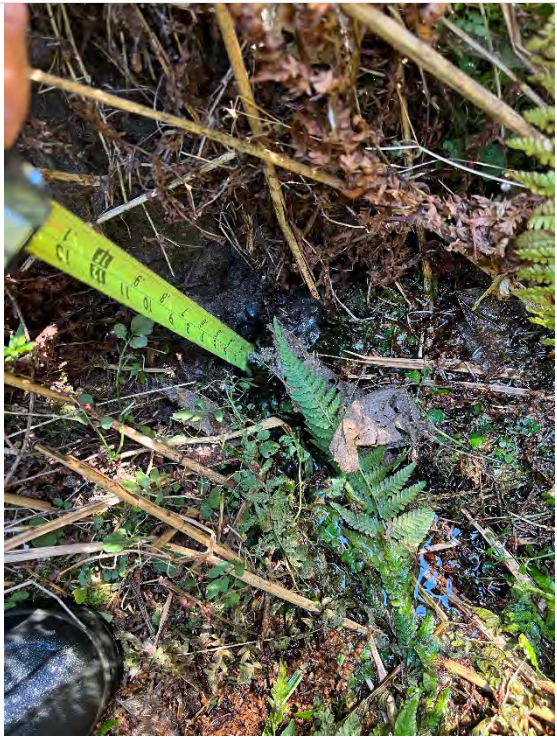
| Shape: <input type="checkbox"/> Round Dimensions: <input type="checkbox"/> Rectangular <input checked="" type="checkbox"/> Other: Crushed 0.3 diameter pipe Additional Details: Non-engineered, crushed, corrugated plastic pipe at base of cell, midway between overflow catch basin and overflow weir structure, beneath a placed log that holds up the east side of cell. | <p>IMG_0481.jpg</p> |
| Damage Indicators: <input checked="" type="checkbox"/> Yes <input type="checkbox"/> No This pipe bypasses the designed overflow structures and renders more than half of the cell ineffectual. This pipe allows for only 0.2 feet of ponded depth before overflowing. | |

A non-engineered outlet pipe exists just south of the designed rock weir overflow. This is a 0.3' diameter crushed corrugated plastic pipe which sits underneath a tree log. The presence of the pipe allows for only 0.2' of ponded depth in the base of the cell before water enters the pipe. Because of the pipe's existence the designed overflow structures (beehive overflow and rock weir) are not used and the infiltrating area of the raingarden is limited to the southern half of the cell since ponded water will flow out the pipe instead of pooling in the slightly higher cell elevation to the north.

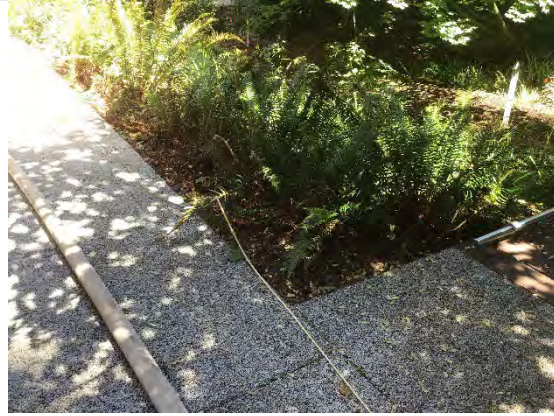
FA_INphoto-20230801-190633.jpg

Additional Details: Abundant ferns on edges cause a build up sediment, it appears the flow into cell can occur around ferns.

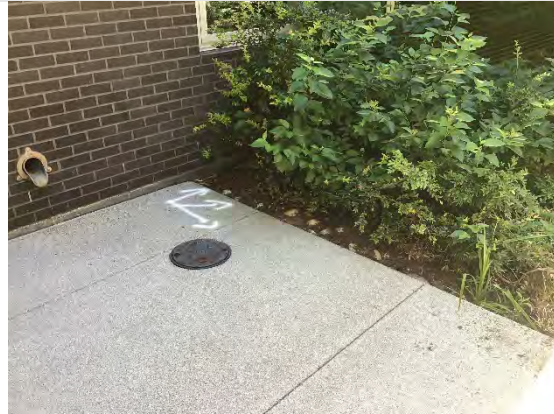
FA_INphoto-20230801-191515.jpg

Additional Details: Vegetative matter almost fully buries stream cobbles along the concrete dispersion from the roof pipe.

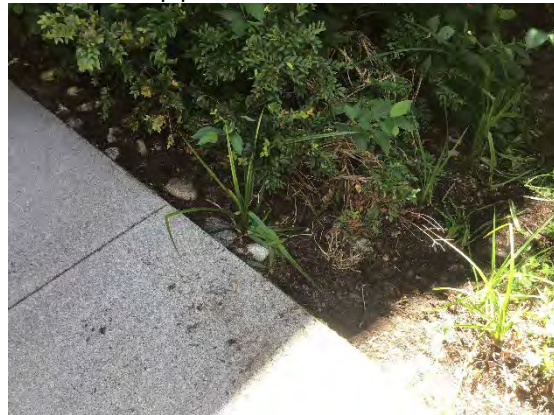
FA_INBLPhoto-20230801-191454.jpg

Additional Details: The rain garden outfall pipe from the roof pours onto the sidewalk, then sheet flows into the cell where there are thickly buried river cobbles placed along edge of sidewalk within the cell for about 4 feet.

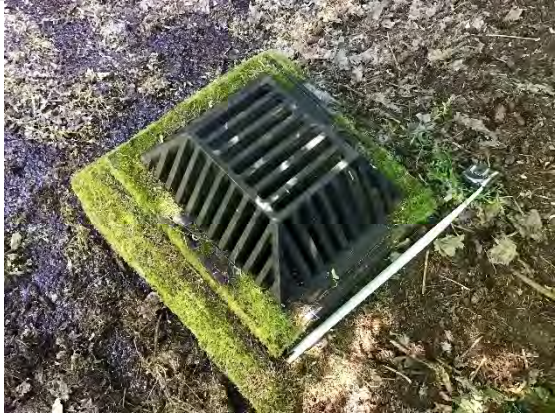
| FA_DOPhoto-20230801-192538.jpg | |

| Trash Rack: <input checked="" type="checkbox"/> Yes <input type="checkbox"/> No Approximately 5% blocked Additional Details: Moss blocks a minimal portion of the trash rack. | |
| Overflow Blocked? <input checked="" type="checkbox"/> Yes <input type="checkbox"/> No Approximately 5% blocked Additional Details: Moss blocks a minimal portion of the overflow structure. | |

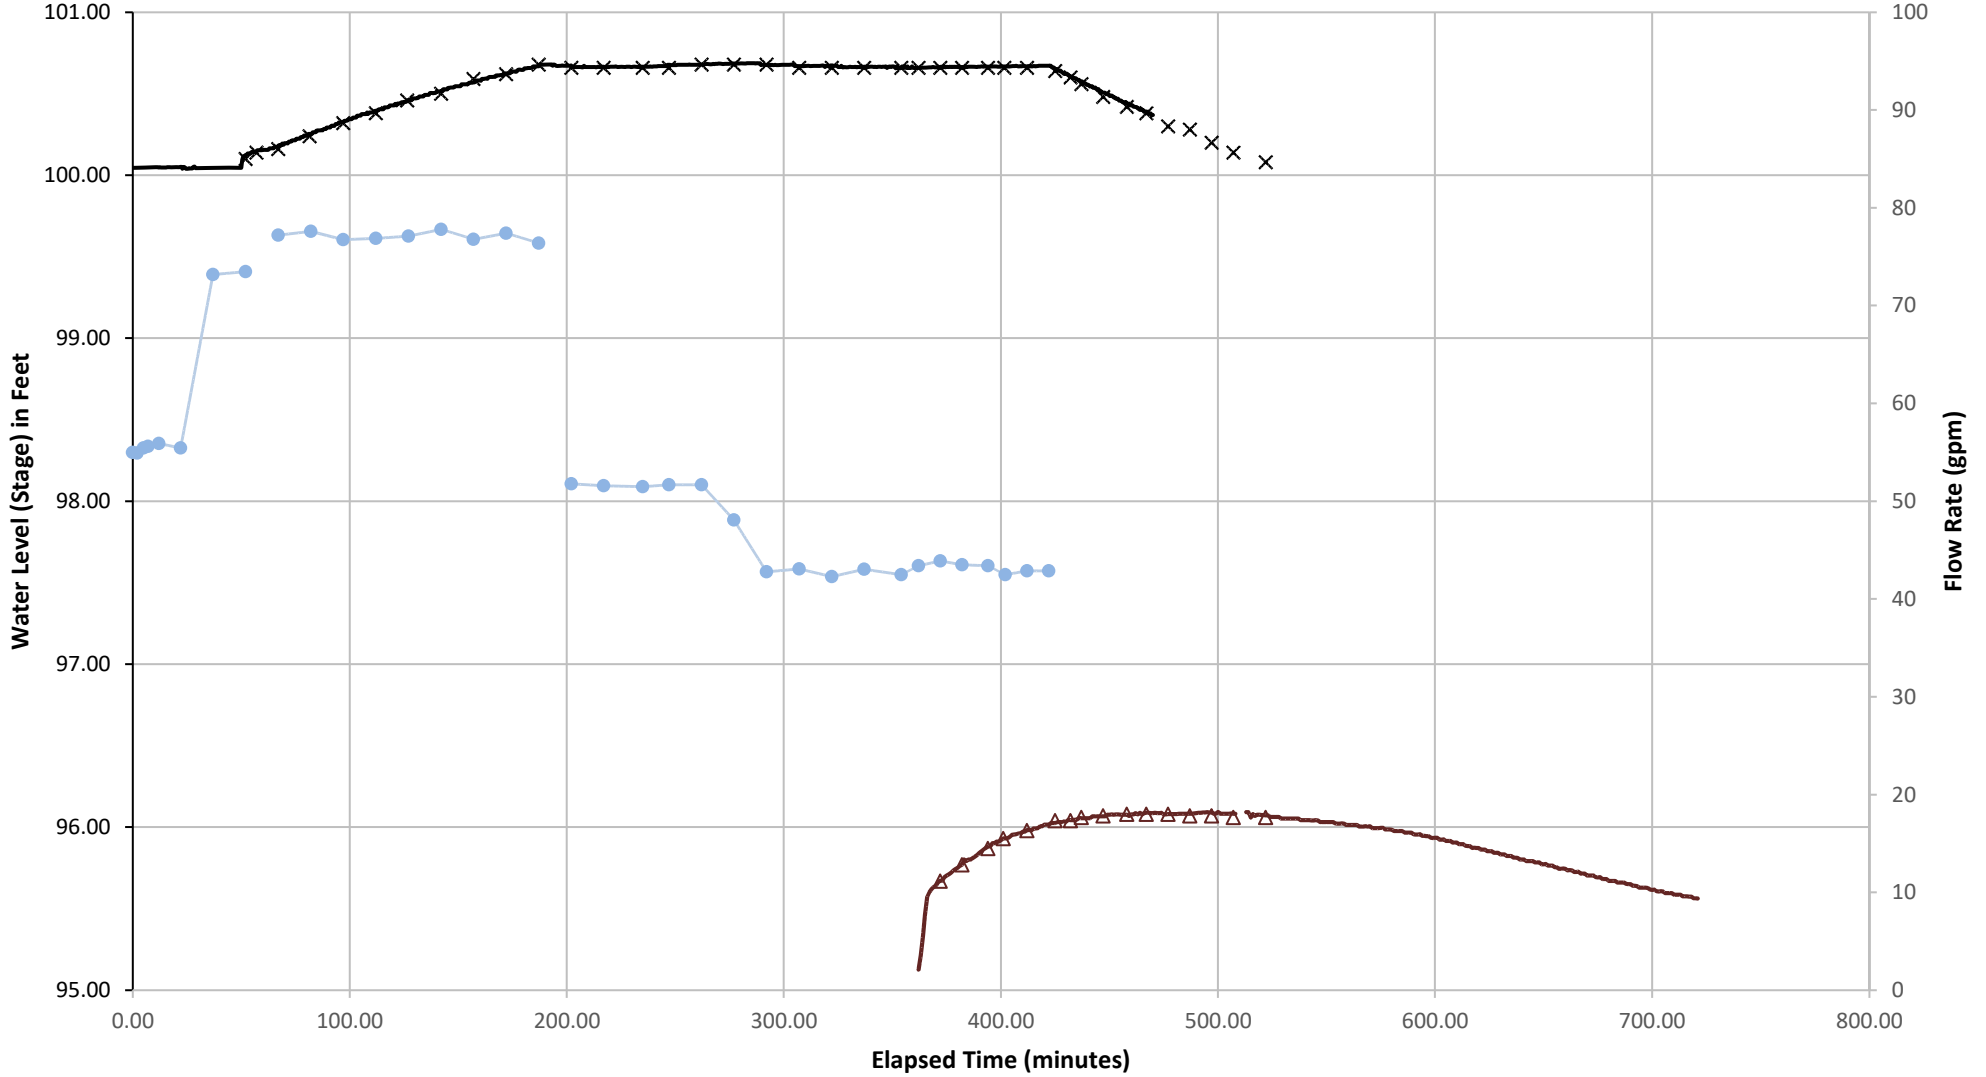
Cherry Crest Elementary School-Raingarden #1 Infiltration Test Stage (feet) on Left Axis; Flow Rate (gpm) on Right Axis vs Elapsed Time (minutes)

Notes: Elevations are not surveyed and should be used as a relative reference. Elevation 100 represents ground surface. Wellpoint dry until minute 362.

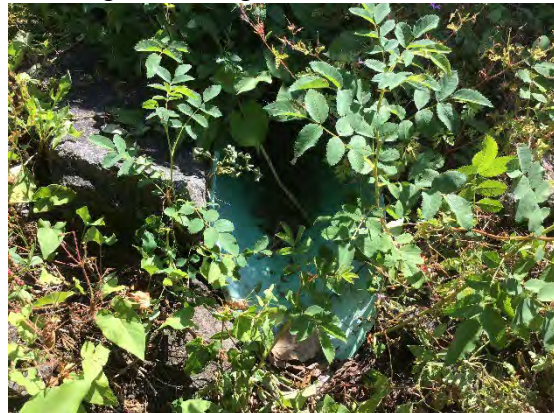
FA_INBLPhoto-20230727-213626.jpg

Additional Details: There is minimal blockage of inlet 1 consisting of some vegetation and dead leaf matter.

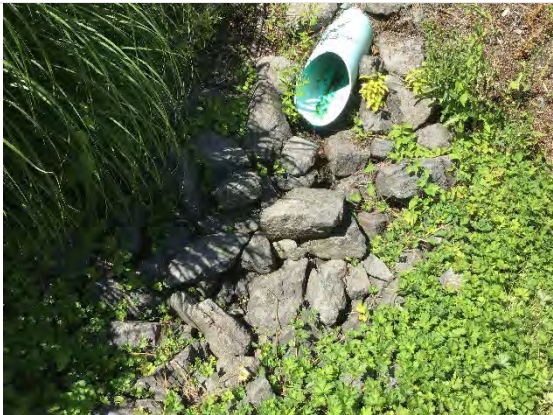
| IN-3 | |

| <input type="checkbox"/> Curb cut <input type="checkbox"/> Sheet Flow <input type="checkbox"/> Dispersed Flow <input checked="" type="checkbox"/> Pipe <input type="checkbox"/> Other: Pipe: Material <input checked="" type="checkbox"/> PVC <input type="checkbox"/> Metal <input type="checkbox"/> Concrete <input type="checkbox"/> Other Diameter: 0.5' Energy Dissipation Angular Rock: Functioning Stream Cobble: n/a Water Wheel: n/a Splash Block: n/a Concrete Apron: n/a | <p>FA_INphoto-20230727-213935.jpg</p> |
| Erosion Present? <input type="checkbox"/> Yes <input checked="" type="checkbox"/> No | Blockage Present? <input type="checkbox"/> Yes <input checked="" type="checkbox"/> No |
| Additional Details: Angular rock | |

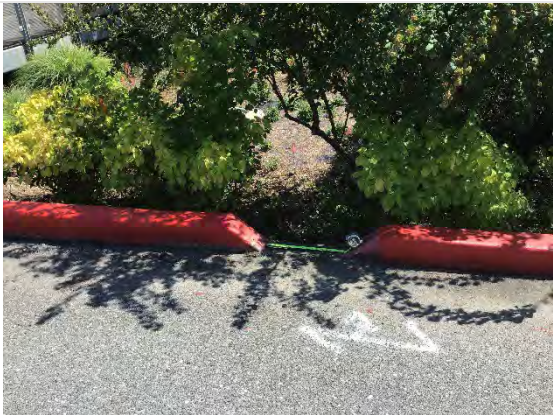
| IN-4 | |

| <input checked="" type="checkbox"/> Curb cut <input type="checkbox"/> Sheet Flow <input type="checkbox"/> Dispersed Flow <input type="checkbox"/> Pipe <input type="checkbox"/> Other: Width: 1.4' Energy Dissipation Angular Rock: Functioning Stream Cobble: n/a Water Wheel: n/a Splash Block: n/a Concrete Apron: n/a | <p>FA_INphoto-20230727-220652.jpg</p> |
| Erosion Present? <input type="checkbox"/> Yes <input checked="" type="checkbox"/> No | Blockage Present? <input type="checkbox"/> Yes <input checked="" type="checkbox"/> No |
| Additional Details: Angular rock scattered around the sidewalls on the perimeter of the cell. Curb cut inlets surround the entire perimeter of the cell. | |

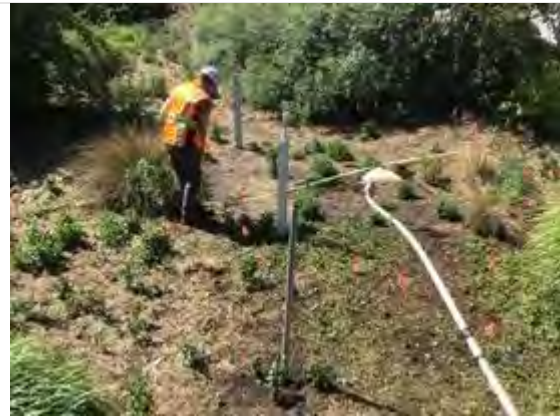
IT_Photo-20230727-221849.jpg

| Two infiltration tests were performed. The first test was conducted in the center of the cell near inlets 2 and 3 on the east side of the bridge. The second test was completed in the center of the cell on the west side of the bridge. Additional test details can be found in the executive summary. | |
| Water was observed flowing out of inlet 3 for the duration of the tests at a very slow trickle, estimated at 0.5 gpm. Water from this discharge pools in the rip rap surrounding the pipe. | |

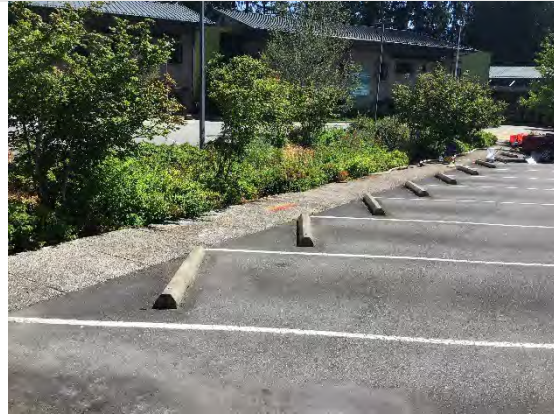
FA_INphoto-20230728-211009.jpg

Width: 132'

Energy Dissipation
Angular Rock: n/a
Stream Cobble: n/a
Water Wheel: n/a
Splash Block: n/a
Concrete Apron: n/a

Erosion Present? Yes No

Additional Details: There is permeable pavement along one edge of cell, otherwise no energy dissipation features were observed.

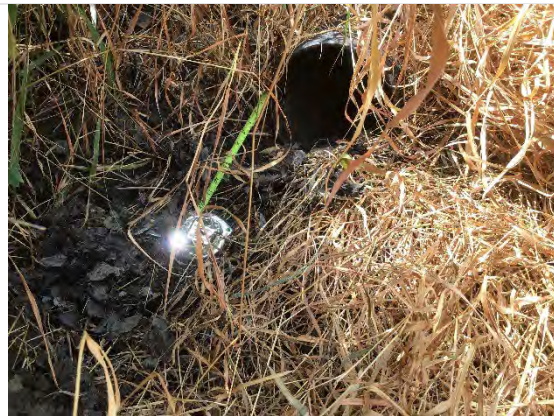
FA_INphoto-20230730-200631.jpg

Pipe:
Material
 PVC Metal Concrete Other
Diameter: 0.68'

Energy Dissipation
Angular Rock: Buried
Stream Cobble: n/a
Water Wheel: n/a
Splash Block: n/a
Concrete Apron: n/a

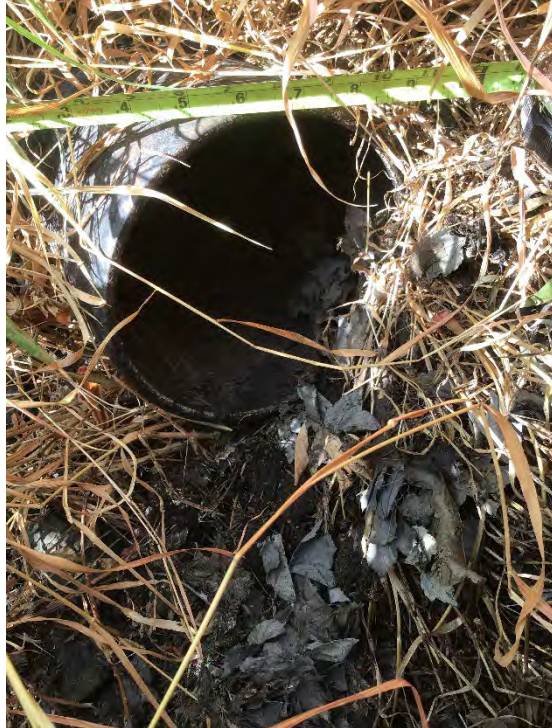
FA_INBLPhoto-20230730-200616.jpg

Additional Details: Pipe is free of blockages. However, there is 0.1 feet of sediment built up immediately outside the pipe. Pipe collects water from portions of the parking lot that are up gradient of Rain Garden #1.

Additional Details: Angular rock is buried in sediment and organic debris.

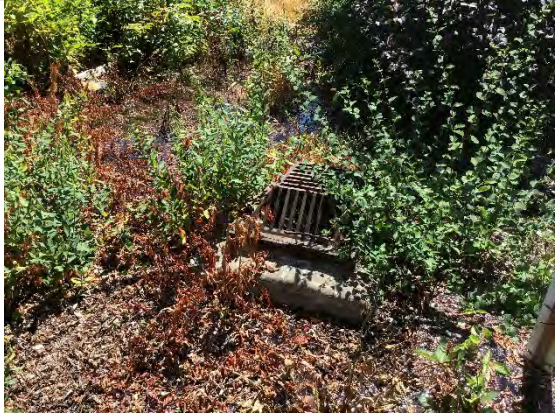
| DO - 1 | | <p>FA_DOPhoto-20230728-211446.jpg</p> |

| <input type="checkbox"/> Round <input checked="" type="checkbox"/> Rectangular <input type="checkbox"/> Other | Length: 1.75' Width: 1.4' | |
| Damage Indicators: <input checked="" type="checkbox"/> Yes <input type="checkbox"/> No Leaks in catch basin allow for water to penetrate from Rain Garden #1. Water was observed flowing from catch basin #1 into catch basin #2 during testing. | | |
| Trash Rack: <input checked="" type="checkbox"/> Yes <input type="checkbox"/> No Additional Details: | | |
| Overflow Blocked? <input type="checkbox"/> Yes <input checked="" type="checkbox"/> No | | |

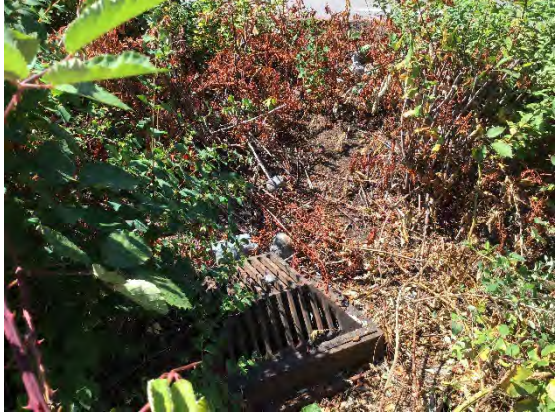
| DO - 2 | | <p>FA_DOPhoto-20230728-214519.jpg</p> |

| <input type="checkbox"/> Round <input checked="" type="checkbox"/> Rectangular <input type="checkbox"/> Other | Length: 1.75' Width: 1.4' | |
| Damage Indicators: <input type="checkbox"/> Yes <input checked="" type="checkbox"/> No | | |

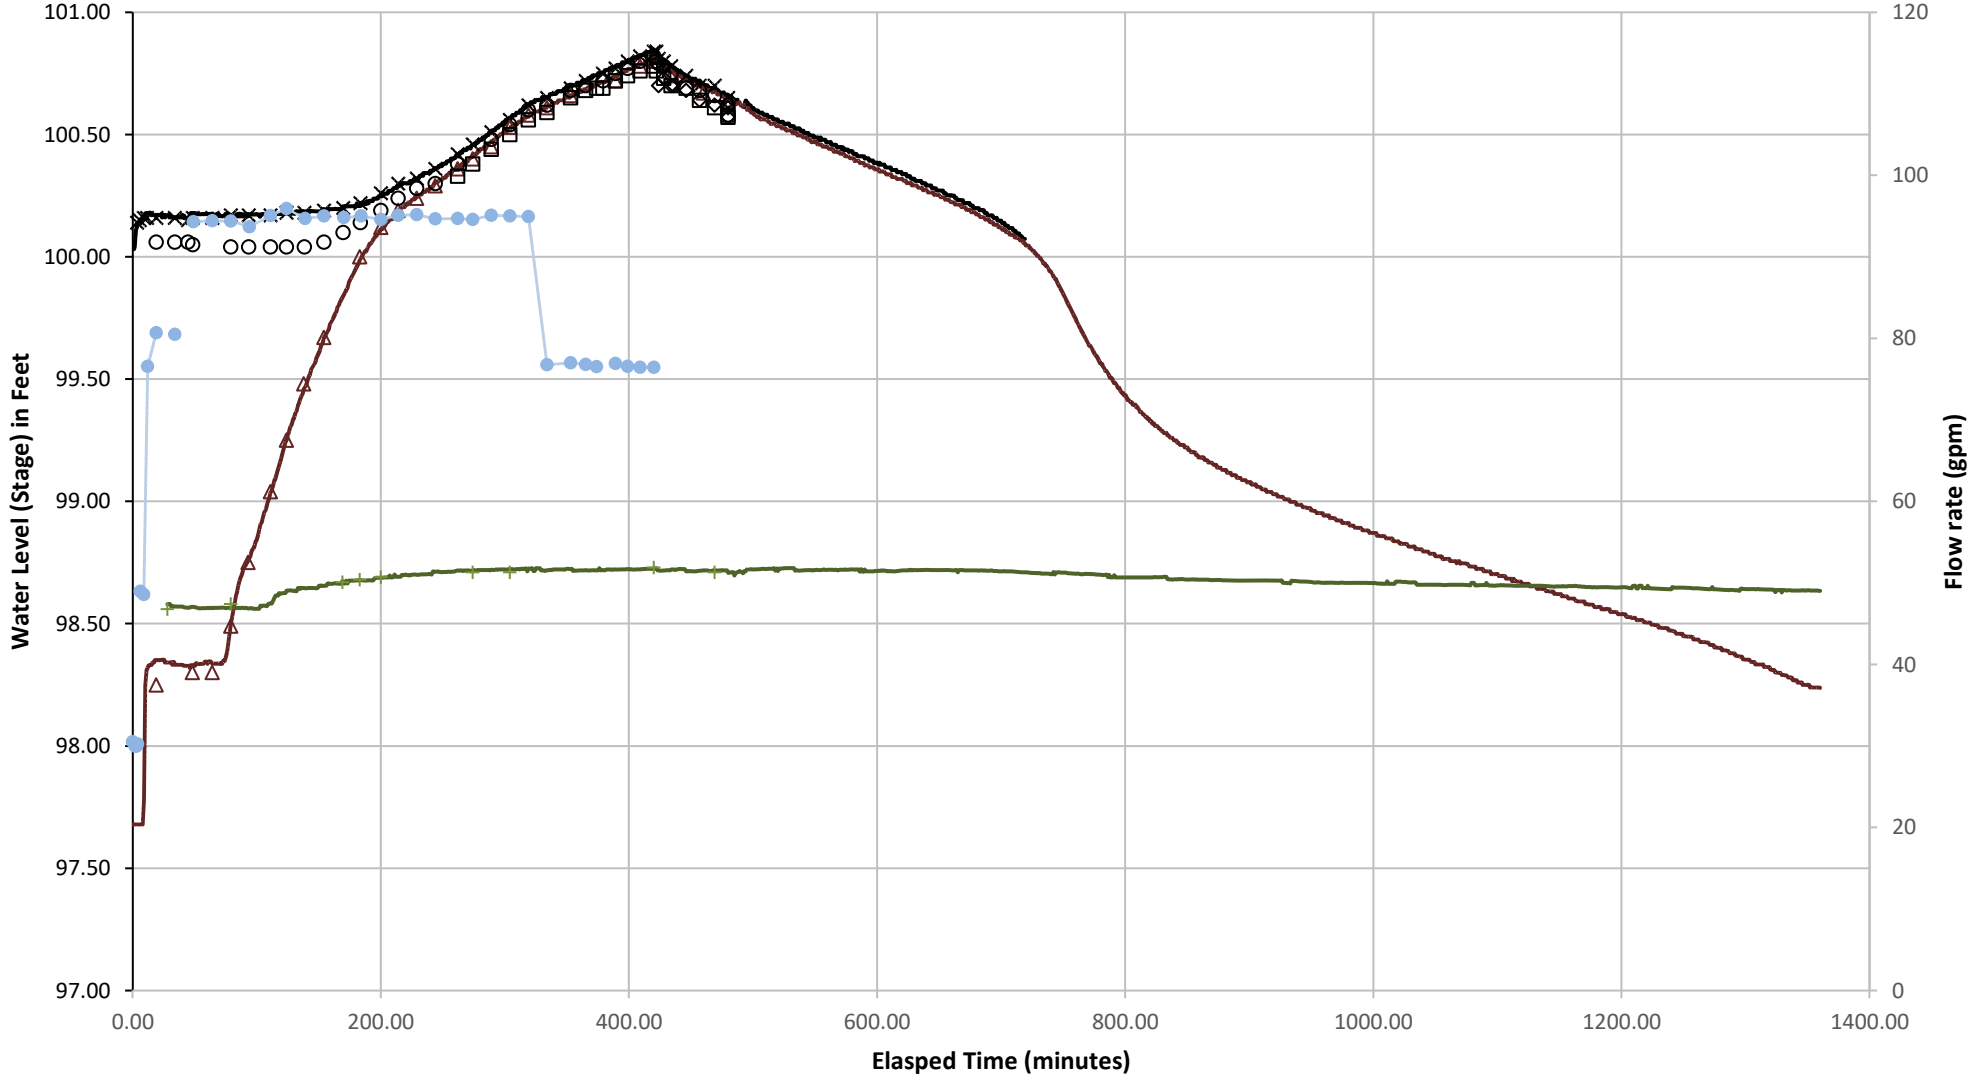
Stage (feet) on Left Axis; Flow Rate (gpm) on Right Axis vs Elapsed Time (minutes)

Notes: Elevations are not surveyed and should be used as a relative reference. Elevation 100 represents ground surface. Dataloggers left in wellpoint and staff gauge over the weekend.

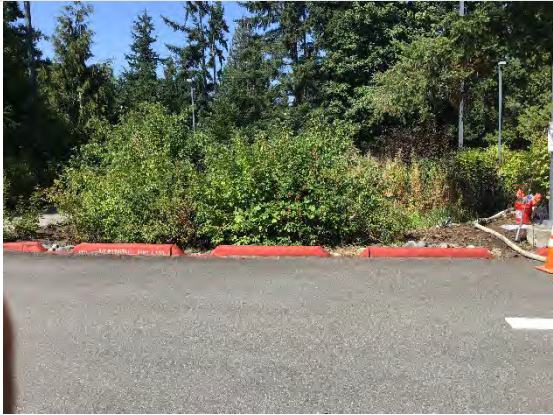
| Erosion Present? <input checked="" type="checkbox"/> Yes <input type="checkbox"/> No Severity: Minor | Blockage Present? <input type="checkbox"/> Yes <input checked="" type="checkbox"/> No | |
| Additional Details: Stream cobbles and angular rocks at the base of the curb cut. | | |

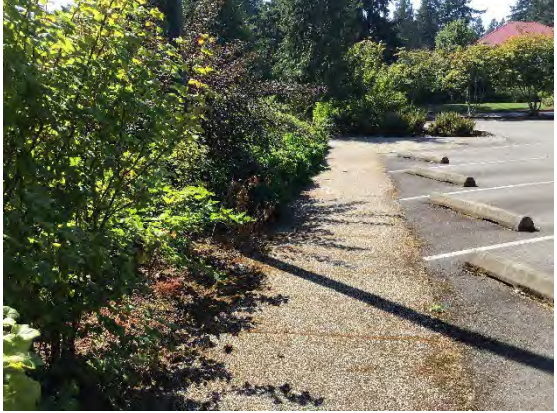
| <p>Erosion Present? <input checked="" type="checkbox"/> Yes <input type="checkbox"/> No Severity: Minor</p> | <p>Blockage Present? <input type="checkbox"/> Yes <input checked="" type="checkbox"/> No</p> |
| <p>Additional Details: Angular rocks scattered along the slope of cell to dissipate energy.</p> | |

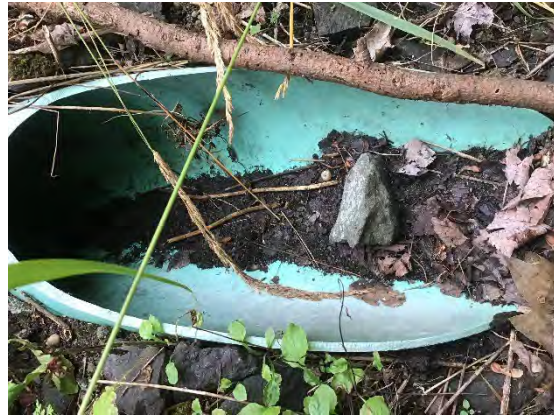
FA_INBLPhoto-20230808-171314.jpg

Additional Details: This inlet connects to an inlet located in Pond B, appears to be possibly an equalization feature to connect the two bioretention ponds.

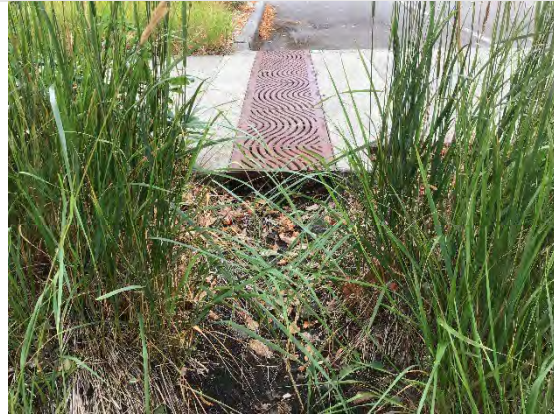
FA_INphoto-20230808-171926.jpg

Additional Details: Leaf debris was observed on the parking lot side of the inlet, sediment blockage increases towards cell.

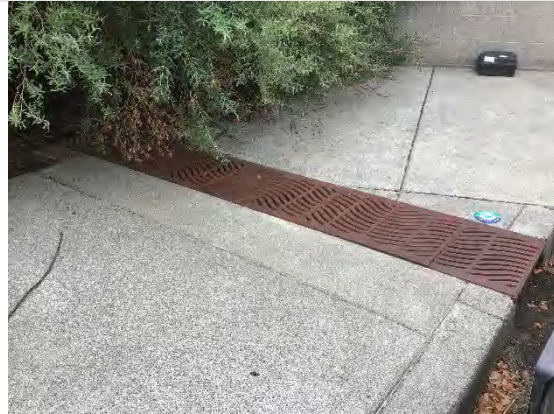
FA_INphoto-20230808-172226.jpg

Additional Details: Sediment deposition was observed on the parking lot side of the inlet. It appears that water pools there before entering cell based on the pattern of the fine sediment deposition.

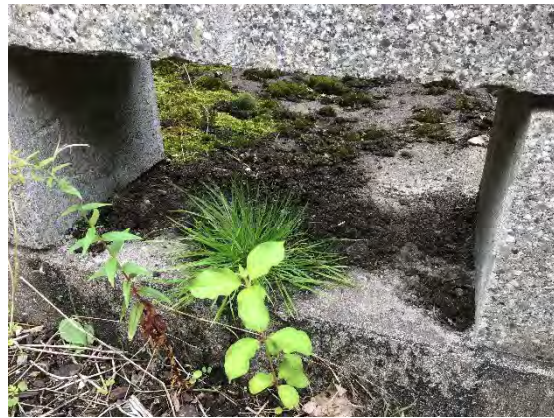
FA_INBLPhoto-20230808-174338.jpg

Additional Details: There is no observable energy dissipation for these four cut outs at the base of the wall of the trash shed. These wall cut outs appear to be in place for spray cleaning out the trash shed, as the three sided shed has a roof, and there are some visible signs that water occasionally flows into the cell.

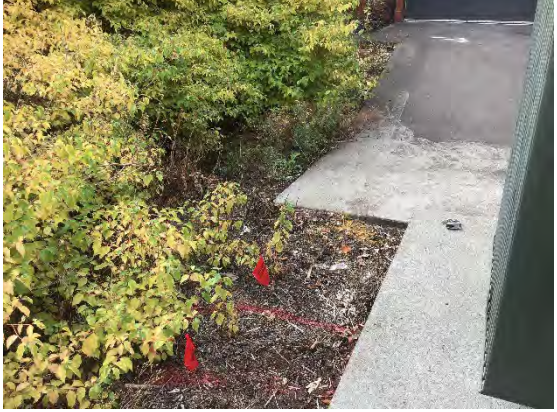
| <p>IN-6</p> <p><input type="checkbox"/> Curb cut <input checked="" type="checkbox"/> Sheet Flow <input type="checkbox"/> Dispersed Flow <input type="checkbox"/> Pipe <input type="checkbox"/> Other:</p> <p>Width: 40'</p> <p>Energy Dissipation Angular Rock: n/a Stream Cobble: n/a Water Wheel: n/a Splash Block: n/a Concrete Apron: n/a</p> | <p>FA_INphoto-20230808-181205.jpg</p> |
| <p>Erosion Present? <input checked="" type="checkbox"/> Yes <input type="checkbox"/> No Severity: Minor Can identify a main flow path from erosion, but the erosion is not major. Water flow paths are potentially from pressure washing the concrete.</p> | <p>Blockage Present? <input type="checkbox"/> Yes <input checked="" type="checkbox"/> No</p> |
| <p>Additional Details: None present, sheet flow from utility access& fire lane</p> | |

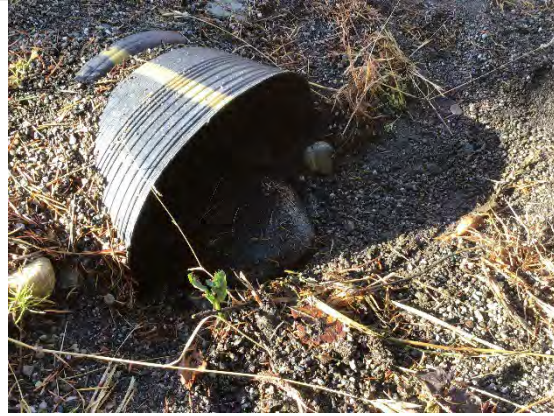
FA_INphoto-20230726-012020.jpg

Additional Details: Sediment deposition blocks 40% of the inlet at the exit of pipe, organic debris blocks 10% of the grate on the catch basin.

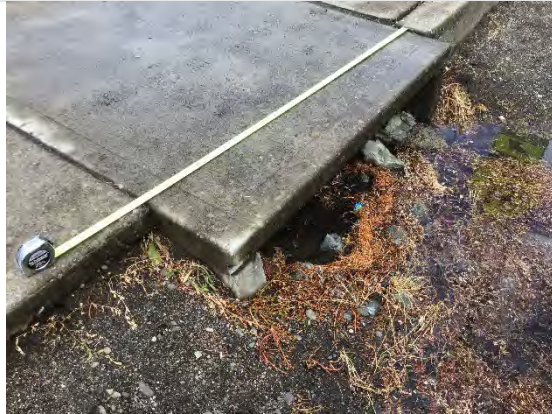
FA_INphoto-20230725-214153.jpg

Additional Details: A thick build up of pine needles block 50% of the street side of the curb cut.

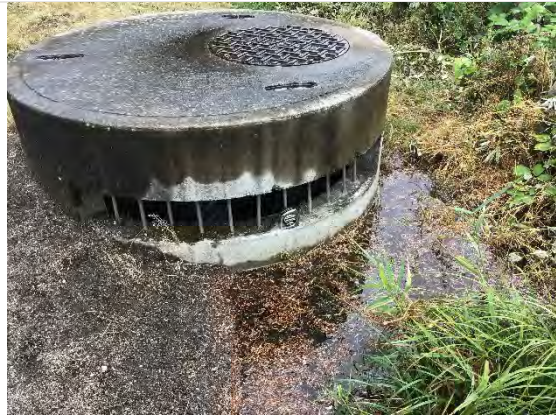
FA_DOPhoto-20230725-214926.jpg

| Damage Indicators: <input checked="" type="checkbox"/> Yes <input type="checkbox"/> No The perimeter of the cell adjacent to the overflow structure is lower than the stick up height of the structure. Water bypasses the designed overflow structure at SG-1=0.26 feet ponded depth, and flows downhill towards the fields below. | |
| Trash Rack: <input checked="" type="checkbox"/> Yes <input type="checkbox"/> No Approximately 2% blocked Additional Details: Minor sediment and moss growth were observed on the trash rack. | |

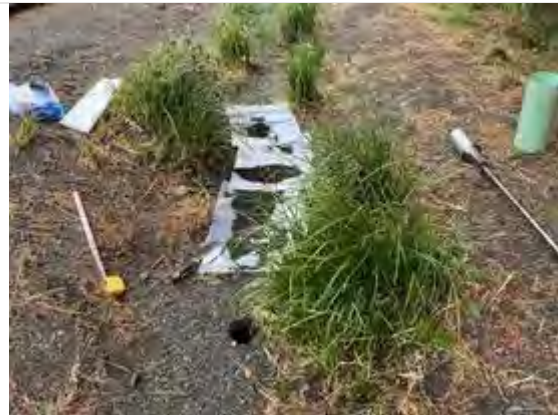
IMG_0364.jpeg

| Rain/Garden Mix Soil Texture: Loose, moist, dark brown, medium to coarse SAND, some fine sand, some gravel, some silt, abundant organics. (SW-SM) Native Soil Texture: Underdrain Gravel: Loose, moist, dark grey, sandy, rounded, coarse GRAVEL (GP) | |
| Additional Details Underdrain gravel has an average of 1" diameter. | |

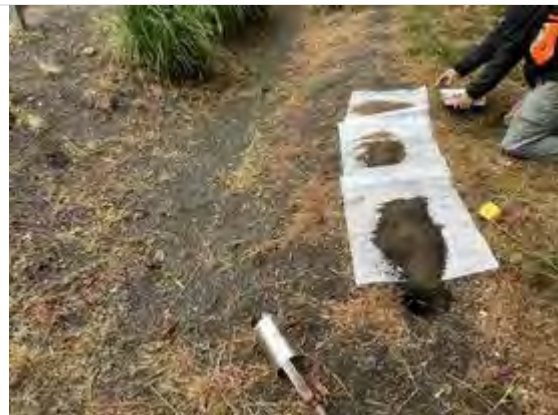
IMG_0365.jpeg

| Hand auger conducted on southern edge of cell to avoid the underdrain. Soils encountered to be native glaciomarine deposits. | |

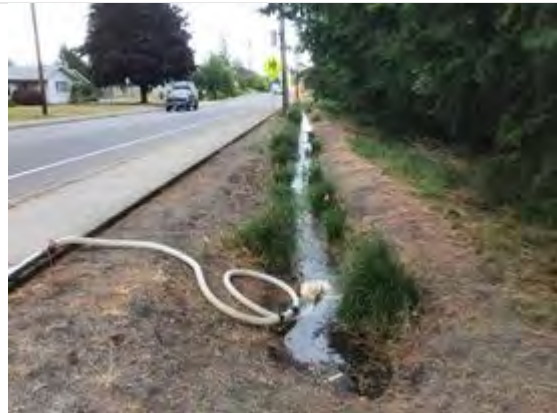
IT_Photo-20230725-234931.jpg

| Additional Details: Some test water overflowed out of the cell behind catch basin due to the non-designed overflow. Flow rate was adjusted as needed to keep test within perimeter of the cell. The western half of the cell drained much more slowly during falling head due to silty surface material. | |

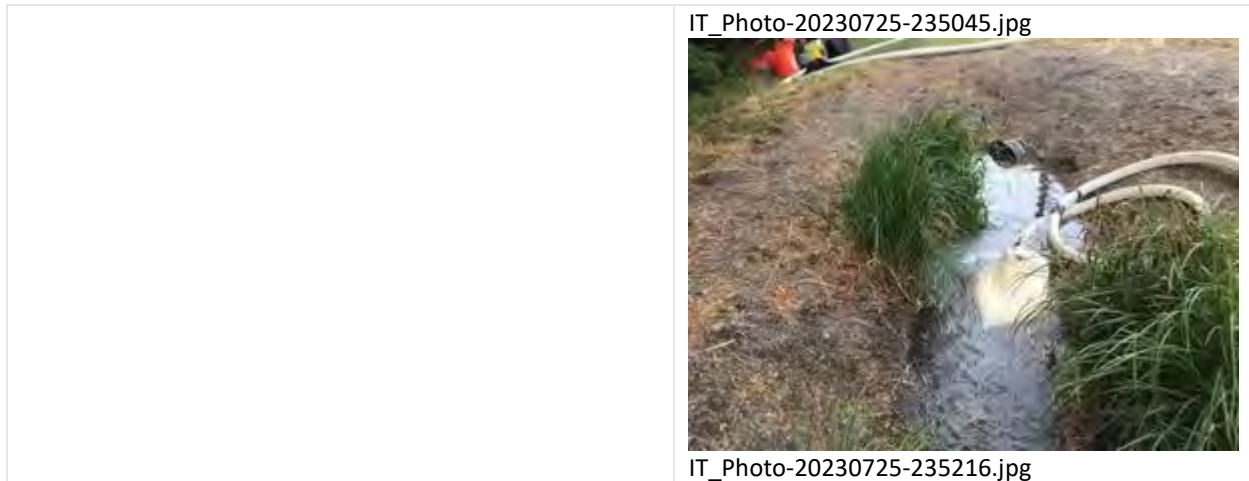
- Staff gauge 3 in photo 8 shows stage during overflow down hill slope.
- Silty material on the half of the cell near the inlet, slower infiltration rate.
- Some backflow into IN-1 was observed while flow rates were increasing, this stabilized during test and is not a significant loss of water.
- Non-design overflow behind the catch basin. Photo 3/8 captures phenomenon.

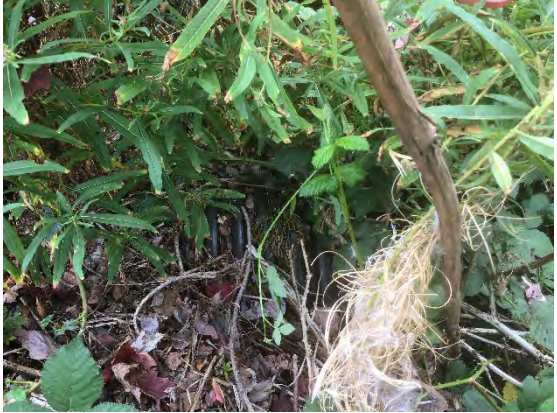
| <p>IN-1</p> <p><input type="checkbox"/> Curb cut <input type="checkbox"/> Sheet Flow <input type="checkbox"/> Dispersed Flow <input checked="" type="checkbox"/> Pipe <input type="checkbox"/> Other:</p> <p>Pipe: Material <input type="checkbox"/> PVC <input type="checkbox"/> Metal <input type="checkbox"/> Concrete <input checked="" type="checkbox"/> Other Other: Other Diameter: 1.3'</p> <p>Energy Dissipation Angular Rock: n/a Stream Cobble: Buried Water Wheel: n/a Splash Block: n/a Concrete Apron: n/a</p> | <p>FA_INphoto-20230911-172542.jpg</p> |
| <p>Erosion Present? <input type="checkbox"/> Yes <input checked="" type="checkbox"/> No</p> | <p>Blockage Present? <input checked="" type="checkbox"/> Yes <input type="checkbox"/> No Approximately 15% blocked</p> <p>Types: <input checked="" type="checkbox"/> Sediment <input checked="" type="checkbox"/> Organic <input type="checkbox"/> Rock <input type="checkbox"/> Trash <input type="checkbox"/> Vegetation</p> <p>Additional Details: The inlet's stream cobble is buried, some dead vegetation blocks the inlet, water backs up over 5 feet into the pipe, full depth of back up was not determined due to dense blackberry canes limiting access.</p> |

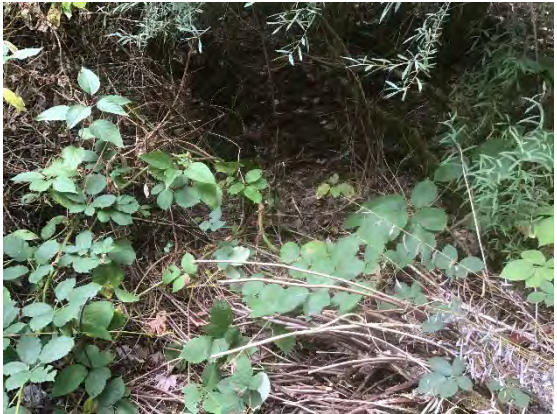
| <p>Additional Details:</p> | <p>FA_INBLPhoto-20230911-224728.jpg</p> |

| <p>IN-2</p> <p><input type="checkbox"/> Curb cut <input type="checkbox"/> Sheet Flow <input type="checkbox"/> Dispersed Flow <input checked="" type="checkbox"/> Pipe <input type="checkbox"/> Other:</p> <p>Pipe: Material <input type="checkbox"/> PVC <input type="checkbox"/> Metal <input type="checkbox"/> Concrete <input type="checkbox"/> Other Diameter: '</p> <p>Energy Dissipation Angular Rock: n/a Stream Cobble: Buried Water Wheel: n/a Splash Block: n/a Concrete Apron: n/a</p> | |
| <p>Erosion Present? <input type="checkbox"/> Yes <input checked="" type="checkbox"/> No</p> | <p>Blockage Present? <input checked="" type="checkbox"/> Yes <input type="checkbox"/> No Approximately 100% blocked</p> <p>Types: <input checked="" type="checkbox"/> Sediment <input type="checkbox"/> Organic <input type="checkbox"/> Rock <input type="checkbox"/> Trash <input type="checkbox"/> Vegetation</p> <p>Additional Details: Field staff could not find inlet as described on plans and in previous field notes, it is assumed that it is completely buried and 100% blocked.</p> |

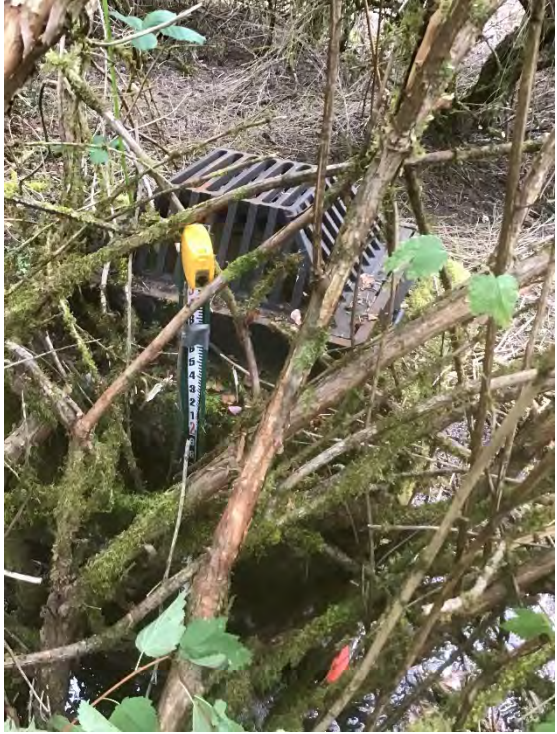
| FA_DOPhoto-20230911-223825.jpg | |

| Overflow Blocked? <input type="checkbox"/> Yes <input checked="" type="checkbox"/> No | |

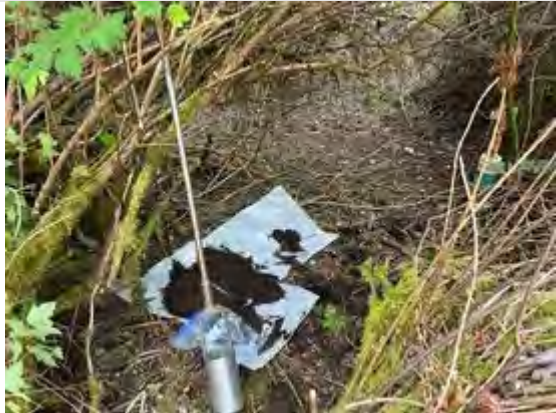
| HA-1 | | <p>IMG_0573.jpg</p> |
| Rain/Garden Mix Soil Texture: Medium, dense, moist, dark brown fine to medium SAND, some coarse sand, some gravel, some silt, abundant organics (root mat)(SW-SM) | | |

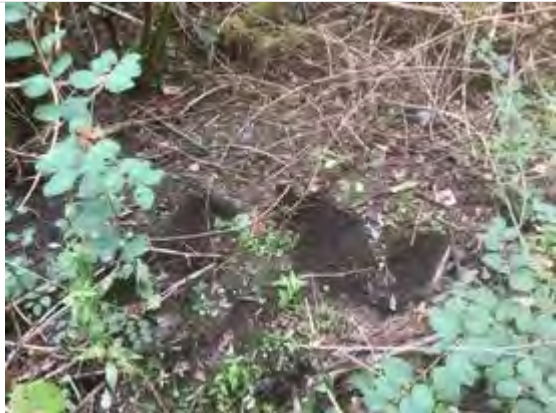
| HA-2 | | <p>FA_FPhoto-20230911-154303.jpg</p> |
| Rain/Garden Mix Soil Texture: medium dense, slightly moist, dark brown, very silty fine to medium SAND, some coarse sand, some gravel, abundant organics (SM) | | |
