Technical Memorandum

| | | Project Name: | Long Term Bioretention Monitoring Study, Phase III |
| Subject: | Task 3.2 Geotechnical and Hydrogeologic Data/Report, City of Olympia Contract Agreement Number: C2300003 | | |

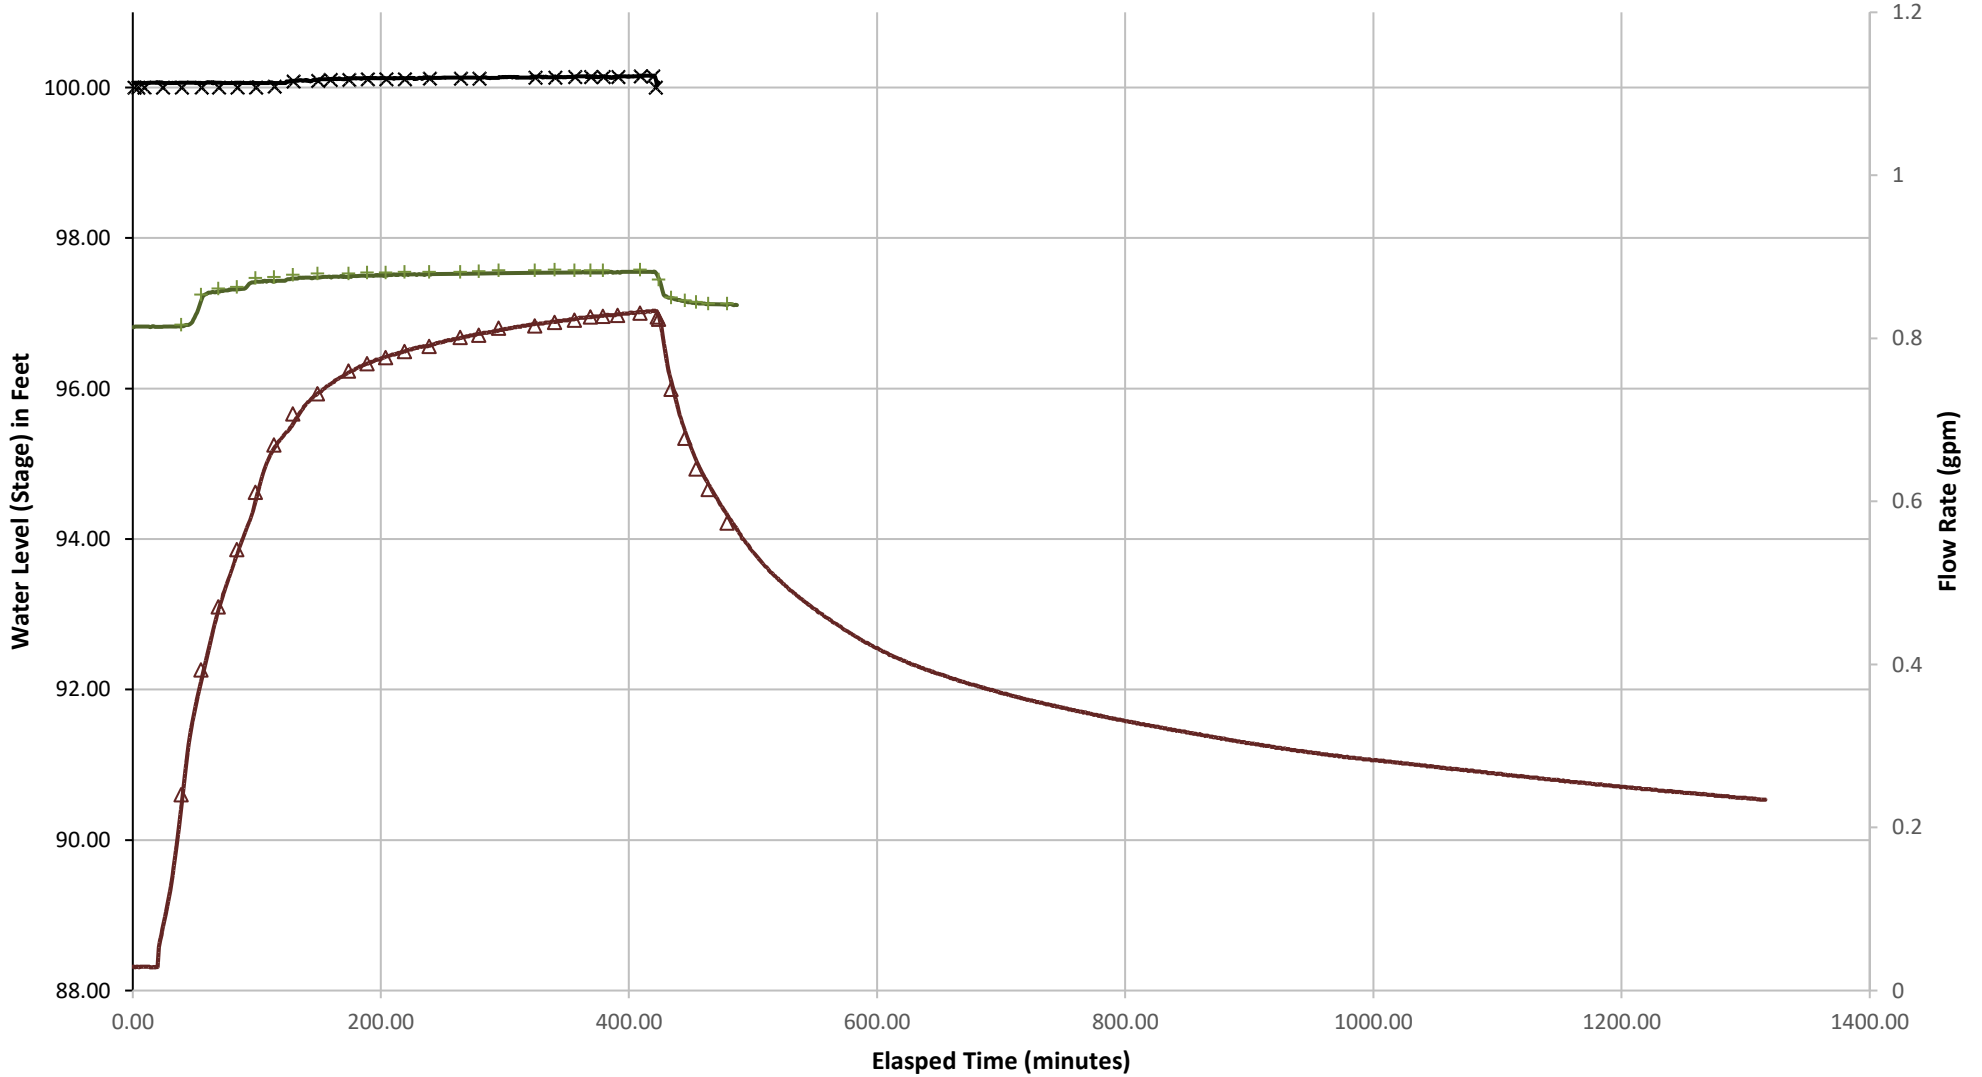
Stage (feet) on Left Axis; Flow Rate (gpm) on Right Axis vs Elapsed Time (minutes)

Notes: Elevations are not surveyed and should be used for relative reference. Elevation 100 represents ground surface. Datalogger left in piezometer to record full falling head response.

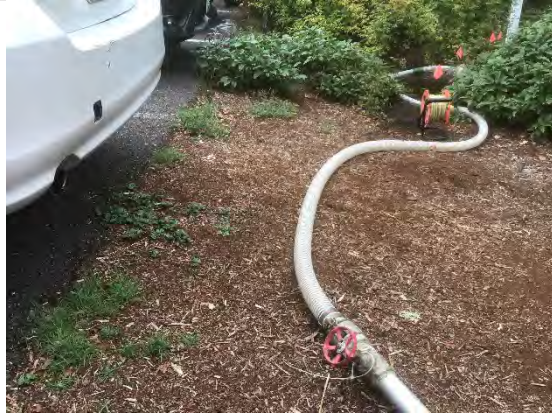
FA_INphoto-20230912-221230.jpg

Width: 96'

Additional Details: No energy dissipation feature was observed.

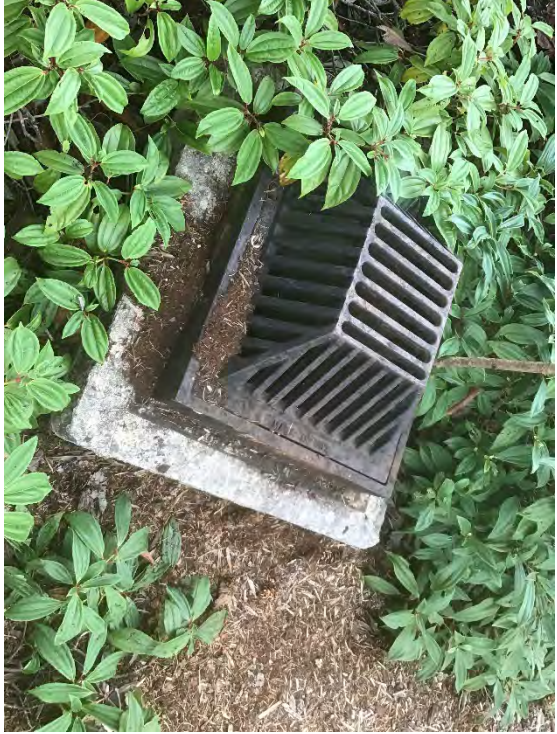
| FA_DOPhoto-20230912-221414.jpg | |

| Overflow Blocked? <input type="checkbox"/> Yes <input checked="" type="checkbox"/> No | |

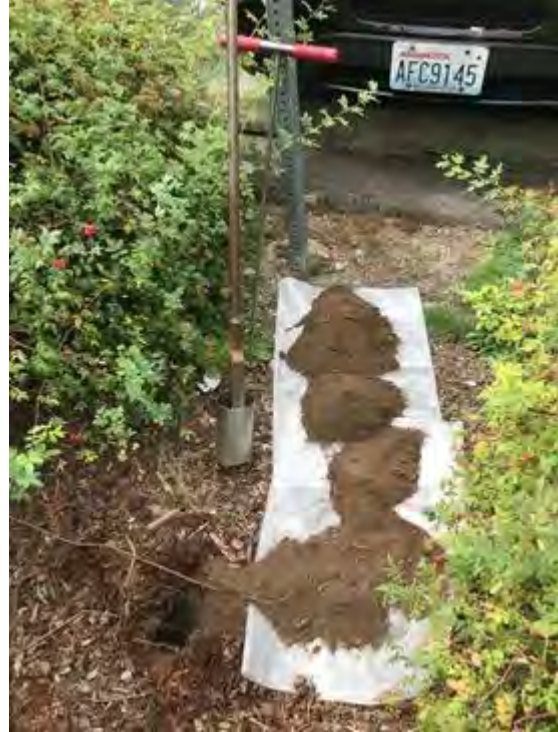
ISHS 1 HA-1.JPG

| Rain/Garden Mix Soil Texture: Loose, slightly moist, dark brown medium to coarse SAND, some fine sand, trace gravel, trace silt, abundant organics (SP) | |

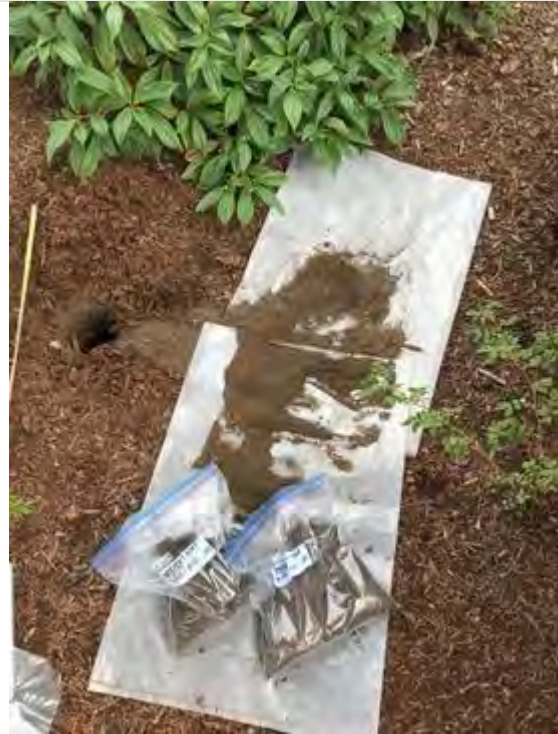
ISHS 1 HA-2.JPG

| Rain/Garden Mix Soil Texture: Loose, slightly moist, dark brown medium to coarse SAND, some fine sand, trace gravel, trace silt, abundant organics (SP) | |

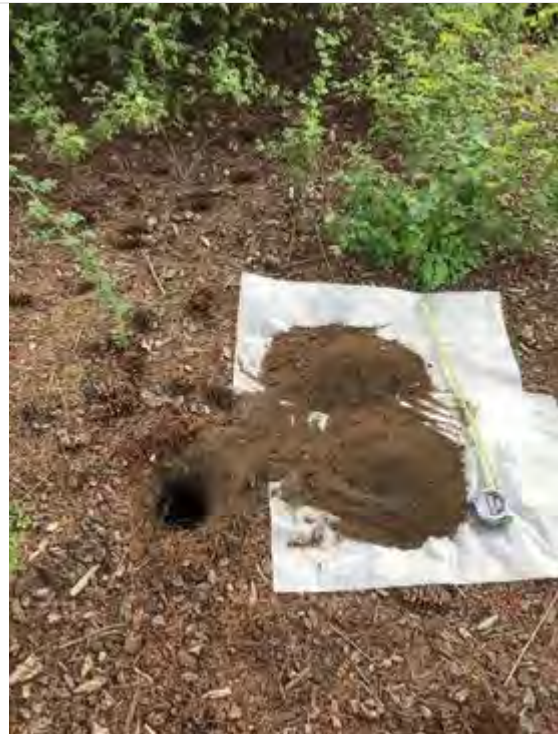
ISHS 1 HA-3.JPG

Rain/Garden Mix Soil Texture: Loose, slightly moist, dark brown medium to coarse SAND, some fine sand, trace gravel, trace silt, abundant organics (SP)

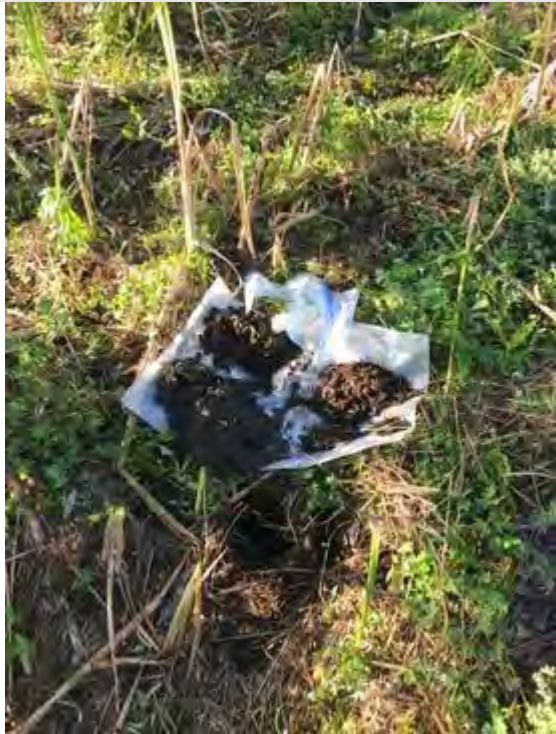
| Additional Details Depth of hand auger limited by excessive caving at depths below groundwater, no returns. Groundwater at 0.9 feet below ground surface. | |

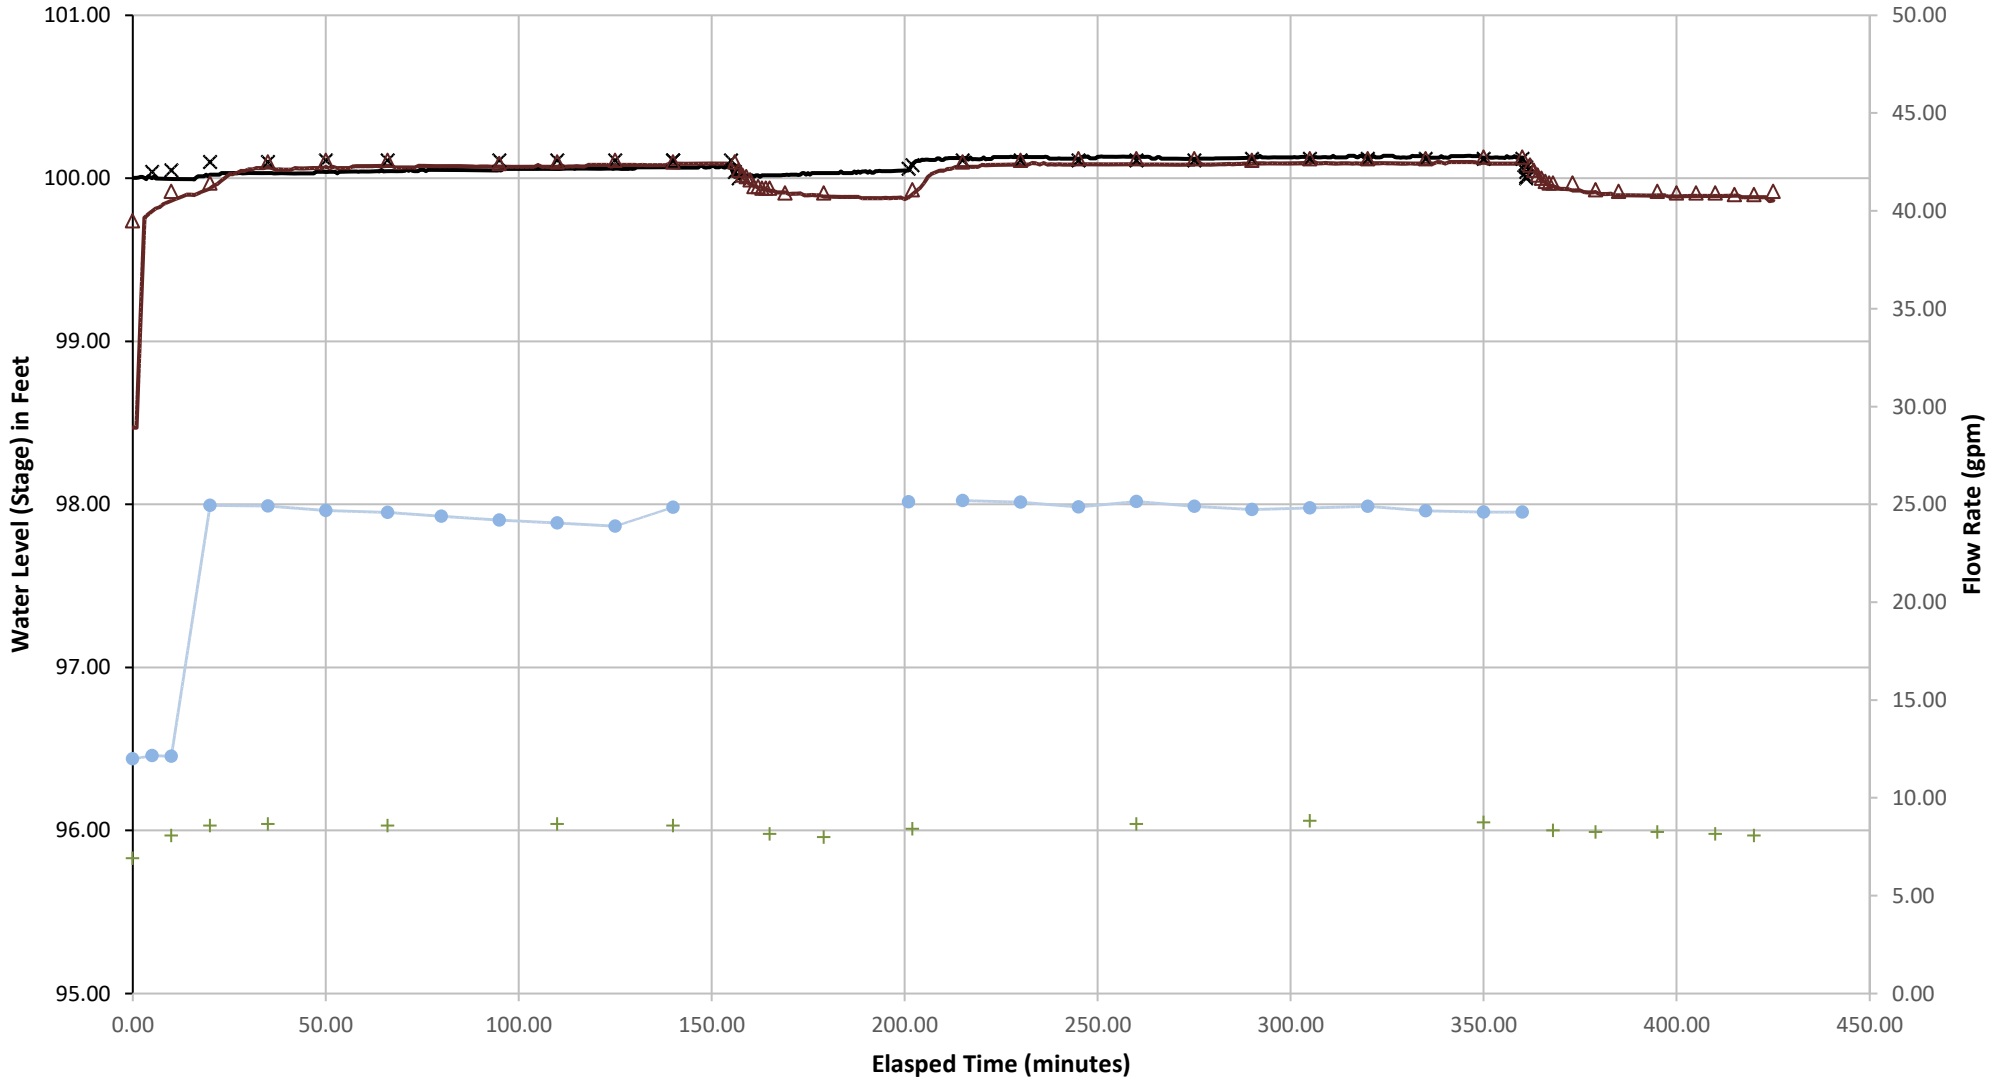
Stage (feet) on Left Axis; Flow Rate (gpm) on Right Axis vs Elapsed Time (minutes)

Notes: Elevations are unsurveyed and are used for relative reference. Elevation 100 represents ground surface. Gap in flow rate due to refill of water truck.

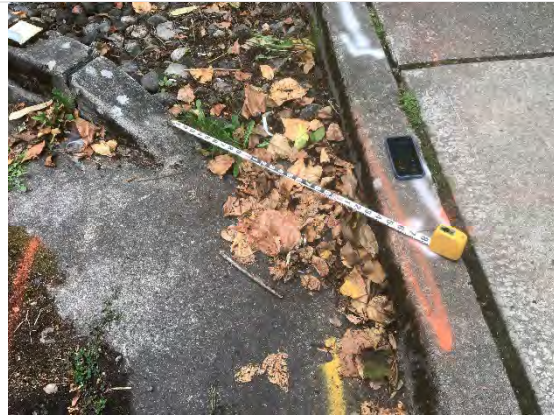
FA_INphoto-20230905-155027.jpg

Width: 2.5'

Energy Dissipation
Angular Rock: n/a
Stream Cobble: Buried
Water Wheel: n/a
Splash Block: n/a
Concrete Apron: n/a

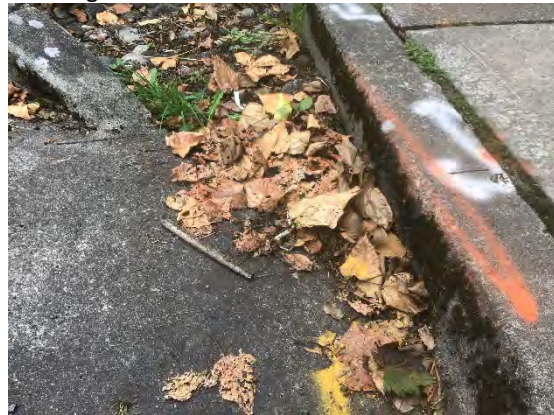
FA_INBLPhoto-20230905-161227.jpg

Additional Details: Dry leaf litter was observed blocking the inlet.

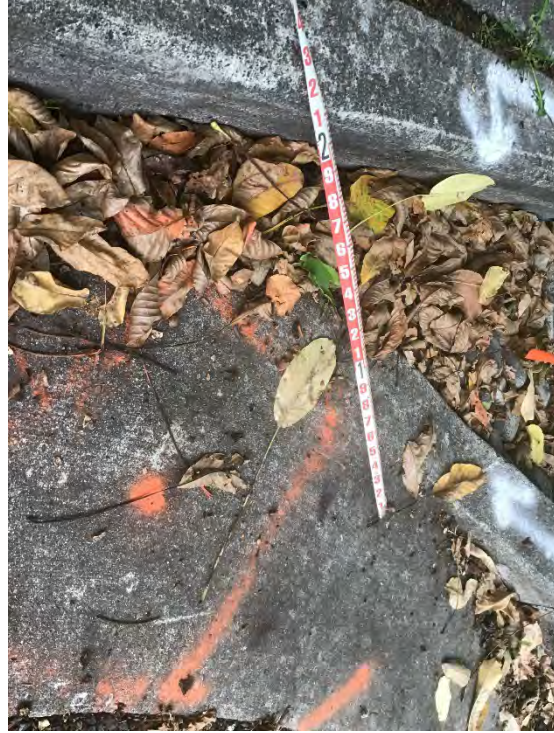
FA_INBLPhoto-20230905-160243.jpg

Additional Details: Dry leaf litter

Additional Details: 8"x8"x16" concrete blocks with 1" gaps, placed 2 rows deep, and with the top designed to be 4" above the ground were installed between the stream cobbles and the main cell. These blocks were mostly buried by mulch and soil.

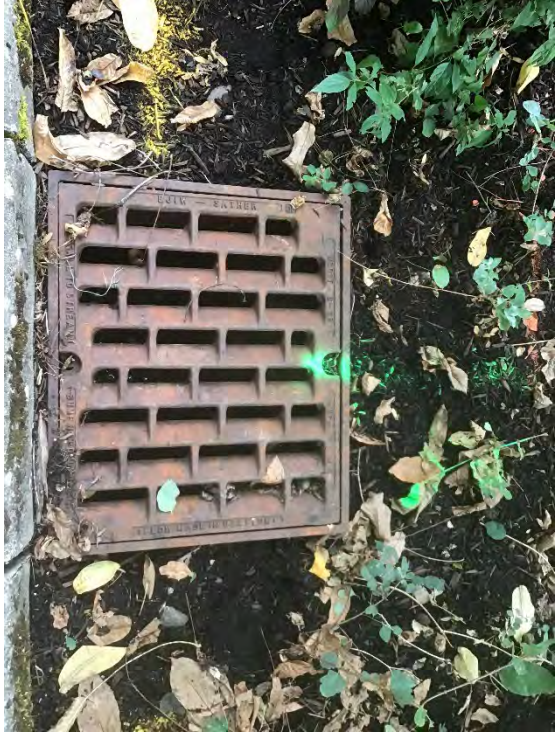
| Stickup (ft) From Ground: 0.14 Relative from staff gauge: 0.5 | |
| Damage Indicators: <input checked="" type="checkbox"/> Yes <input type="checkbox"/> No The stick up of the overflow is above the elevation of inlet 1, so water will flood into the street near inlet 1 before it will overflow into the catch basin. | |
| Trash Rack: <input checked="" type="checkbox"/> Yes <input type="checkbox"/> No Additional Details: Overflow Blocked? <input checked="" type="checkbox"/> Yes <input type="checkbox"/> No Approximately 5% blocked Additional Details: Some dead leaves caught in spiderwebs slightly block overflow. | |

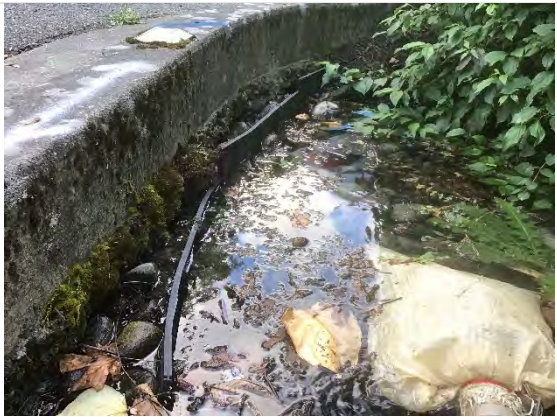
| DO - 2 | |

| Shape: <input type="checkbox"/> Round Dimensions: <input type="checkbox"/> Rectangular <input checked="" type="checkbox"/> Other: Non engineered overflow | |
| Additional Details: Cracks under the street were observed at the perimeter of the stream cobble energy dispersion feature for Inlet 1 for a width of 3 feet. | |
| Damage Indicators: <input checked="" type="checkbox"/> Yes <input type="checkbox"/> No Water was observed flowing into cracks under the street pavement on the NE edge of the cell during testing. Some past mitigation efforts were observed by means of a short plastic barrier, this was ineffectual at the time of testing. | |

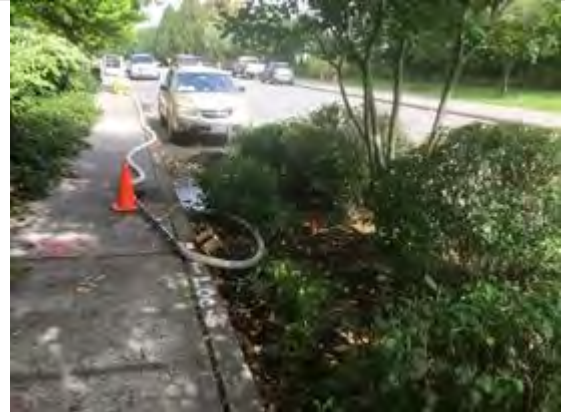
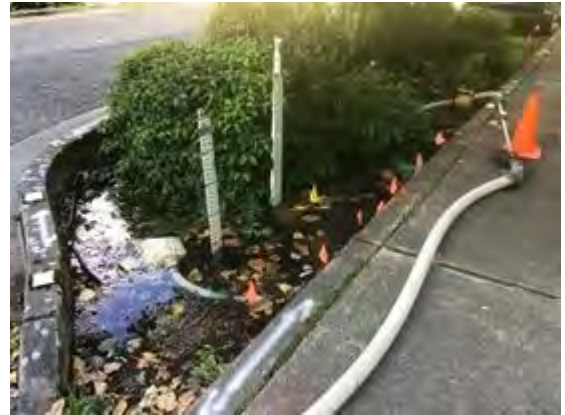
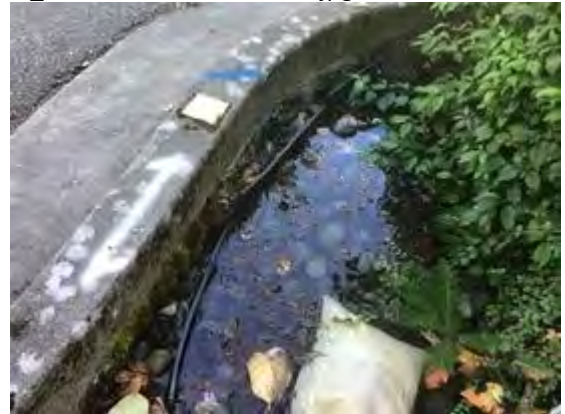
Field staff reduced flow rate due to lateral flow under the street at ponded depth of 0.54 or greater. No WellPoint was installed due to the proximity of buried utilities. Additional test details can be found in the executive summary.

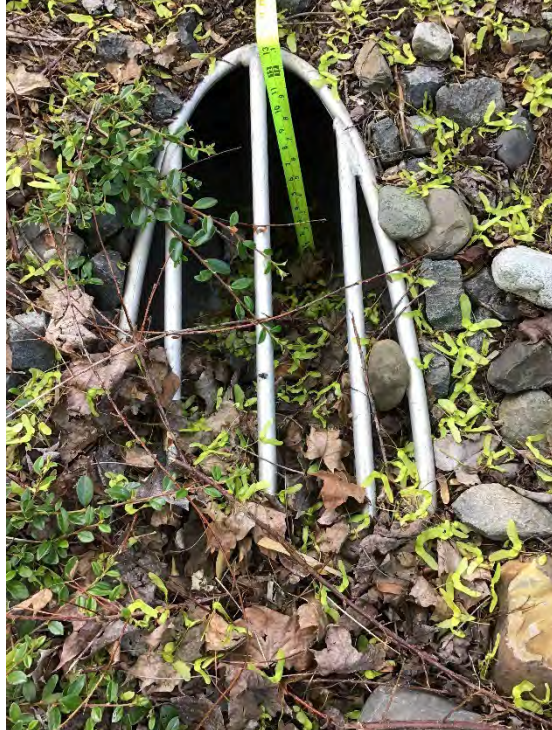
20230526-183955.jpg

Additional Details: Heavy leaf litter exists near grate of inlet but it is not a substantial blockage of flow.

Additional Details: Stream cobbles are up to 6" diameter and clustered around inlet, and are dispersed up to 15 feet away.

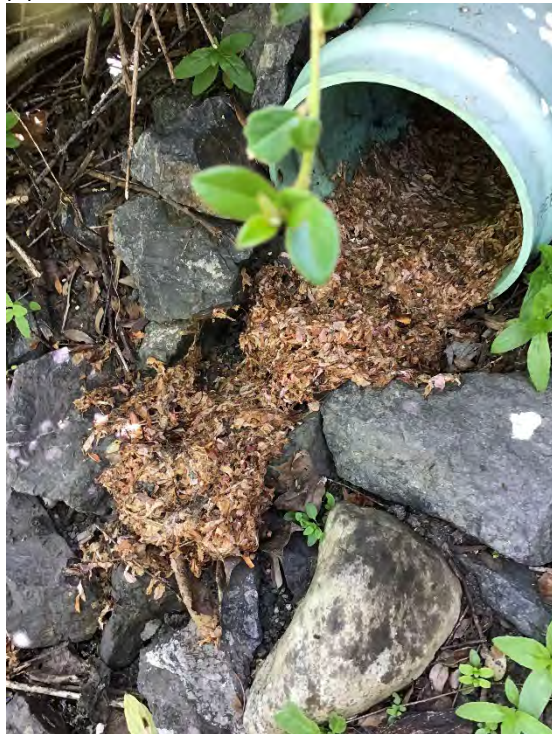
20230526-185002.jpg

Additional Details: Fine leaf litter was observed at the bottom of pipe, It appears to be sourced from the pipe's flow.

Additional Details: Angular rock between cell base and inlet.

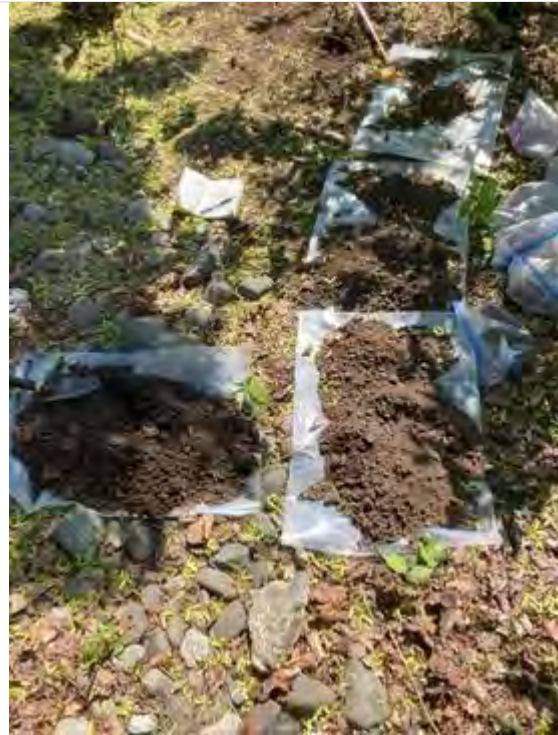
HA-1W.jpg

| Additional Details Unusual Bioretention soil mix. Gravels are angular with an average diameter of 0.5-1". Shallowest depth to water during the test was above the ground surface. | |

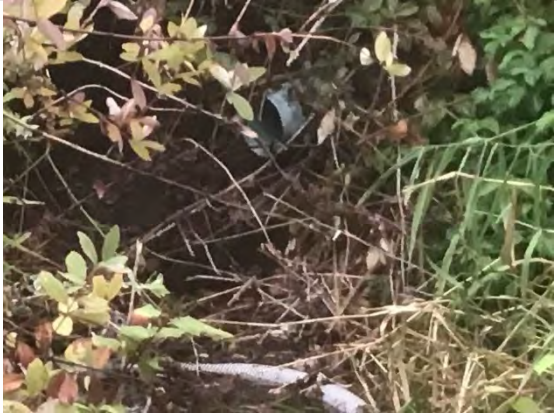
| <p>IN-1</p> <p> <input type="checkbox"/> Curb cut <input type="checkbox"/> Sheet Flow <input type="checkbox"/> Dispersed Flow <input checked="" type="checkbox"/> Pipe <input type="checkbox"/> Other: </p> <p>Pipe: Material <input checked="" type="checkbox"/> PVC <input type="checkbox"/> Metal <input type="checkbox"/> Concrete <input type="checkbox"/> Other Diameter: 0.5'</p> <p>Energy Dissipation Angular Rock: Buried Stream Cobble: n/a Water Wheel: n/a Splash Block: n/a Concrete Apron: n/a</p> | | <p>FA_INphoto-20230829-175101.jpg</p> |
| <p>Additional Details: Angular rock is buried about 0.5' below ground surface, as described in HA-3.</p> | | |

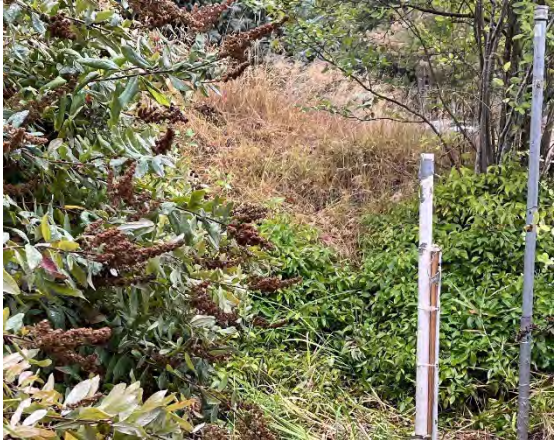
| <p>IN-2</p> <p> <input type="checkbox"/> Curb cut <input type="checkbox"/> Sheet Flow <input checked="" type="checkbox"/> Dispersed Flow <input type="checkbox"/> Pipe <input type="checkbox"/> Other: </p> <p>Width: 4'</p> <p>Energy Dissipation Angular Rock: n/a Stream Cobble: n/a Water Wheel: n/a Splash Block: n/a Concrete Apron: n/a</p> | | <p>DrainageSwale.jpeg</p> |
| <p>Additional Details: Design plans state armoring along drainage swale, this was buried in grasses and thick vegetation.</p> | | |

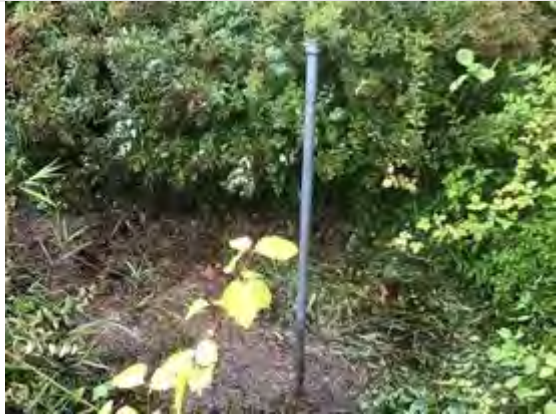
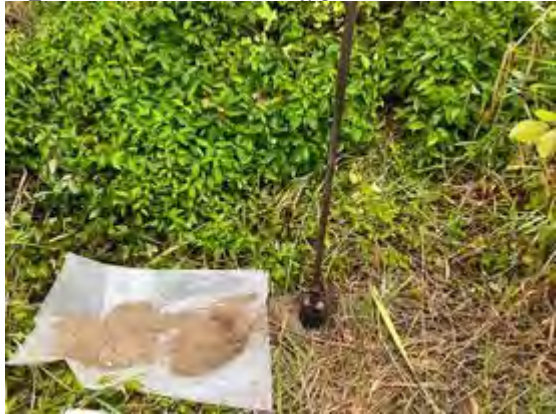
| Bioretention soil mix observed in cell is not what is typically observed. Plans state compost amended soil. Assumption is there was once compost mixed in with the native substrate. Shallowest depth to water during the test was above the ground surface. | |

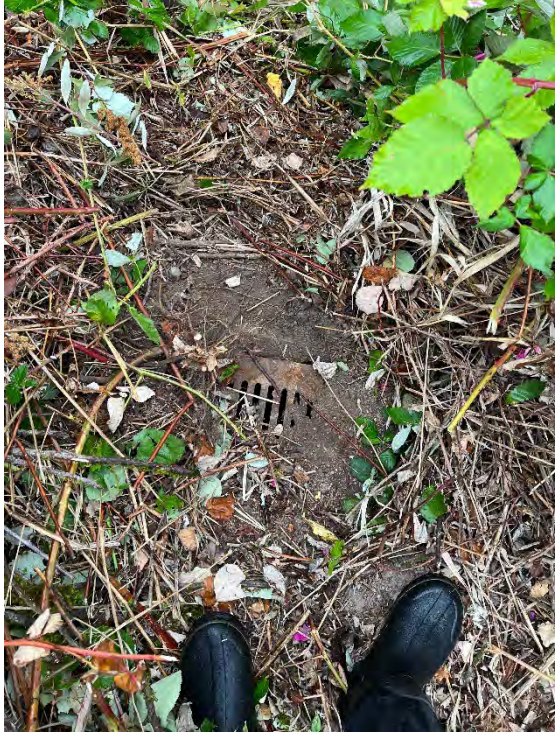
| IMG_0519.jpg | |

| Trash Rack: <input checked="" type="checkbox"/> Yes <input type="checkbox"/> No Approximately 99% blocked Additional Details: Yard drain catch basin was buried in soil and natural mulch by about 0.2', water was observed seeping out of the side of the cell before it overflows into this structure. | |
| Overflow Blocked? <input checked="" type="checkbox"/> Yes <input type="checkbox"/> No Approximately 99% blocked Additional Details: See above, the overflow was cleared in order to find it the day before testing. | |

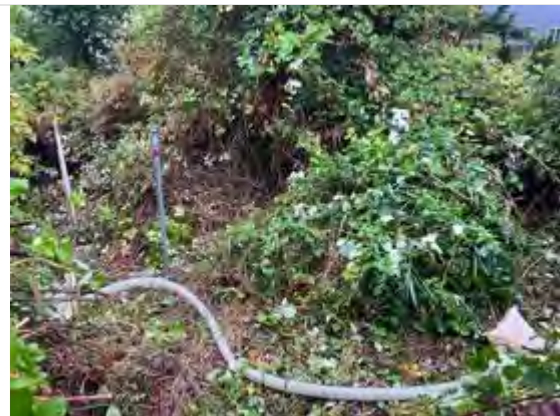
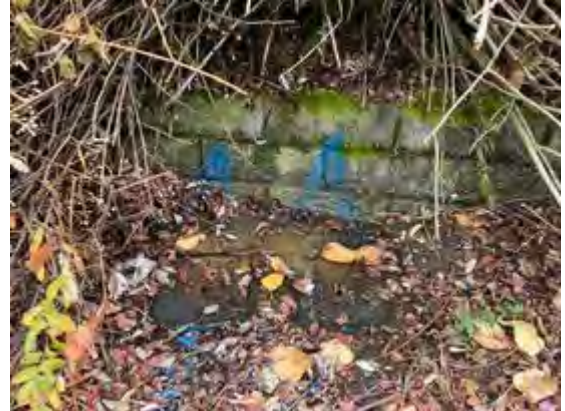
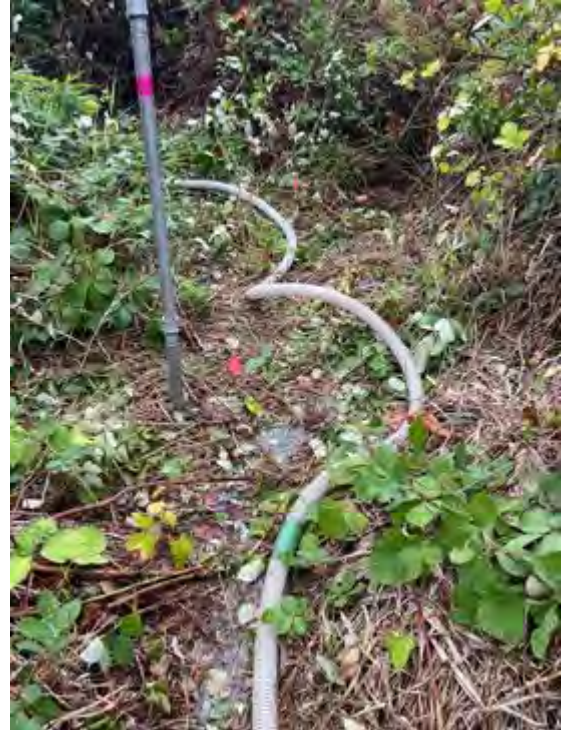
Noticed leaking water out of NW side of cell, line of seepage comes out through low concrete block wall above water meter boxes, in line with water pipes marked by utility. Water pools over between sidewalk and edge of wall, then overflows sidewalk into street and down the street gutter to the north for 50+ feet before reaching a catch basin to connect to the storm drain network.

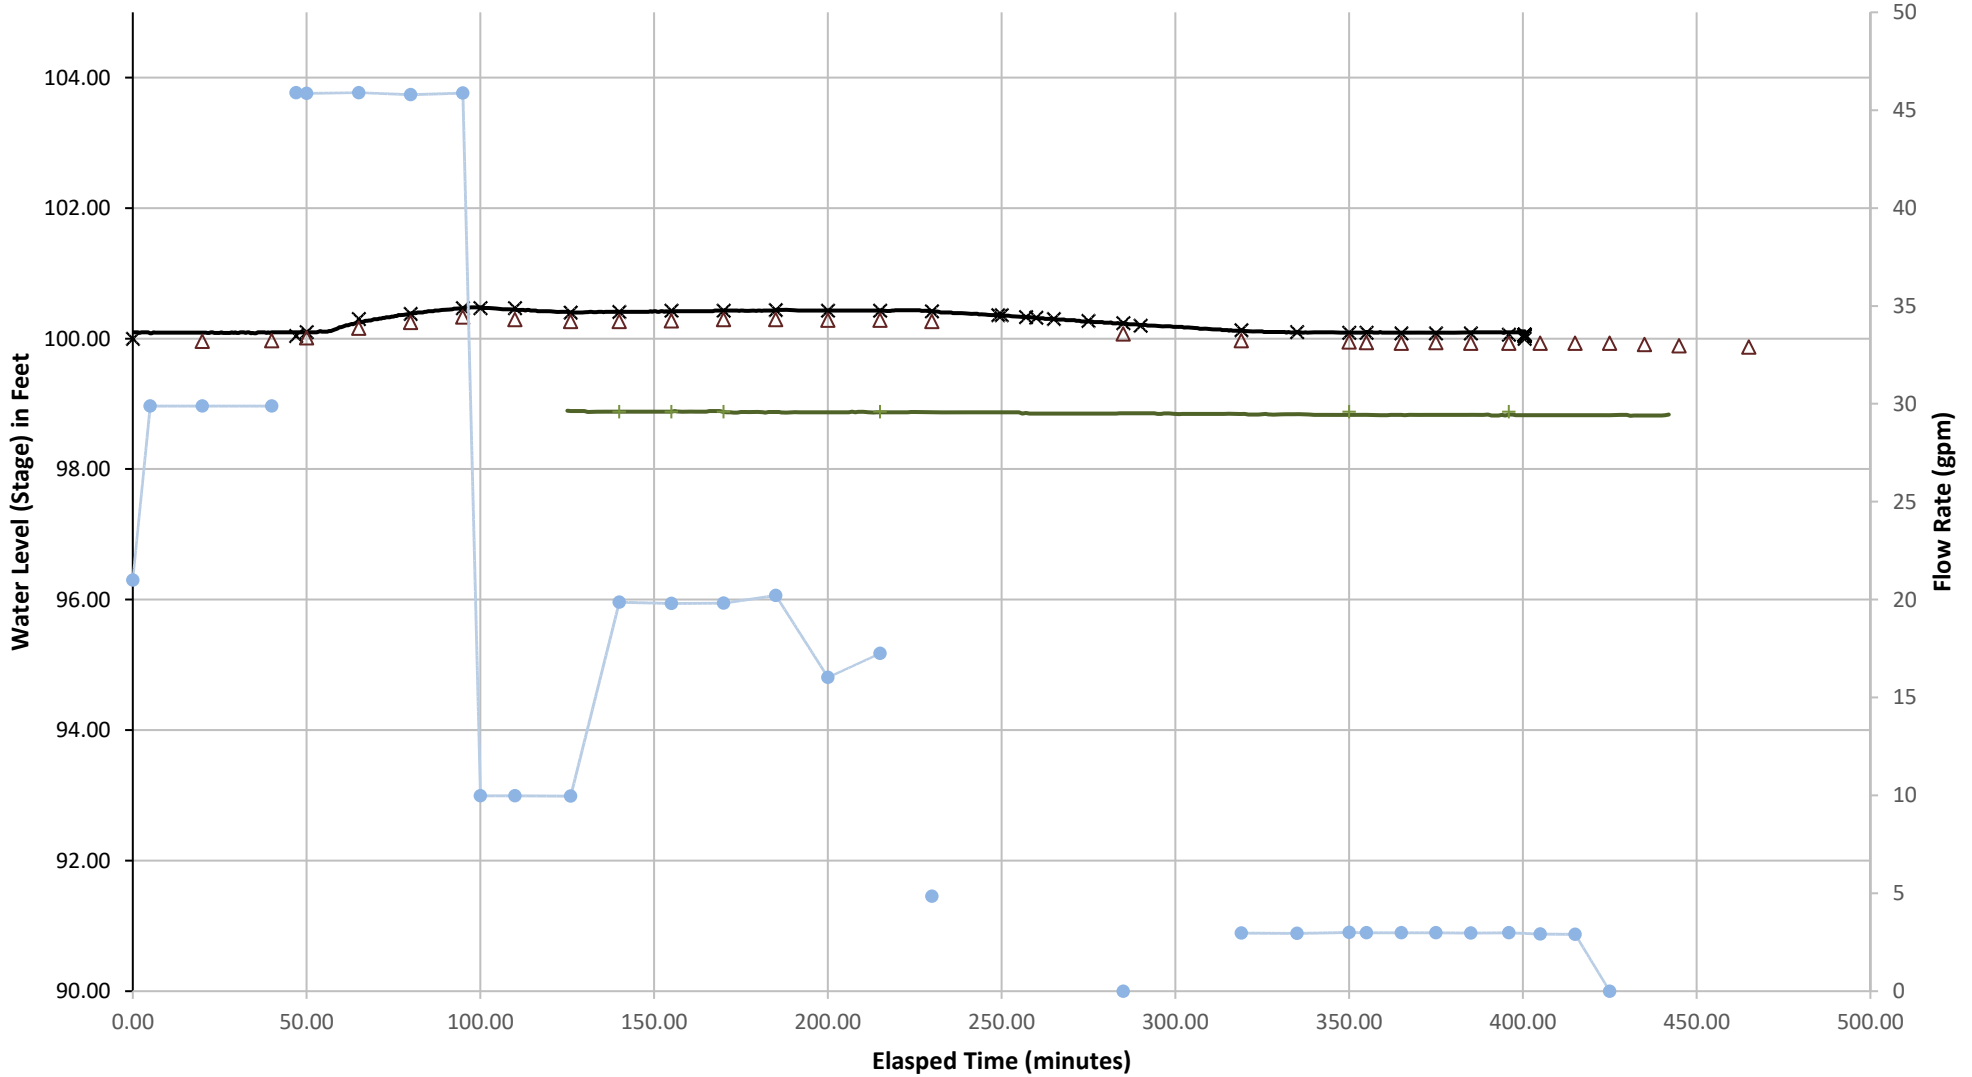
Notes: Elevations are not surveyed and should be used as relative reference. Elevation 100 represents ground surface. Wellpoint logger data faulty and not included in chart.

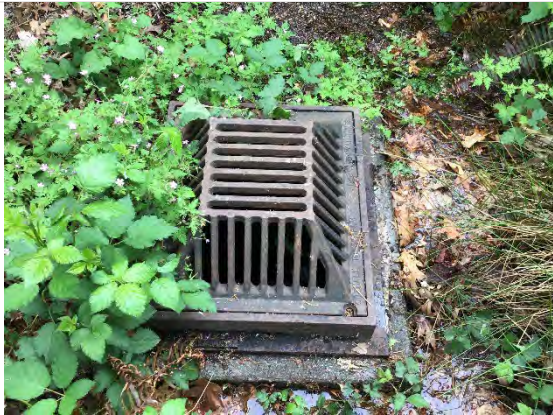
| Shape: <input type="checkbox"/> Round Dimensions: <input checked="" type="checkbox"/> Rectangular Length: 1.76' <input type="checkbox"/> Other Width: 1.44' | <p>20230523-213315.jpg</p> |

| Additional Details: Stickup (ft) From Ground: 1.1 Relative from staff gauge: 1.22 | |
| Damage Indicators: <input checked="" type="checkbox"/> Yes <input type="checkbox"/> No Small cracks in the catch basin allow ponded surface and subsurface water to enter the catch basin. The catch basin does not properly function as an "overflow" feature, instead it is a conduit for lateral flow. | |

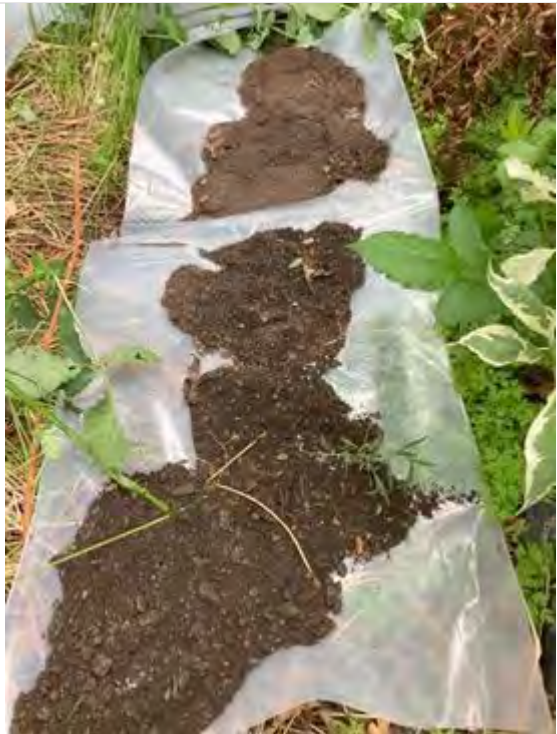
20230523_183729283_iOS.jpg

| Additional Details Water measured at 1.8' below ground surface in HA-2 at 10:37am, just under 3 hours into the test. No water was encountered during excavation. | |

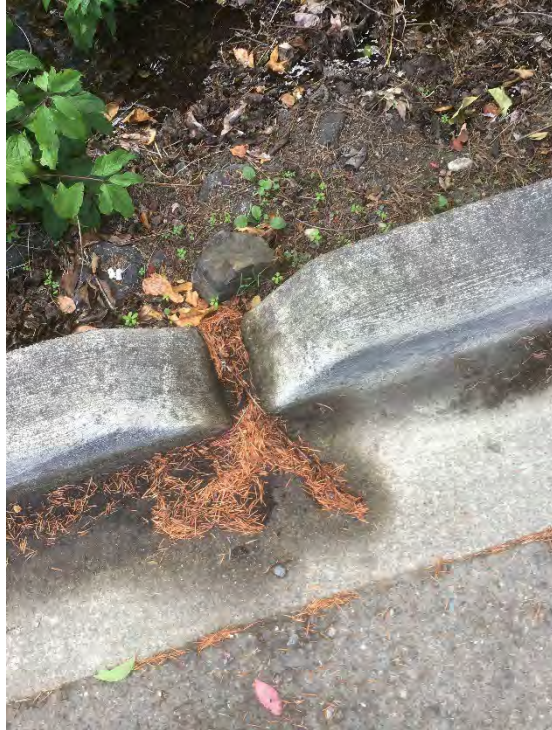
FA_INBLPhoto-20230920-164826.jpg

Additional Details: A thick deposition of pine needles partially block the inlet.

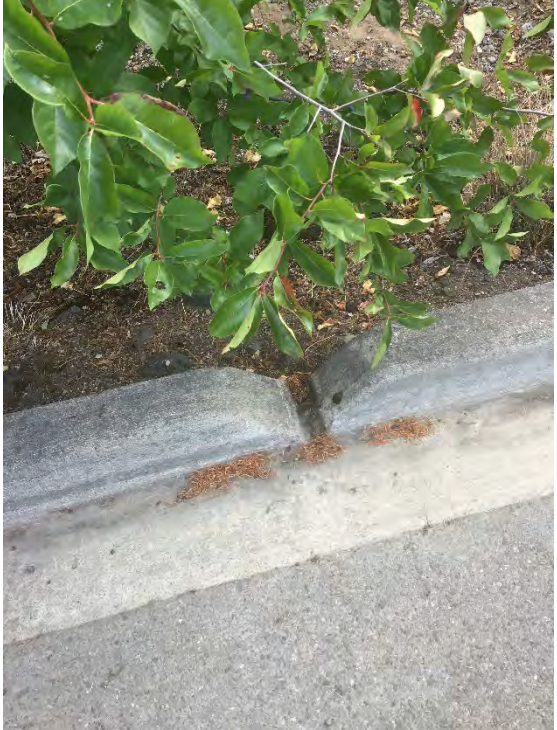
| <p>Erosion Present? <input checked="" type="checkbox"/> Yes <input type="checkbox"/> No Severity: Minor</p> | <p>Blockage Present? <input checked="" type="checkbox"/> Yes <input type="checkbox"/> No Approximately 5% blocked</p> <p>Types: <input type="checkbox"/> Sediment <input checked="" type="checkbox"/> Organic <input type="checkbox"/> Rock <input type="checkbox"/> Trash <input type="checkbox"/> Vegetation</p> <p>Additional Details: A thin deposition of pine needles partially block the inlet.</p> |

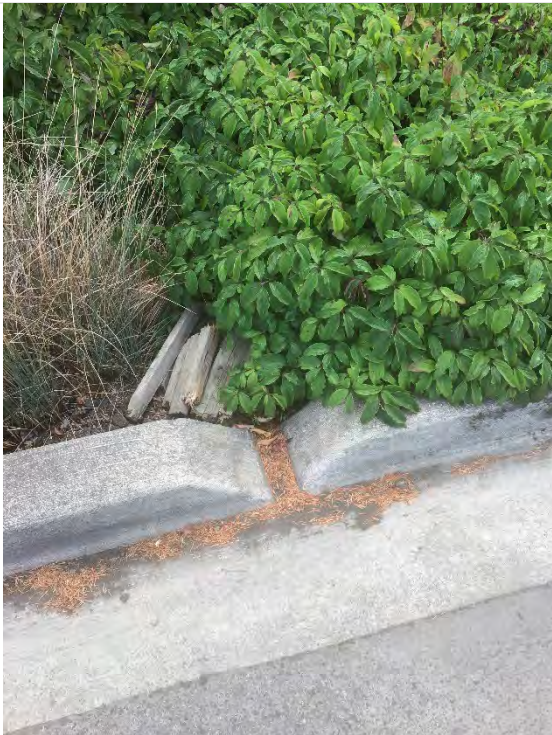
| <p>Erosion Present? <input type="checkbox"/> Yes <input checked="" type="checkbox"/> No</p> | <p>Blockage Present? <input checked="" type="checkbox"/> Yes <input type="checkbox"/> No Approximately 10% blocked</p> <p>Types: <input type="checkbox"/> Sediment <input checked="" type="checkbox"/> Organic <input type="checkbox"/> Rock <input type="checkbox"/> Trash <input type="checkbox"/> Vegetation</p> <p>Additional Details: A thin deposition of pine needles partially block the inlet.</p> |

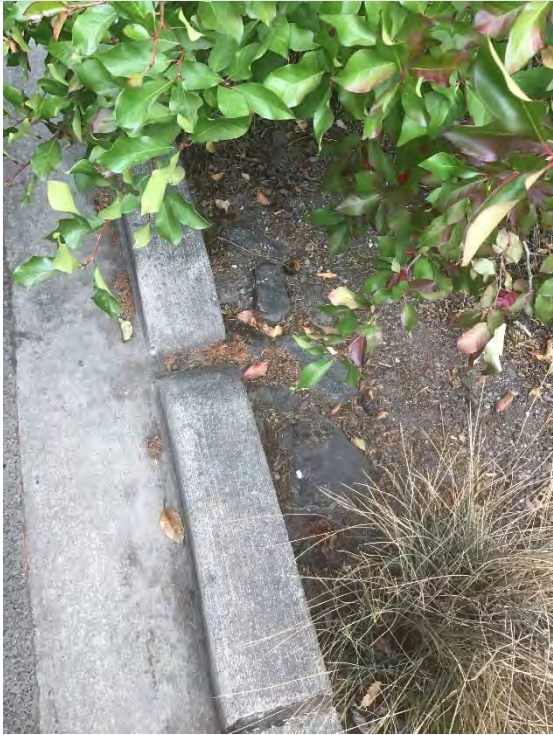
| <p>IN-8</p> | |

| <p>Erosion Present? <input type="checkbox"/> Yes <input checked="" type="checkbox"/> No</p> | <p>Blockage Present? <input checked="" type="checkbox"/> Yes <input type="checkbox"/> No Approximately 10% blocked</p> <p>Types: <input type="checkbox"/> Sediment <input checked="" type="checkbox"/> Organic <input type="checkbox"/> Rock <input type="checkbox"/> Trash <input type="checkbox"/> Vegetation</p> <p>Additional Details: A thin deposition of pine needles partially block the inlet.</p> |

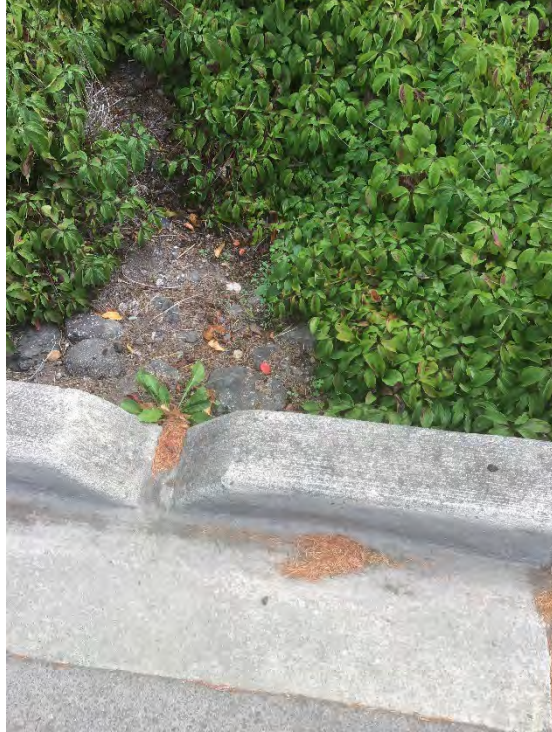
FA_INBLPhoto-20230920-165138.jpg

Additional Details: A dandelion and a thin deposition of pine needles partially block the inlet.

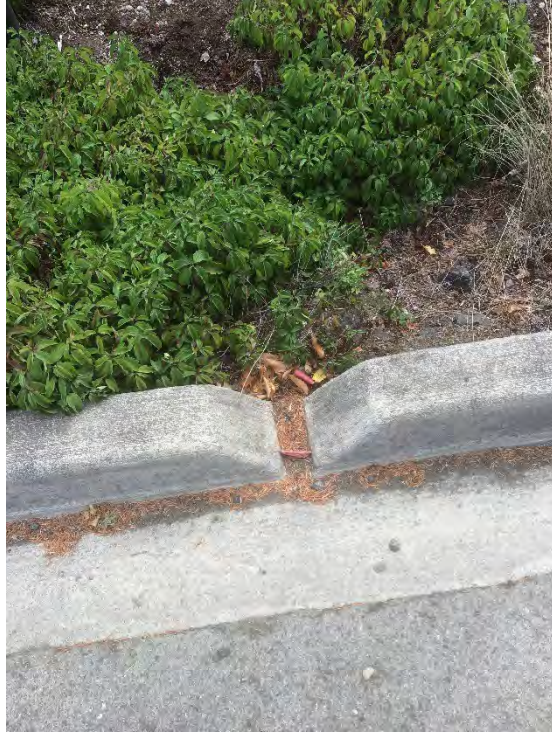
FA_INBLPhoto-20230920-165347.jpg

Additional Details: A thick deposition of pine needles partially block the inlet.

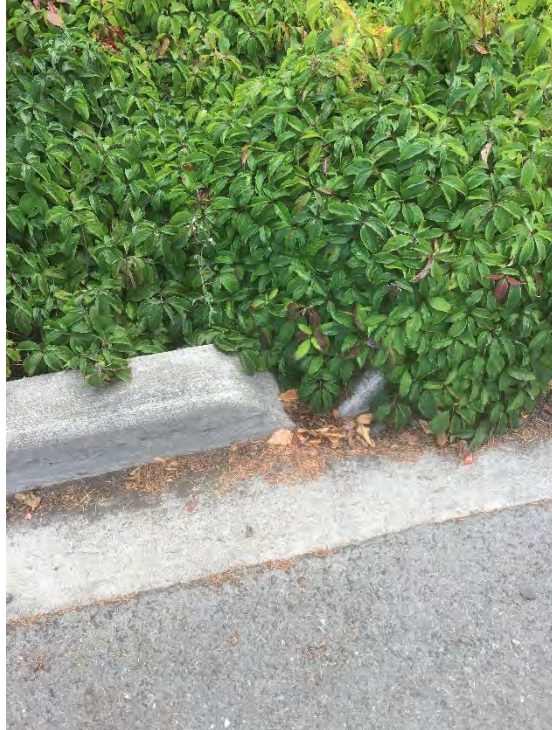
FA_INBLPhoto-20230920-165503.jpg

Additional Details: A thick deposition of pine needles, dried leaves and vegetation block the inlet.

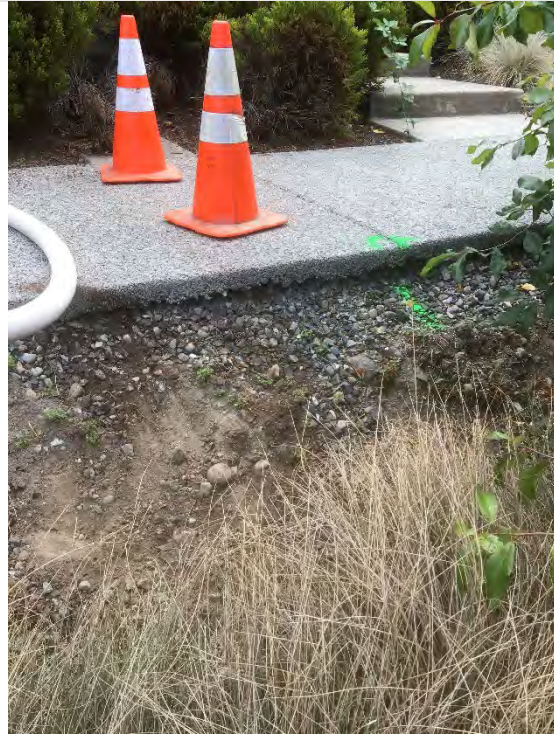
FA_INphoto-20230920-165629.jpg

Erosion Present? Yes No
Severity: Major
Sidewalk basecourse is severely undermined.
Additional Details:

Side slopes were designed for a shallow slope from the top of the sidewalk, and road surface, to the base of the cell. Existing conditions consisted of a steep side slope and an undercut sidewalk with the underlying clean crushed rock exposed and eroding into the cell.

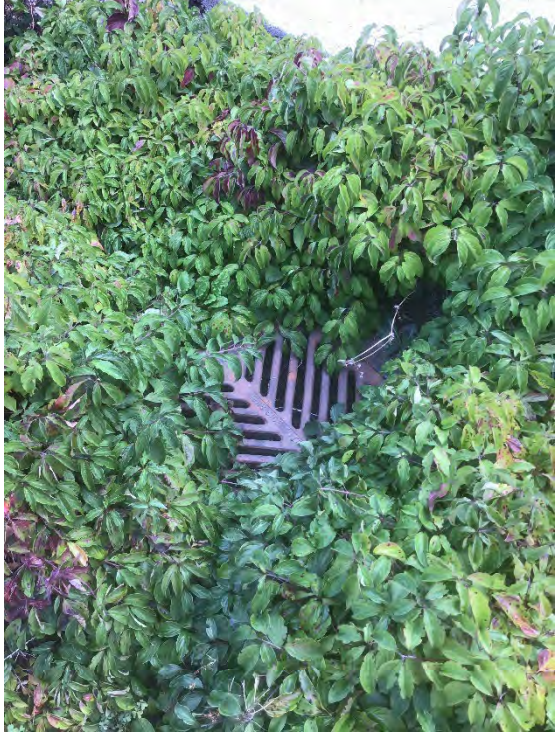
| FA_DOPhoto-20230920-165712.jpg | |

| Damage Indicators: <input checked="" type="checkbox"/> Yes <input type="checkbox"/> No Cracks in concrete allow test water to seep in during the test. Water was observed ponding at the outfall, in what is the 436 McPhee bioretention cell, towards the end of the test. | |

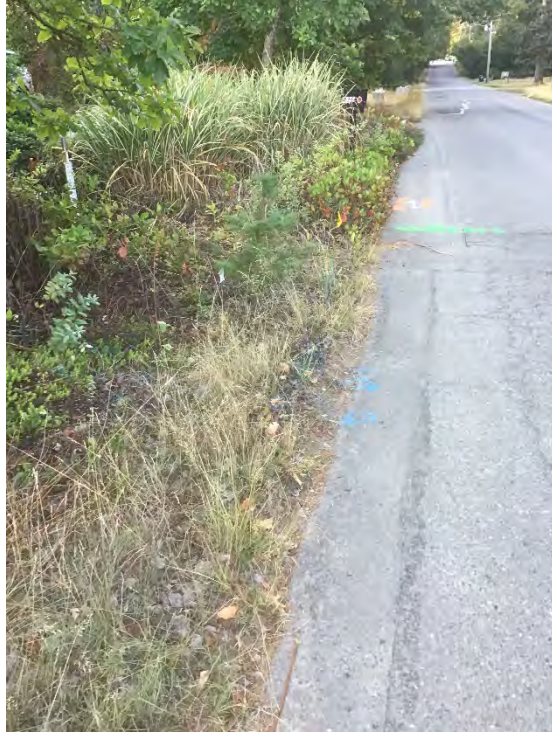
FA_INBLPhoto-20230921-143929.jpg

Additional Details: Vegetation blockage on street side of cell.

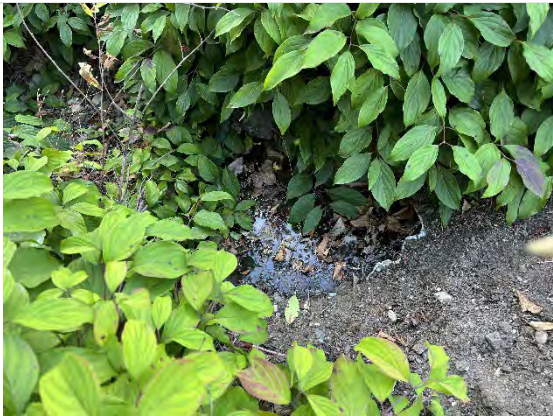
| <input type="checkbox"/> Curb cut <input type="checkbox"/> Sheet Flow <input type="checkbox"/> Dispersed Flow <input checked="" type="checkbox"/> Pipe <input type="checkbox"/> Other: | <p>OutfallPonding.JPG</p> |

| Additional Details: No energy dissipation feature was observed. Photograph of the outfall is from the test the day before on 420 McPhee. | |

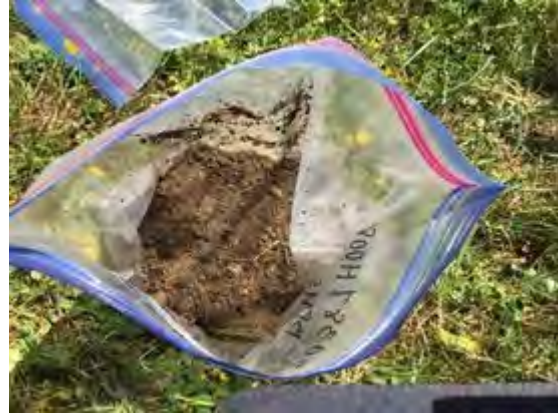
FA_FPhoto-20230605-190903.jpg

| Stopped excavation at filter fabric. | |

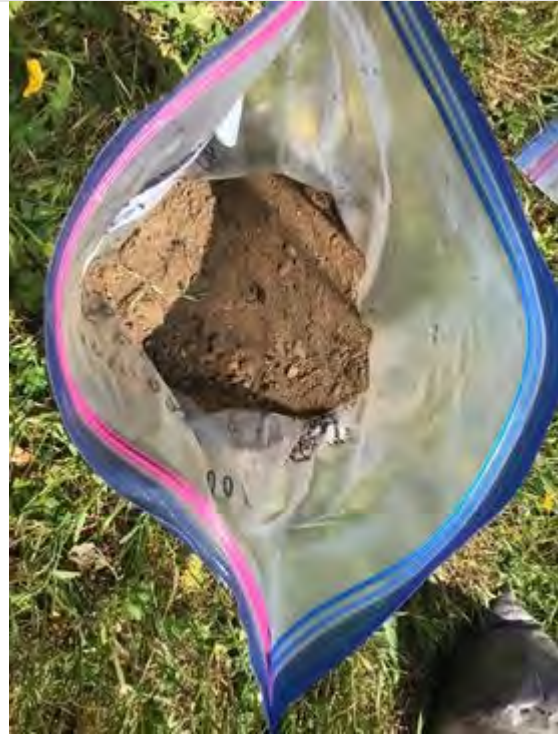
FA_FPhoto-20230605-190944.jpg

Additional Details
 Stopped excavation at filter fabric.
