Technical Memorandum

| | | Project Name: | Long Term Bioretention Monitoring Study, Phase III |
| Subject: | Task 3.2 Geotechnical and Hydrogeologic Data/Report, City of Olympia Contract Agreement Number: C2300003 | | |

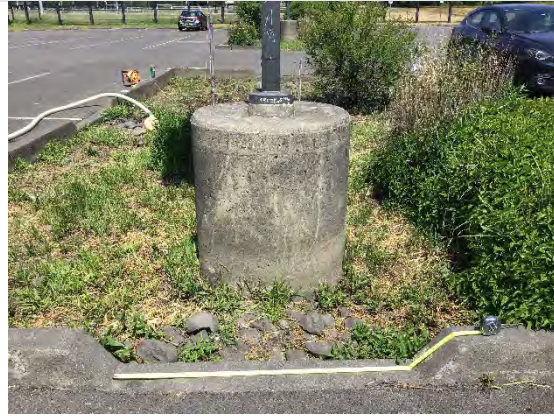
20230601-191718.jpg

Erosion Present? Yes No
Severity: Minor

Additional Details: Stream cobbles were observed near the beginning of the inlet, the concrete base of the light post is located 2.2 feet from the curb cut with stream cobbles wrapping around to the west of the light post.

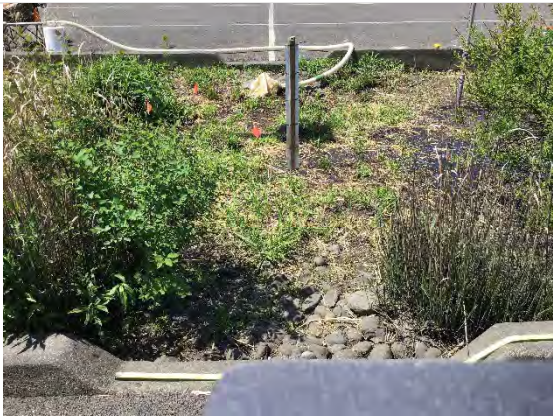
| IN-4 | |

| Erosion Present? <input checked="" type="checkbox"/> Yes <input type="checkbox"/> No Severity: Minor | Blockage Present? <input type="checkbox"/> Yes <input checked="" type="checkbox"/> No |
| Additional Details: Rounded cobbles at the base of inlet, shrubs on either side. | |

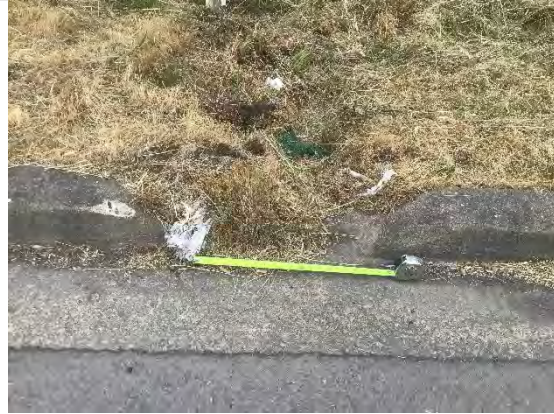
FA_INphoto-20230614-190447.jpg

Erosion Present? Yes No
Severity: Minor
Slight scouring into cell.

Additional Details: Significant sediment & organic buildup was observed on the uphill side of curb cut.

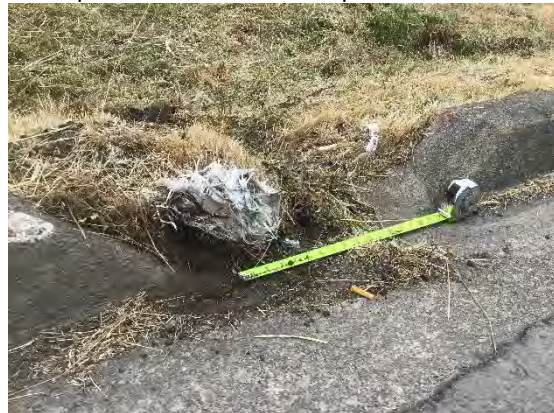
FA_INBLPhoto-20230614-190630.jpg

Additional Details: No energy dissipation was observed on any of the curb cut inlets.

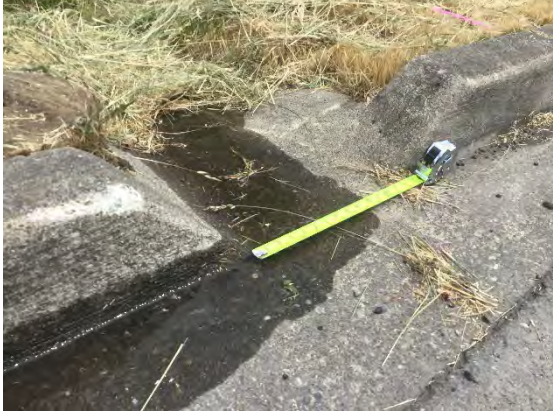
| IN-2 <input checked="" type="checkbox"/> Curb cut <input type="checkbox"/> Sheet Flow <input type="checkbox"/> Dispersed Flow <input type="checkbox"/> Pipe <input type="checkbox"/> Other: Width: 1.25' Energy Dissipation Angular Rock: n/a Stream Cobble: n/a Water Wheel: n/a Splash Block: n/a Concrete Apron: n/a | | <p>FA_INphoto-20230614-190904.jpg</p> |
| Erosion Present? <input type="checkbox"/> Yes <input checked="" type="checkbox"/> No | | Blockage Present? <input type="checkbox"/> Yes <input checked="" type="checkbox"/> No |
| Additional Details: No energy dissipation was observed on any of the curb cut inlets. | | |

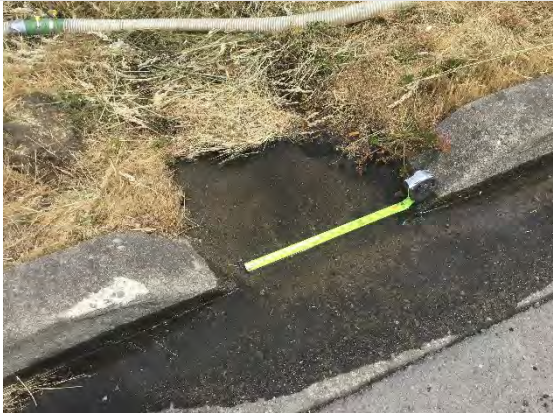
| IN-3 <input checked="" type="checkbox"/> Curb cut <input type="checkbox"/> Sheet Flow <input type="checkbox"/> Dispersed Flow <input type="checkbox"/> Pipe <input type="checkbox"/> Other: Width: 1.4' Energy Dissipation Angular Rock: n/a Stream Cobble: n/a Water Wheel: n/a Splash Block: n/a Concrete Apron: n/a | | <p>FA_INphoto-20230614-191007.jpg</p> |
| Erosion Present? <input type="checkbox"/> Yes <input checked="" type="checkbox"/> No | | Blockage Present? <input type="checkbox"/> Yes <input checked="" type="checkbox"/> No |
| Additional Details: No energy dissipation was observed on any of the curb cut inlets. | | |

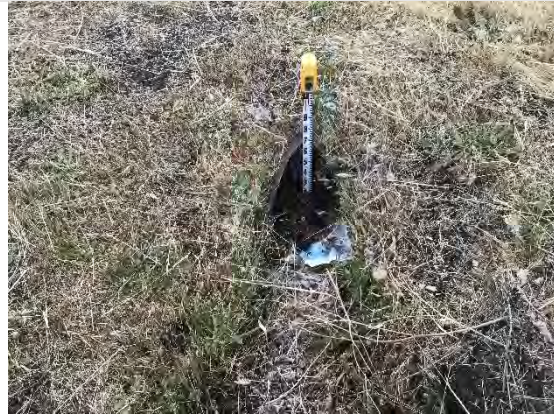
FA_INphoto-20230615-010218.jpg

Erosion Present? Yes No

Some scouring was observed where the pipe meets the cell.

Additional Details: Newspaper and leaf litter were observed blocking the bottom of pipe. *Blockage photograph is upside down?

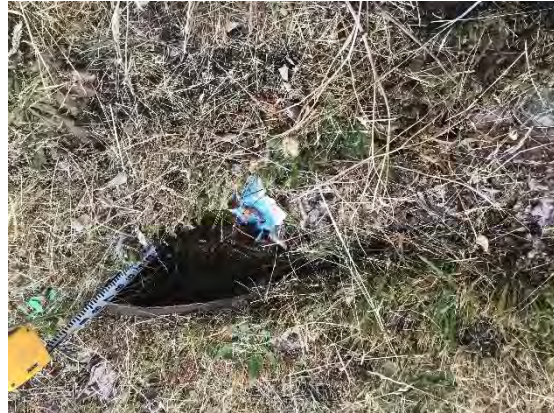
FA_INBLPhoto-20230615-010345.jpg

Additional Details: No energy dissipation was observed.

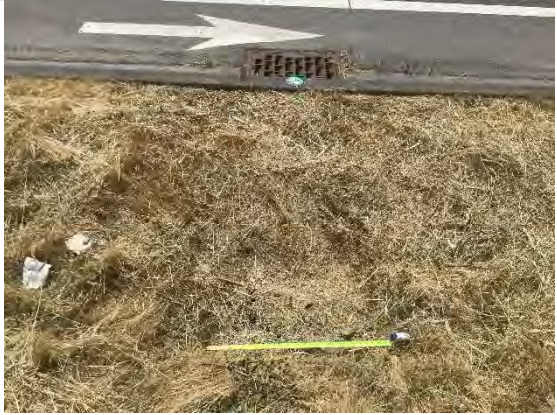
FA_DOPhoto-20230614-192246.jpg

| DO - 1 | | |
| Damage Indicators: <input type="checkbox"/> Yes <input checked="" type="checkbox"/> No | | |
| Trash Rack: <input checked="" type="checkbox"/> Yes <input type="checkbox"/> No Approximately 90% blocked Additional Details: This overflow feature is outside of the tested cell and is in the easternmost cell, which flows out to the city's storm drain network. The trash rack was completely covered with grass from recent mowing with only some sediment blockage. On prior site visits, no grass was observed covering the trash rack. | | |
| Overflow Blocked? <input type="checkbox"/> Yes <input checked="" type="checkbox"/> No | | |

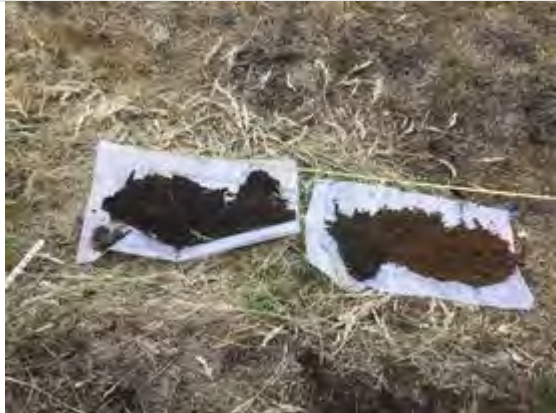
| FA_FPhoto-20230614-131348.jpg | |

| Additional Details More than one unit is present Fill encountered at 1.4-2 feet depth: Moist, medium dense, brownish grey, coarse-medium SAND, some gravel, trace silt. Scattered angular rock chips. Fill not found in other explorations. | |

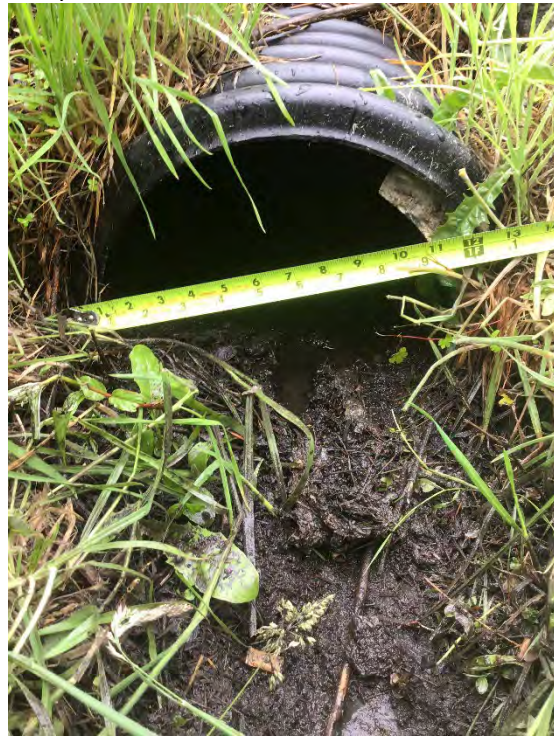
FA_INBLPhoto-20230620-234417.jpg

Additional Details: Bottom 1/3 of pipe full of dark grey silty material. Standing water observed in pipe after today's rain event.

Additional Details: Angular rock scattered up to 5 feet away from cell and buried in silty organic material was present at the base of the inlet.

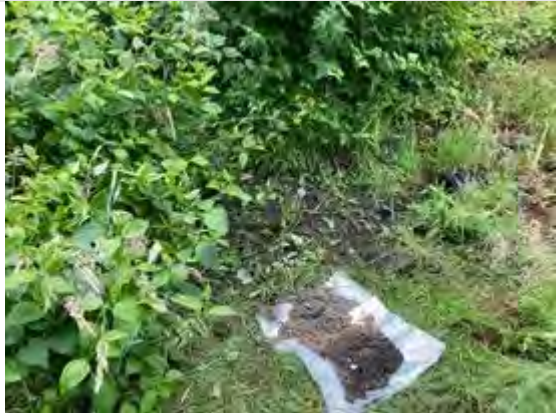
IMG_2946.jpg

| <p>Additional Details</p> <p>0-1.4: Bioretention Soil</p> <p>1.4-2.0: Fill: Described above</p> <p>2.0-2.5: Fill: Loose, very moist, greyish brown, GRAVEL, some silt, some sand, some silt.</p> <p>No groundwater encountered. Review with physical log.</p> | |

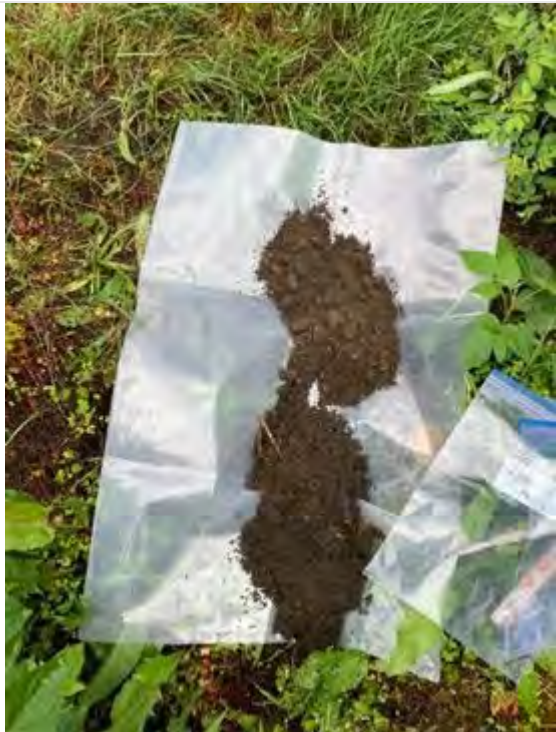
IMG_2928.jpg

| <p>Additional Details</p> <p>0-0.7': BSM</p> <p>0.7': Mixed sand and gravel encountered</p> <p>0.7-1.3': Underdrain Gravels</p> | |

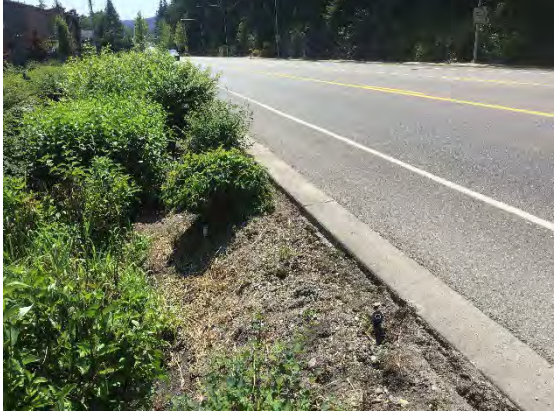
| Additional Details: Sheet flow into the cell. No energy dissipation observed. | |

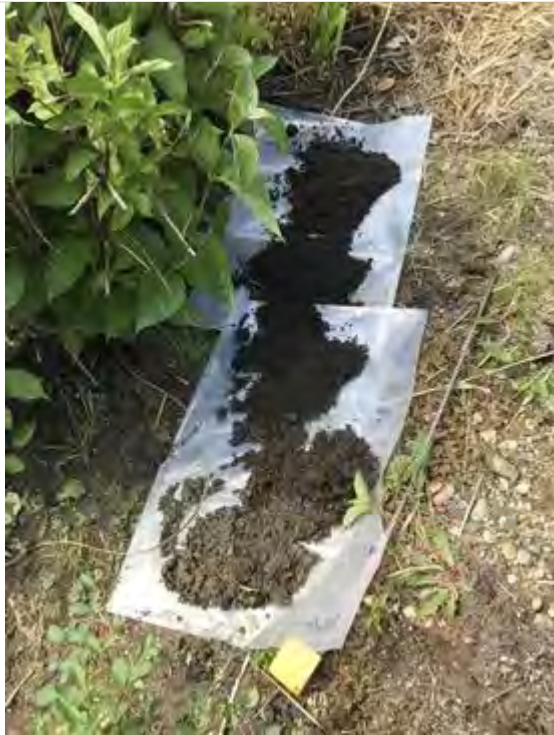
FA_FPhoto-20230622-154657.JPG

0-0.9': Surface cover: Loose, moist, dark-brown-gray, silty, medium SAND, abundant organics, occasional brick fragment and plastic debris
 0.9-1.4': BSM
 1.4-1.6': BSM/Fill contact
 1.6-1.8': Fill

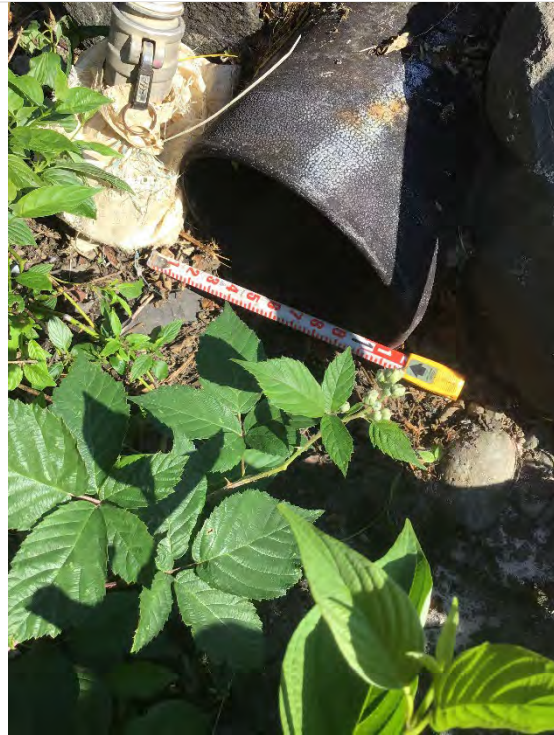
FA_INphoto-20230623-162311.jpg

Additional Details: Trace sediment at base of inflow pipe.

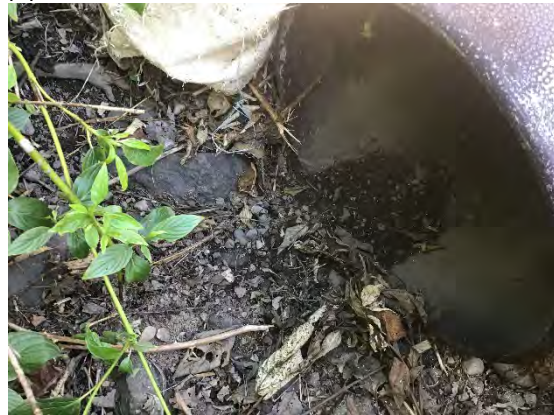
FA_INBLPhoto-20230623-162212.jpg

Additional Details: Angular rock, partially buried by sediment discharge.

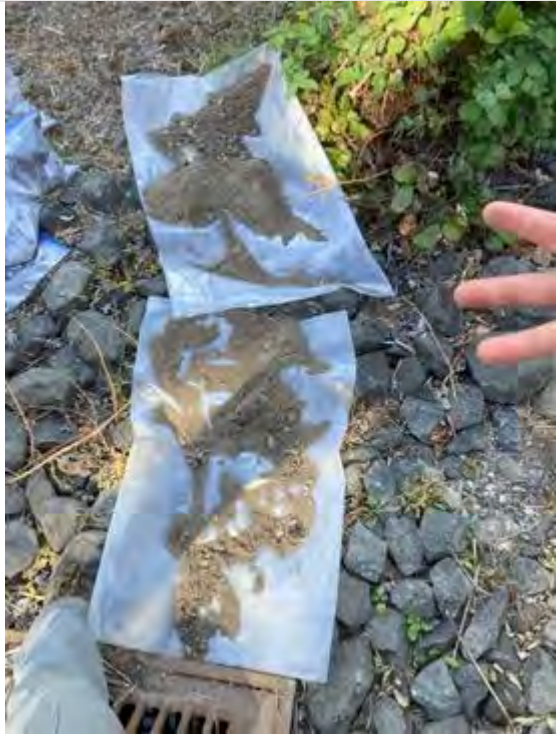
| HA-3.jpg | |

| <p>Additional Details</p> <p>0-0.75': BSM</p> <p>0.75-1.5': Same as above, becomes dark brown-brown; possibly different BSM batch</p> <p>1.5-1.6': Gravels</p> | |

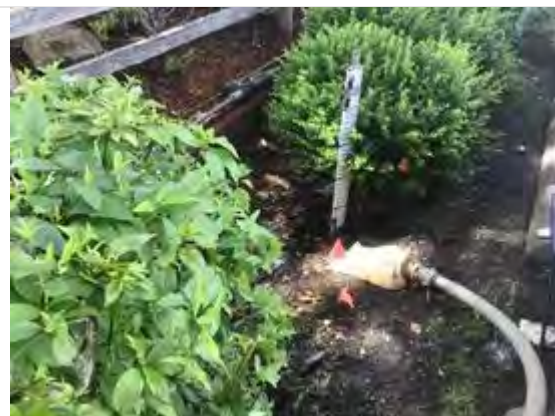
Additional Details:
 Max flow off irrigation bib ~15gpm. Water connected to cell through garden hose. Flow estimate from Poulsbo PUD was upwards of 30. Ponded area only small portion of cell. Ponded area expanded to south during testing. Difficult to measure wetted area due to dense thorny vegetation.

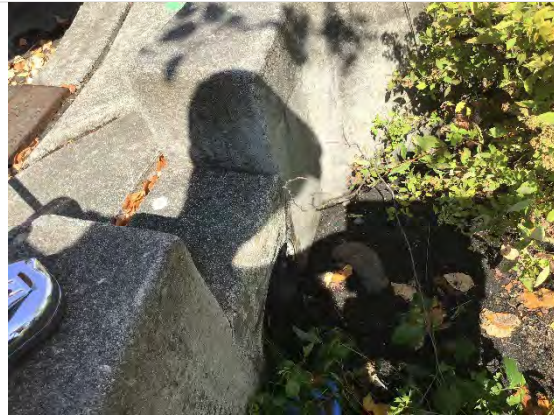
FA_INphoto-20230720-222250.jpg

Additional Details: Leaf litter blocking small portion of inlet.

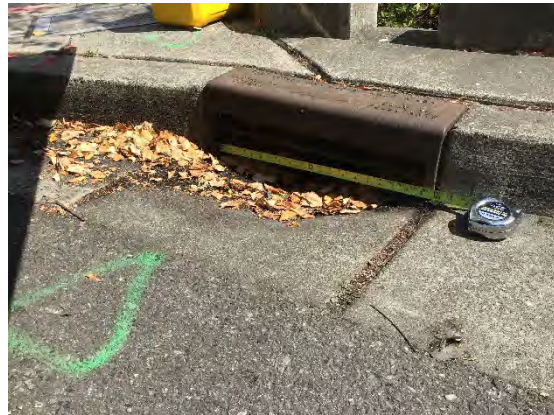
FA_INBLPhoto-20230720-222227.jpg

Additional Details: Stream cobbles extend 2.5' from inlet. Buried with bioretention soil.

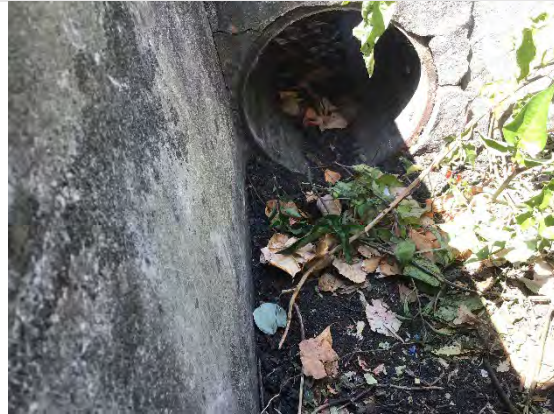
FA_INphoto-20230720-194300.jpg

Additional Details: Inlet is a curb cut which flows into .69' inlet pipe. Curb cut is filled with loose leaf debris, sediment, cigarettes. Trace sedimentation at base of inlet pipe.

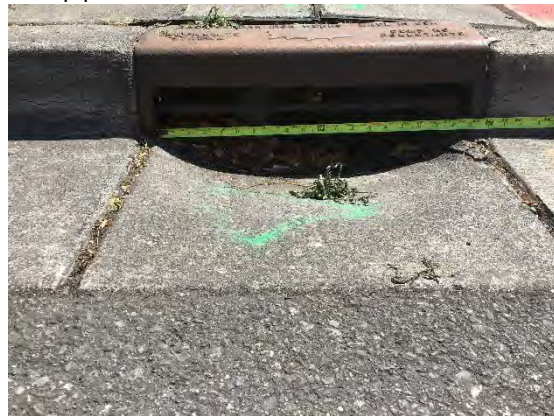
FA_INBLPhoto-20230720-194158.jpg

Additional Details: Stream cobbles extend 3' beyond inlet.

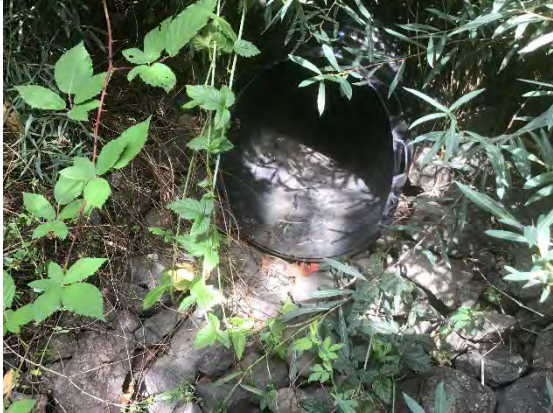
| Erosion Present? <input type="checkbox"/> Yes <input checked="" type="checkbox"/> No | Blockage Present? <input type="checkbox"/> Yes <input checked="" type="checkbox"/> No |

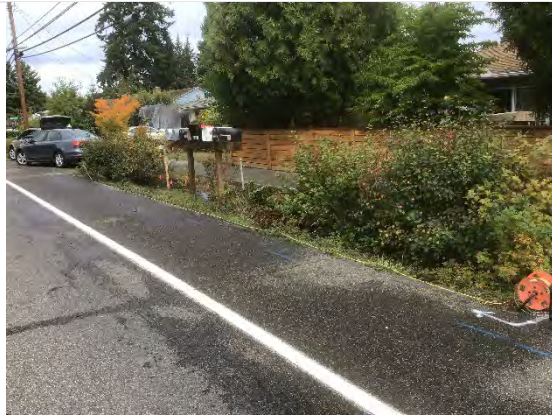
FA_INphoto-20230927-202345.jpg

Energy Dissipation
Angular Rock: n/a
Stream Cobble: n/a
Water Wheel: n/a
Splash Block: n/a
Concrete Apron: n/a

Erosion Present? Yes No

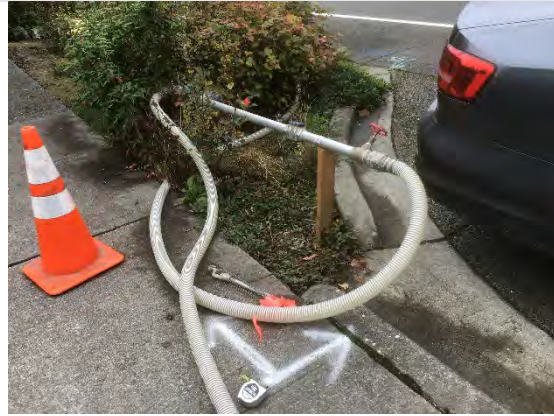
FA_INphoto-20230927-205424.jpg

Additional Details: Inlet base filled in with organics and surface cover plants, room for water to enter available.

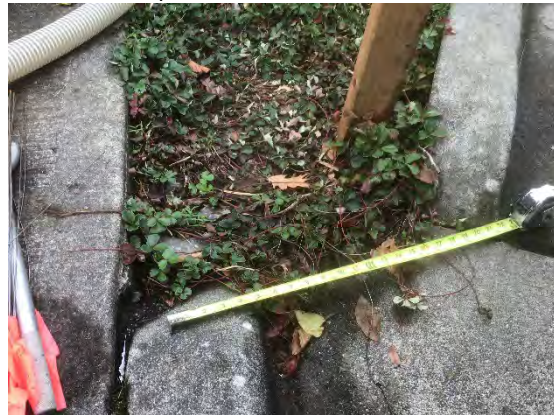
FA_INBLPhoto-20230927-205412.jpg

Additional Details: Buried stream cobbles adjacent inlet.

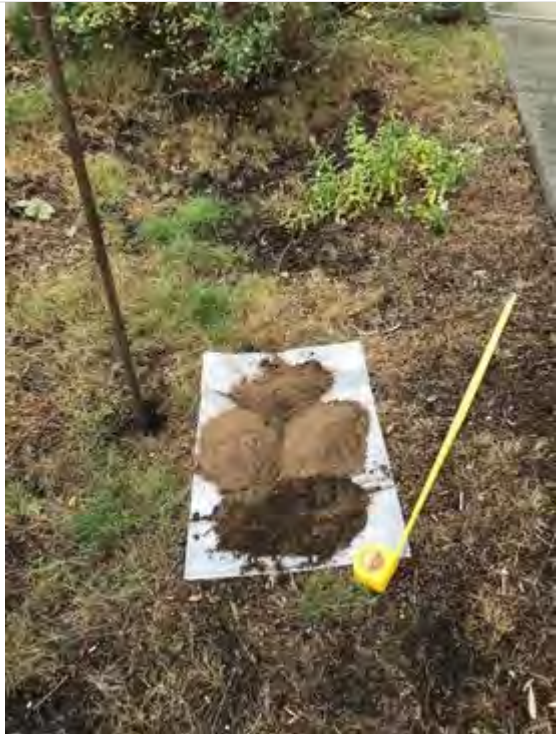
SHAS-1_HA-2.jpg

0-0.1: Grass
 0.1-1.8: BSM
 1.8-2.1: [Amended Soil] medium dense, very moist, tannish-brown, gravelly fine to medium SAND, some silt, trace organics, angular gravel (SP)

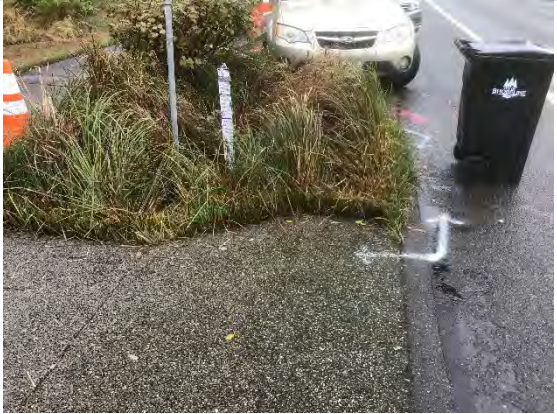
| <p>Erosion Present? <input type="checkbox"/> Yes <input checked="" type="checkbox"/> No</p> | <p>Blockage Present? <input checked="" type="checkbox"/> Yes <input type="checkbox"/> No Approximately 35% blocked</p> <p>Types: <input type="checkbox"/> Sediment <input type="checkbox"/> Organic <input type="checkbox"/> Rock <input type="checkbox"/> Trash <input checked="" type="checkbox"/> Vegetation</p> <p>Additional Details: Thick sedges border the edge of the pavement, but will allow water through.</p> |
| <p>Additional Details: No energy dissipation features were observed, if present they would be significantly buried.</p> | |

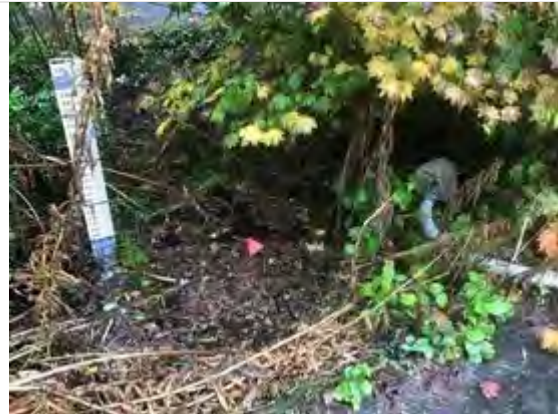
FA_FPhoto-20231010-213008.jpg

| Amended native soil sample is made of broken up chunks of till, possibly broken up when construction amended and placed the 12" of amended native soil per design plans below the bioretention soil. Groundwater was encountered at 0.9' below ground surface. | |

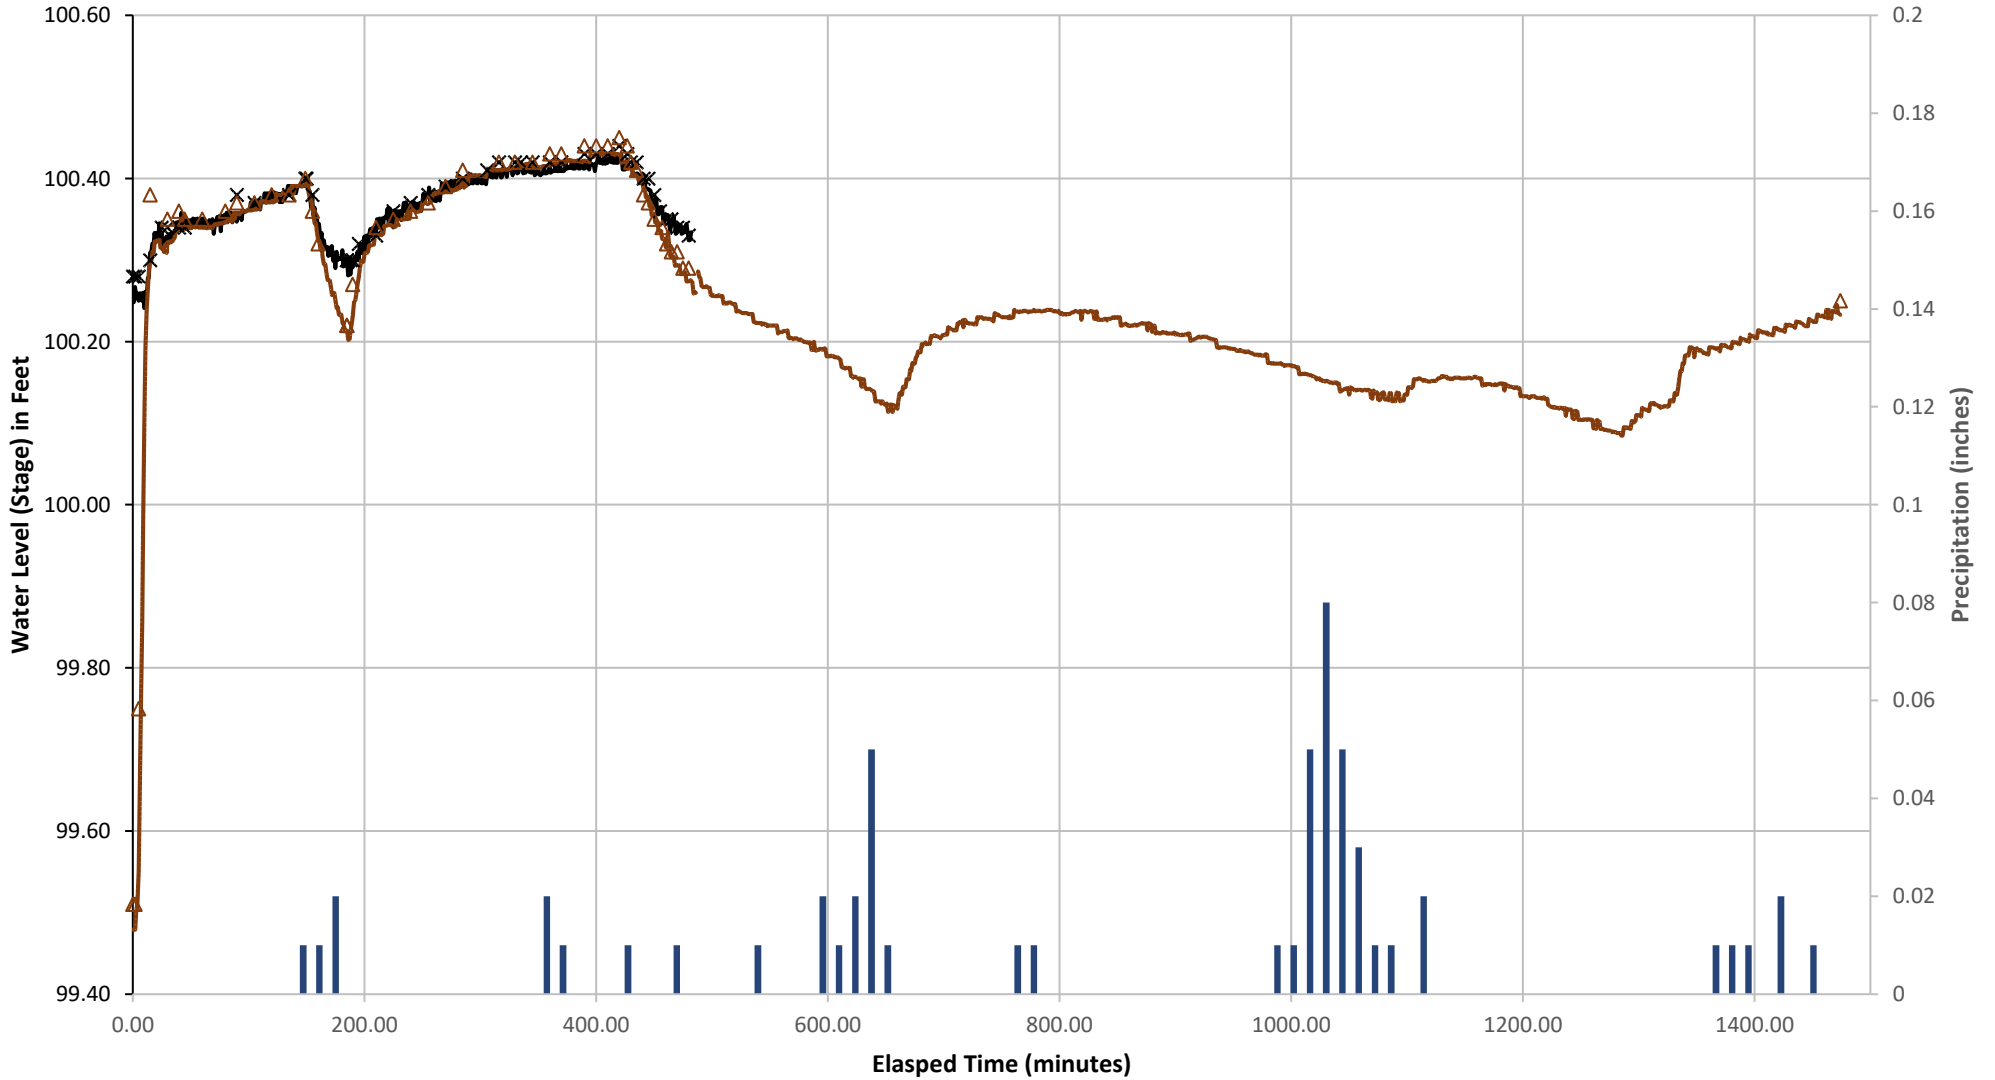
Notes: Elevations are not surveyed and should be used as a relative reference. Elevation 100 represents ground surface. Precipitation data from King County gauge #04u

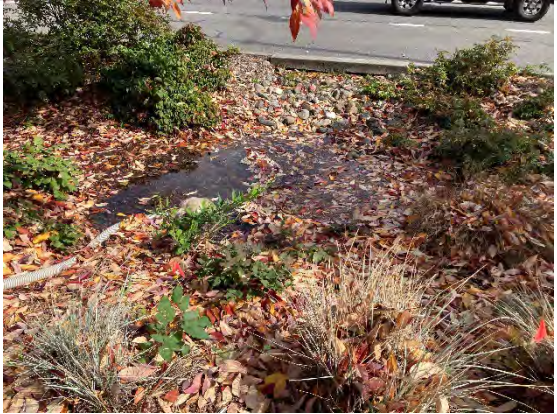
| <p>IN-1</p> <p><input checked="" type="checkbox"/> Curb cut <input type="checkbox"/> Sheet Flow <input type="checkbox"/> Dispersed Flow <input type="checkbox"/> Pipe <input type="checkbox"/> Other:</p> <p>Width: 2'</p> <p>Energy Dissipation Angular Rock: n/a Stream Cobble: Functioning Water Wheel: n/a Splash Block: n/a Concrete Apron: n/a</p> | <p>IMG_6096.JPG</p> |
| <p>Erosion Present? <input checked="" type="checkbox"/> Yes <input type="checkbox"/> No Severity: Minor Minimal erosion and fines deposition around stream cobbles near inlet.</p> | <p>Blockage Present? <input type="checkbox"/> Yes <input checked="" type="checkbox"/> No</p> |

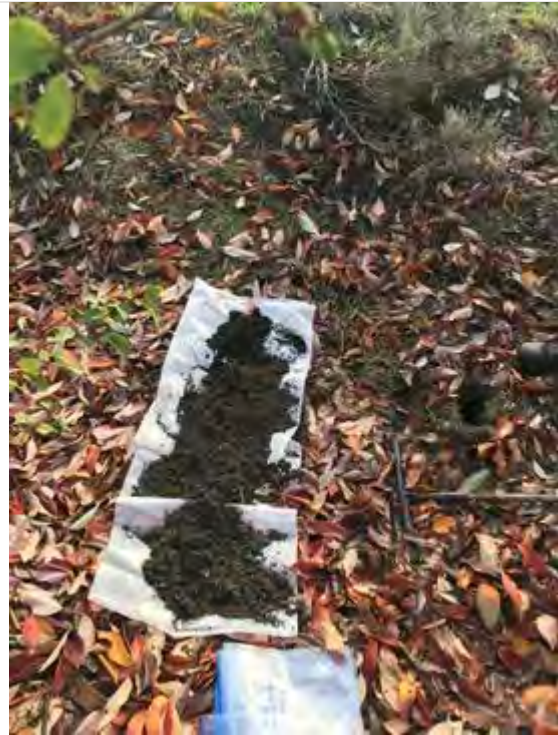
SHAU_HA-3-WP.jpg

| Well Point Detail Is the well point dry? <input checked="" type="checkbox"/> Yes <input type="checkbox"/> No Depth to water from TOC (ft): Respond to Testing: <input checked="" type="checkbox"/> Yes <input type="checkbox"/> No Shallowest Depth to water during testing from Ground Surface (ft): 0 | |
| Additional Details 0-0.2': Mulch/topsoil 0.2-2.2': BSM 2.2-2.9': Vashon Advance Outwash: probed an additional 2-3 inches after refusal No groundwater | |

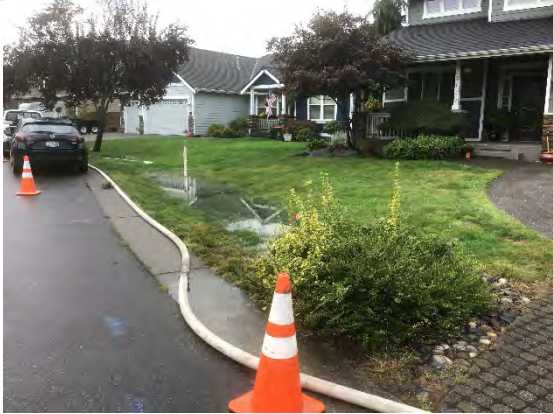
| IN-1 <input type="checkbox"/> Curb cut <input checked="" type="checkbox"/> Sheet Flow <input type="checkbox"/> Dispersed Flow <input type="checkbox"/> Pipe <input type="checkbox"/> Other: Width: 75' Energy Dissipation Angular Rock: n/a Stream Cobble: Functioning Water Wheel: n/a Splash Block: n/a Concrete Apron: n/a | | <p>FA_INphoto-20230925-172106.jpg</p> |
| Erosion Present? <input checked="" type="checkbox"/> Yes <input type="checkbox"/> No Severity: Minor Minor erosion around cobbles near catch basins Additional Details: Stream cobbles around catch basins | Blockage Present? <input type="checkbox"/> Yes <input checked="" type="checkbox"/> No | |

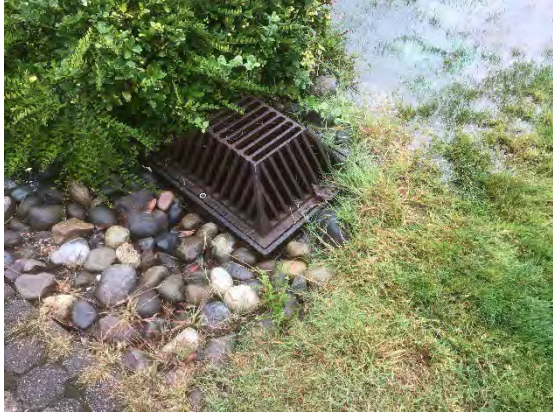
| DO - 1 Shape: <input type="checkbox"/> Round Dimensions: <input checked="" type="checkbox"/> Rectangular Length: 2' <input type="checkbox"/> Other Width: 1.7' Additional Details: Stickup (ft) From Ground: 0.3 Relative from staff gauge: Damage Indicators: <input type="checkbox"/> Yes <input checked="" type="checkbox"/> No Trash Rack: <input checked="" type="checkbox"/> Yes <input type="checkbox"/> No Additional Details: Overflow Blocked? <input type="checkbox"/> Yes <input checked="" type="checkbox"/> No | | <p>FA_DOPhoto-20230925-172243.jpg</p> |

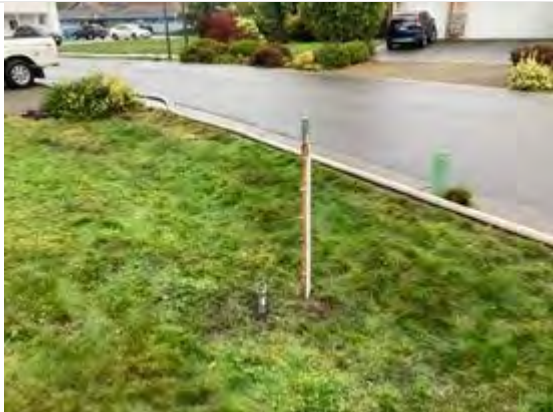
IMG_6038.JPG

| WP stickup=0.7'. Potential surface water influence in well point from pooling water. Possibly poor surface seal. | |
| Groundwater encountered at 2.7' | |

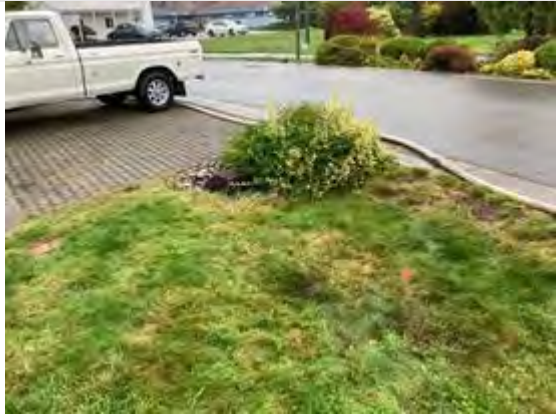
| IMG_6042.JPG | |

| <p>Additional Details</p> <p>0-0.2': Topsoil</p> <p>0.2-0.7': Hydrologic soil group B</p> <p>0.7-2': Fill (reworked alluvium?): Loose, v moist, brown sandy SILT with occasional orangeish-brown oxidation (ML)</p> <p>2-2.6': Recent alluvium</p> <p>Groundwater encountered at 2.4'</p> | |

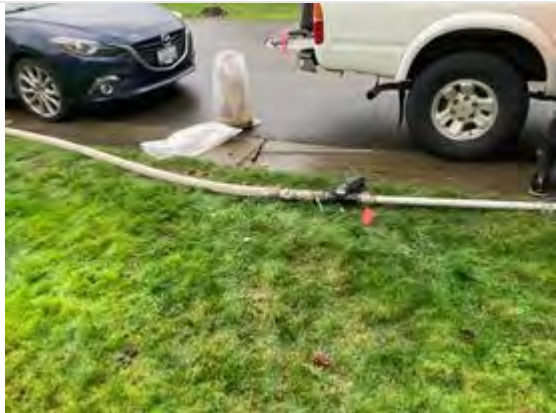
| IMG_6033.JPG | |

| <p>Additional Details</p> <p>0-0.2: grass</p> <p>0.2-0.8: Hydrologic soil group B</p> <p>0.8-1.3: Sand Lens</p> <p>1.3-1.7: Pea gravel; probed down another 0.2' and encountered a pipe</p> | |

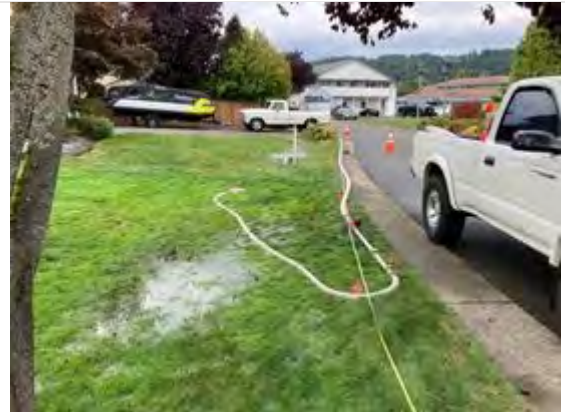
IMG_6057.JPG

| Wetted area began at 550 square feet due to high flow but was decreased to 491 square feet at the steady state of the test. Some water did seep into the catch basin on the downstream end of the cell through the spacers below the overflow grate, estimated rate of flow directly into the basin was less than 1gpm | |

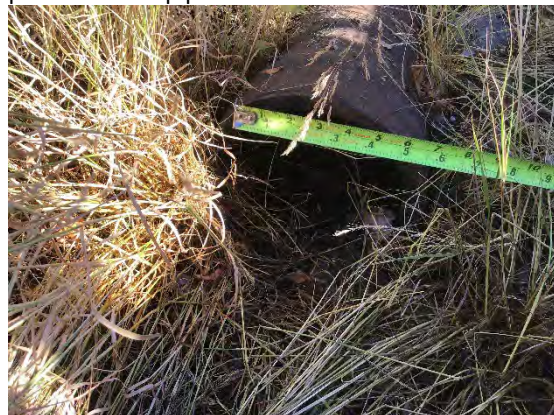
FA_INBLPhoto-20230719-010618.jpg

Additional Details: Organic sediments fill the bottom portion of the pipe.

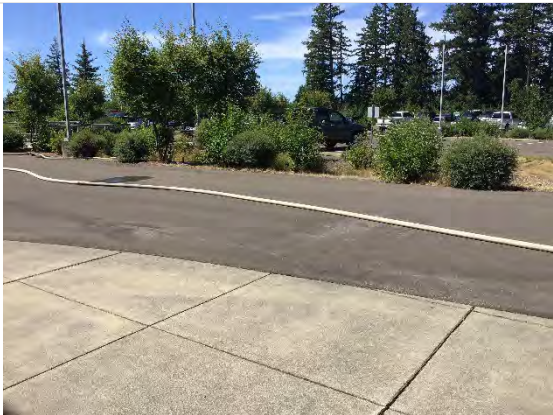
| <input type="checkbox"/> Curb cut <input checked="" type="checkbox"/> Sheet Flow <input type="checkbox"/> Dispersed Flow <input type="checkbox"/> Pipe <input type="checkbox"/> Other: Width: ' Energy Dissipation Angular Rock: n/a Stream Cobble: n/a Water Wheel: n/a Splash Block: n/a Concrete Apron: n/a | <p>FA_INphoto-20230718-215631.jpg</p> |
| Erosion Present? <input type="checkbox"/> Yes <input checked="" type="checkbox"/> No | Blockage Present? <input type="checkbox"/> Yes <input checked="" type="checkbox"/> No |
| Additional Details: No energy dissipation methods in place for sheet flow from the parking lot. | |

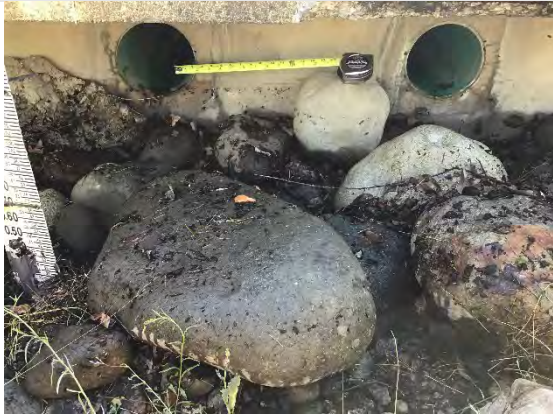
| Shape: <input checked="" type="checkbox"/> Round <input type="checkbox"/> Rectangular <input type="checkbox"/> Other Additional Details: Stickup (ft) From Ground: 0.72 Relative from staff gauge: 0.74 | Dimensions: Diameter: 0.66' |
| Damage Indicators: <input type="checkbox"/> Yes <input checked="" type="checkbox"/> No | <p>FA_DOPhoto-20230719-010223.jpg</p> |
| Additional Details: Overflow Blocked? <input type="checkbox"/> Yes <input checked="" type="checkbox"/> No | |

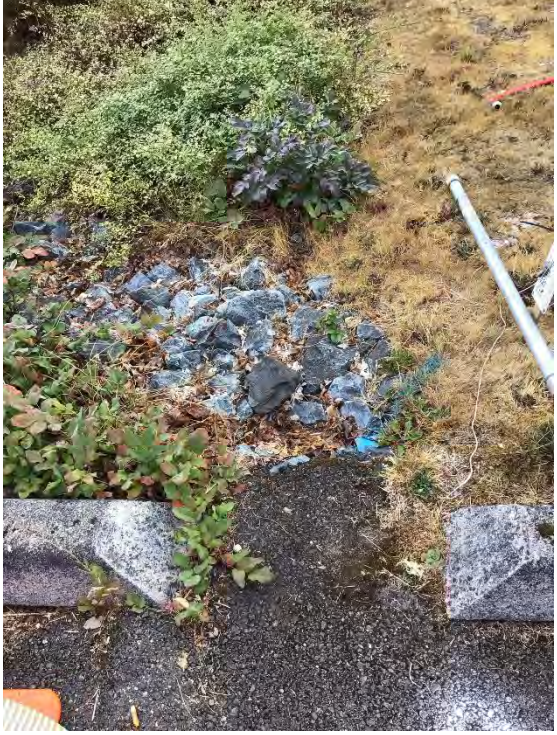
| <p>IN-2</p> <p><input checked="" type="checkbox"/> Curb cut <input type="checkbox"/> Sheet Flow <input type="checkbox"/> Dispersed Flow <input type="checkbox"/> Pipe <input type="checkbox"/> Other:</p> <p>Width: 1.83'</p> <p>Energy Dissipation Angular Rock: Functioning Stream Cobble: n/a Water Wheel: n/a Splash Block: n/a Concrete Apron: n/a</p> | <p>FA_INphoto-20230824-075537.jpg</p> |
| <p>Erosion Present? <input checked="" type="checkbox"/> Yes <input type="checkbox"/> No Severity: Minor Rocks are settled a little bit into the ground</p> | <p>Blockage Present? <input type="checkbox"/> Yes <input checked="" type="checkbox"/> No</p> |
| <p>Additional Details: Leaves and plant debris throughout angular rocks</p> | |

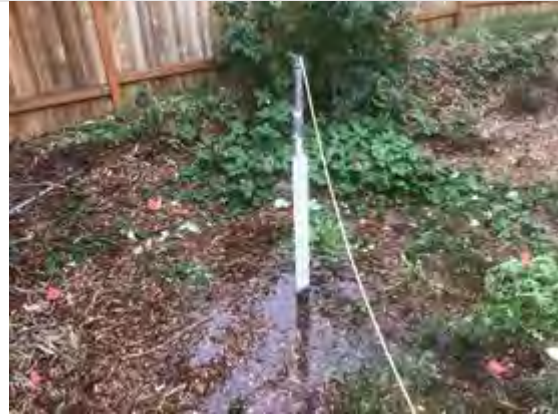
FA_FPhoto-20231005-172432.jpg

| Well Point Detail Is the well point dry? <input checked="" type="checkbox"/> Yes <input type="checkbox"/> No Depth to water from TOC (ft): Respond to Testing: <input checked="" type="checkbox"/> Yes <input type="checkbox"/> No Shallowest Depth to water during testing from Ground Surface (ft): 0 | |
| Additional Details Shallowest depth to water during the test was above the ground surface. | |

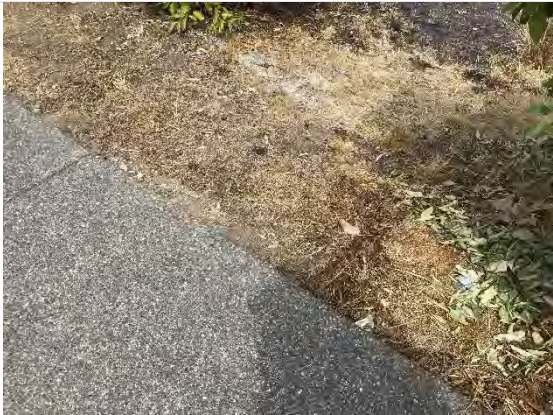
| IN-1 <input type="checkbox"/> Curb cut <input checked="" type="checkbox"/> Sheet Flow <input type="checkbox"/> Dispersed Flow <input type="checkbox"/> Pipe <input type="checkbox"/> Other: Width: 35' Energy Dissipation Angular Rock: n/a Stream Cobble: n/a Water Wheel: n/a Splash Block: n/a Concrete Apron: n/a | | <p>FA_INphoto-20230822-203840.jpg</p> |
| Erosion Present? <input checked="" type="checkbox"/> Yes <input type="checkbox"/> No Severity: Minor Some scours were observed where water has entered the cell in the SW corner adjacent to walkway leading to house, this could be from pressure washing sidewalk or surface irrigation runoff. | Blockage Present? <input type="checkbox"/> Yes <input checked="" type="checkbox"/> No | |
| Additional Details: No energy dissipation features were observed. | | |

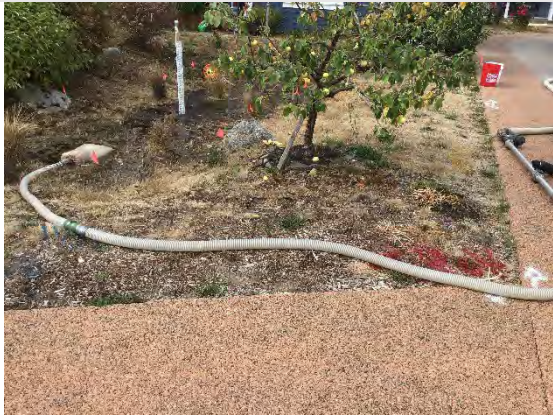
FA_DOPhoto-20230822-223817.jpg

| Overflow Blocked? <input type="checkbox"/> Yes <input checked="" type="checkbox"/> No | |

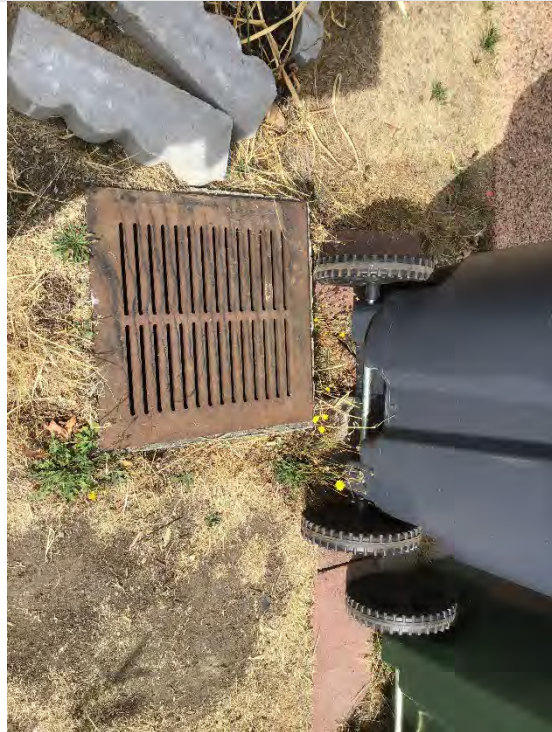
FA_DOPhoto-20230822-224049.jpg

| Damage Indicators: <input checked="" type="checkbox"/> Yes <input type="checkbox"/> No This catch basin may not be part of the design for this cell as it is several feet outside of the perimeter of the cell. The height of the trash rack is slightly above the level of the adjacent pervious pavement roadway. Pipes were observed in the catch basin conveying a consistent flow of water from the east, to the west for the entirety of the test, and after water was shut off. Folding signs for water main flushing were observed in the neighborhood, which may be the source of the flowing water. | |
| Trash Rack: <input checked="" type="checkbox"/> Yes <input type="checkbox"/> No Approximately 0% blocked Additional Details: The spaces between the trash rack bars were too narrow to fit a water level tape or place a pressure transducer into the catch basin to track water levels for the duration of the test. | |

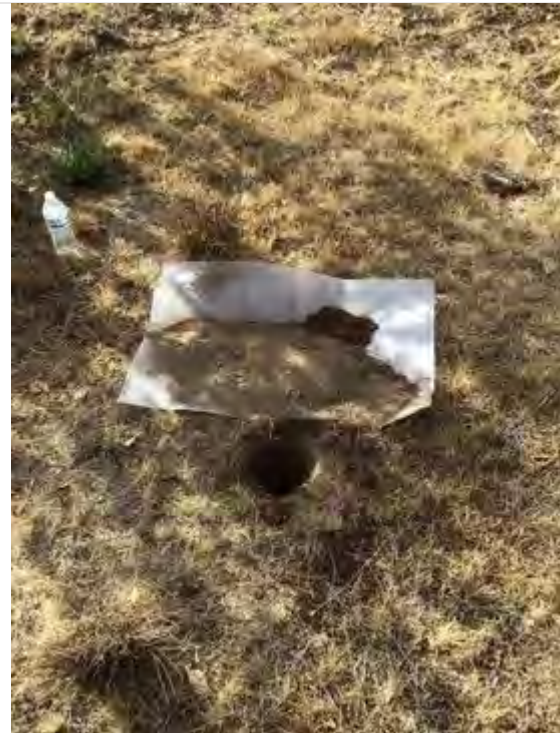
FA_FPhoto-20230822-122908.jpg

Filter Fabric Present:
 Yes No
 Filter fabric located 1' below ground surface. Fabric is sitting on top of angular gravel.

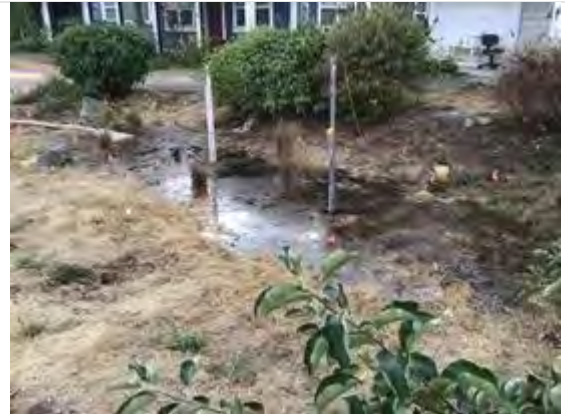
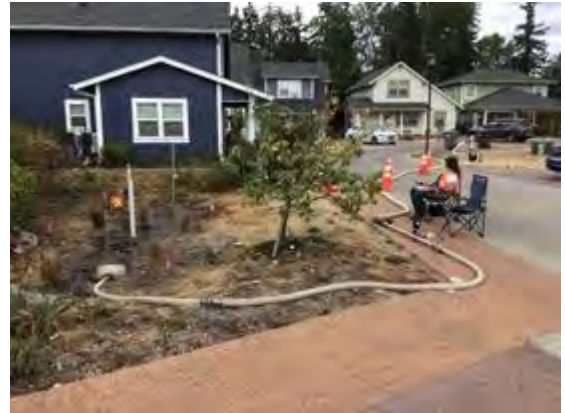
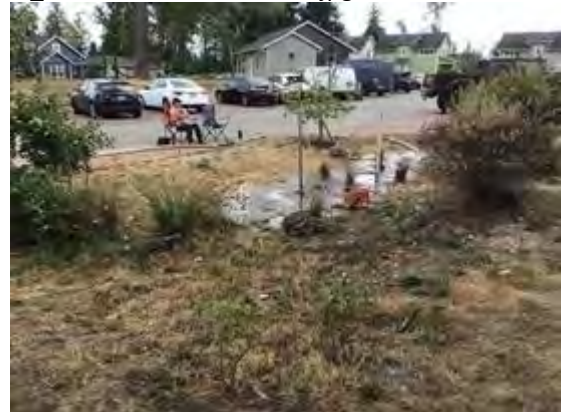
| Steady State Flow Rate (GPM) | 58 |
| Additional Details: Hydrant fluctuates pressure through out the test, possibly due to water main flushing in neighborhood. Field staff dropped flow rate at 14:23 due to lateral flow into an animal burrow, burrow filled at 15:15 and pond stabilized. Additional test details can be found in the executive summary. | |

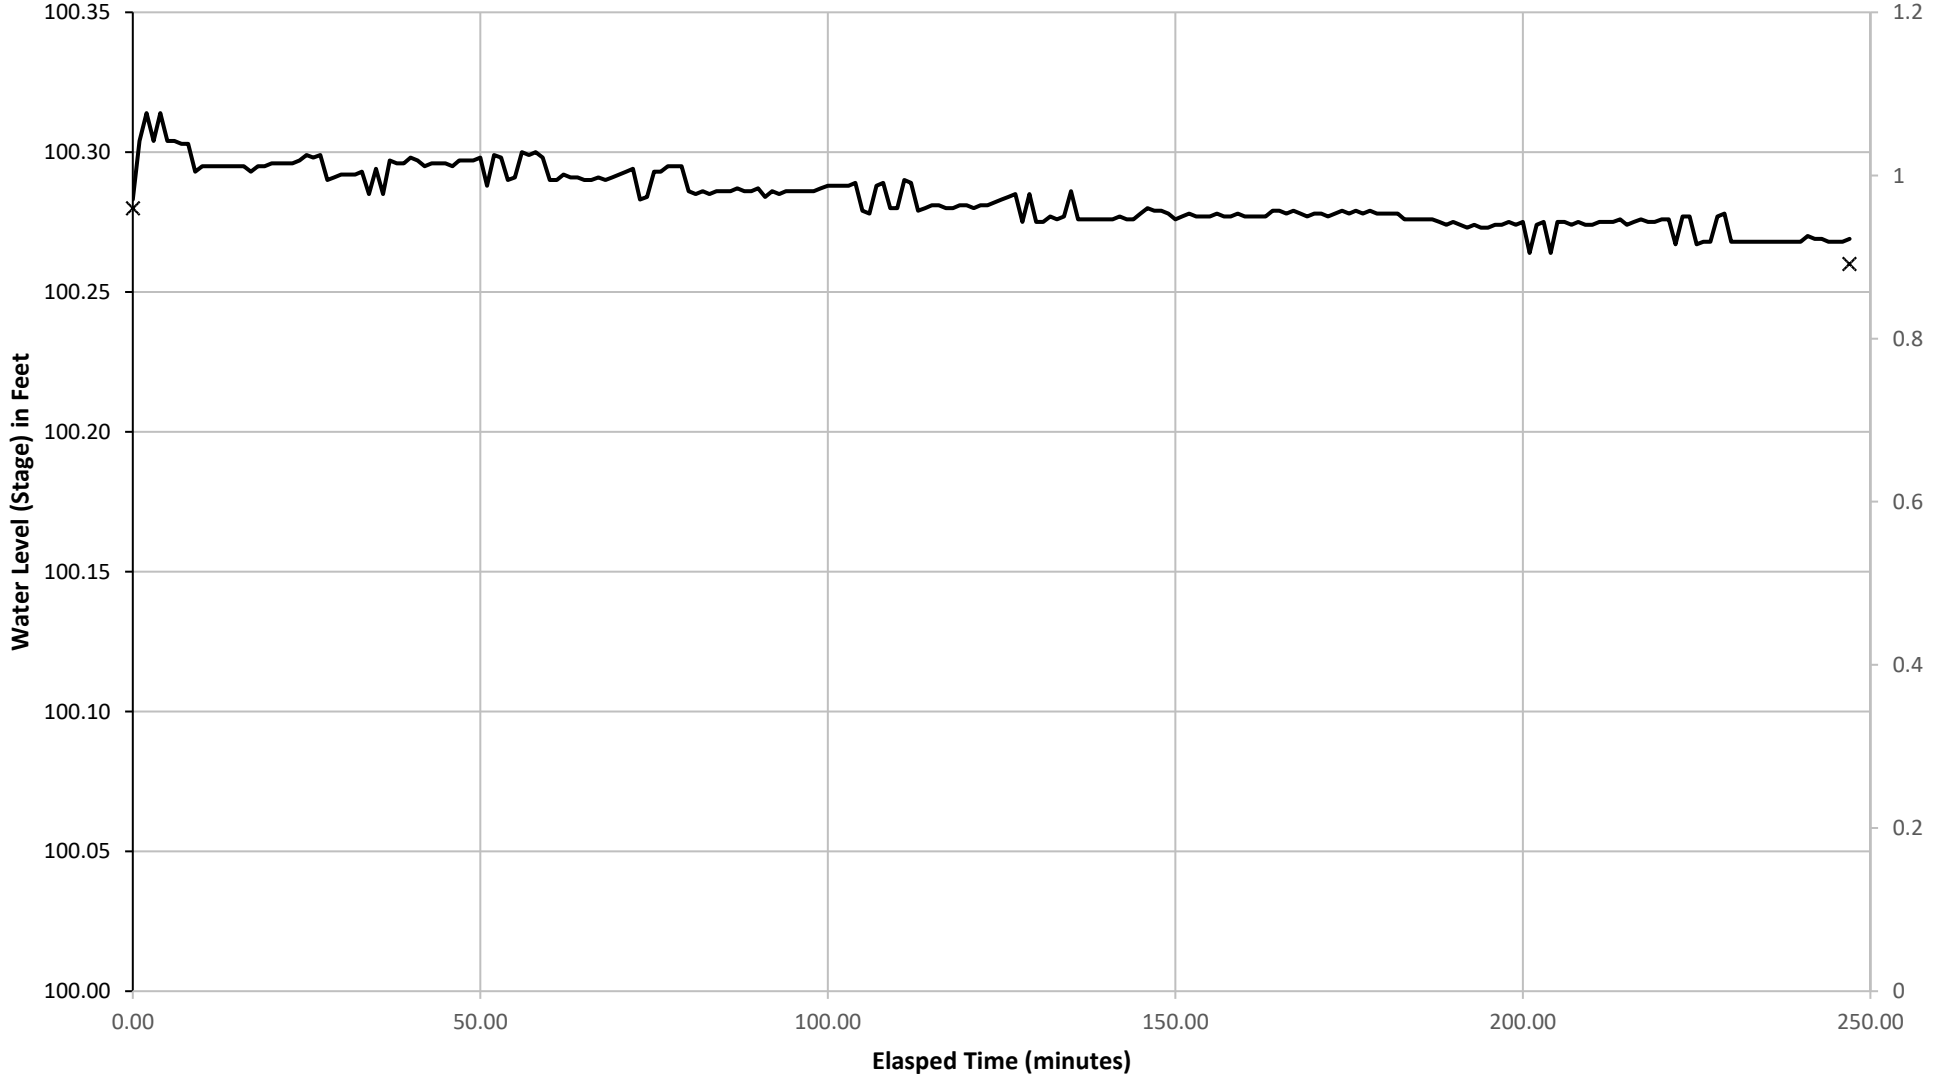
Notes: Elevations are not referenced and should be used as a relative reference. Elevation 100 represents ground surface. Standing water in cell, likely from hydrant flushing the day prior. Falling head observed from 12:50-17:00. Datalogger was not left in place overnight.
