Overview of Washington Coastal Erosion

George Kaminsky, Washington Department of Ecology

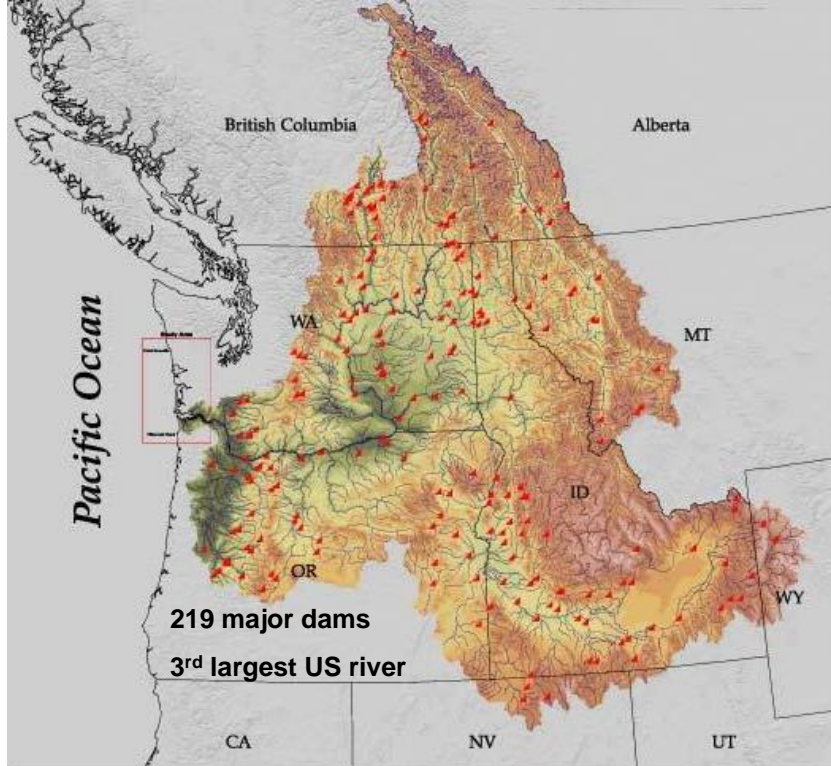
Sediment Retention Structure, North Fork Toutle River

- Modern rate of sediment supply from river is less than 1/4 of prehistoric rate
- Decrease in sediment supply due to dams trapping sediment and reducing peak flows that flush sand out of river

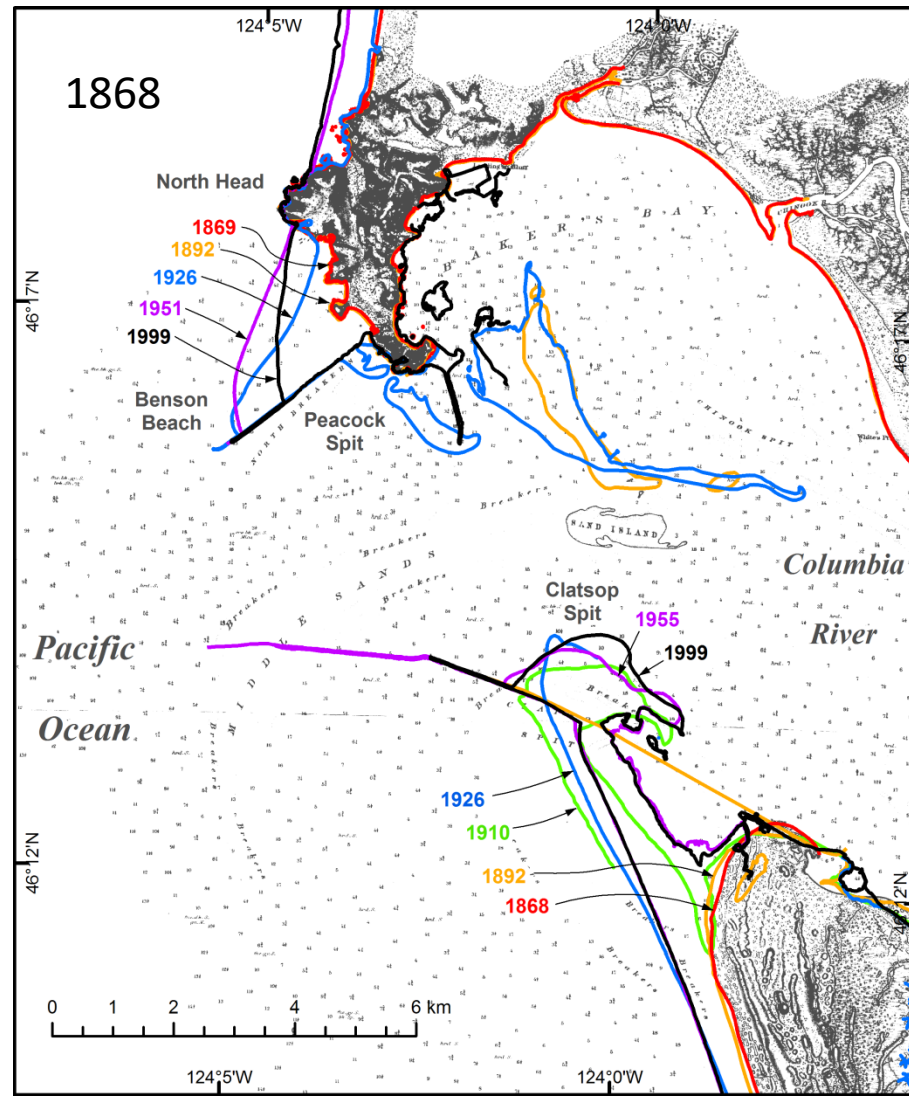
Jetty Construction and Shoreline Change

- Inlet width = 3.2 km
- Inlet shoals dispersed seaward
- Single entrance channel forms
- Shoreline progradation up to 2.5 km (north) and 4.5 km (south)

North Jetty
1913-1917

South Jetty
1885-1895
1903-1913

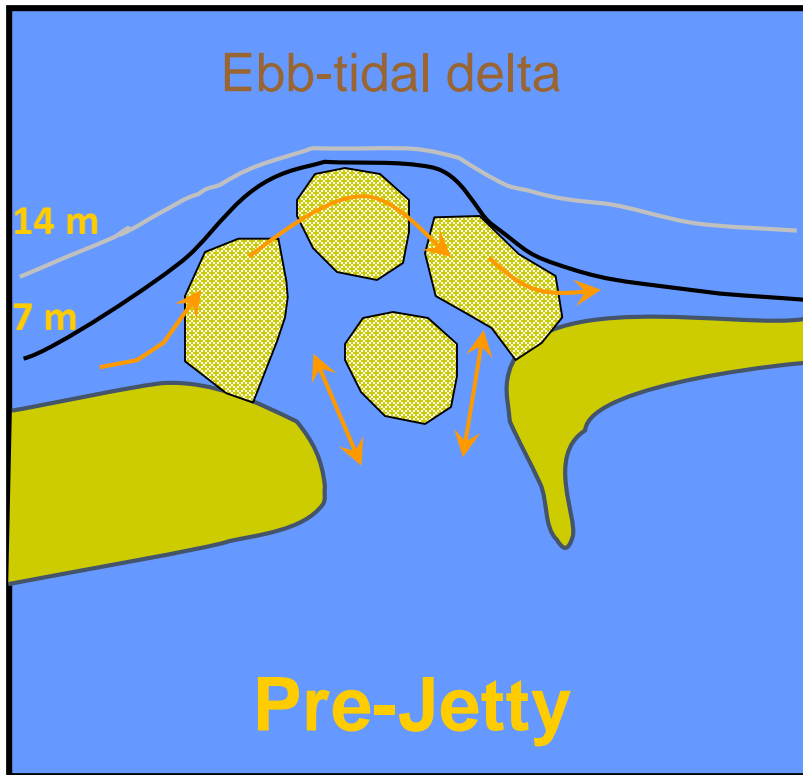
- Several shallow channels
- Shallow ebb-tidal delta
- Attached sub-aqueous shoals
- Alongshore sand bypassing

Morphology Change Caused by Jetties

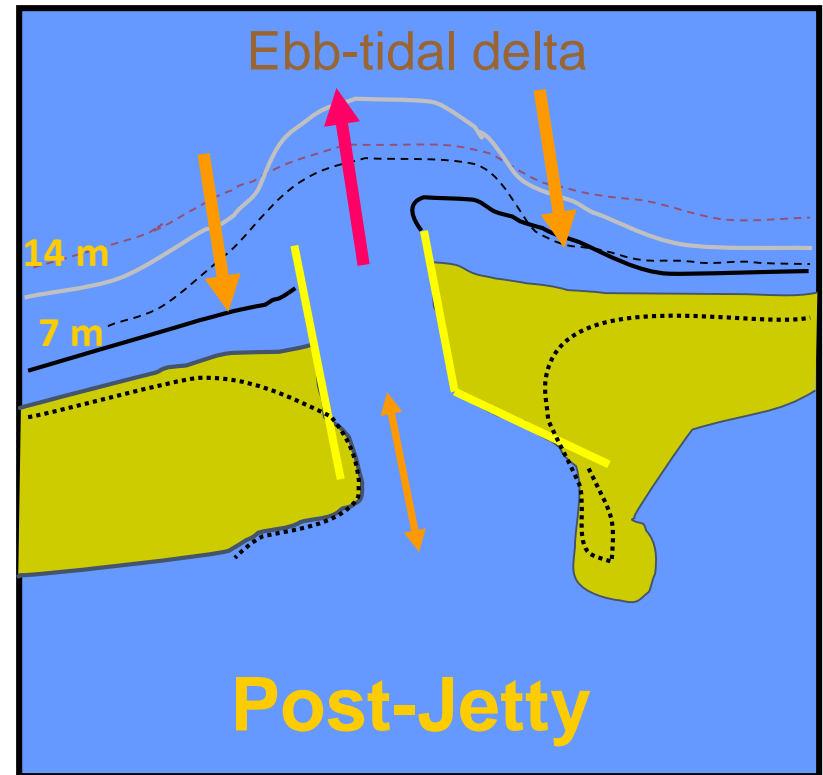
- Single deep channel
- Deep ebb-tidal delta
- Shoals migrate onshore
- Reduced sand bypassing

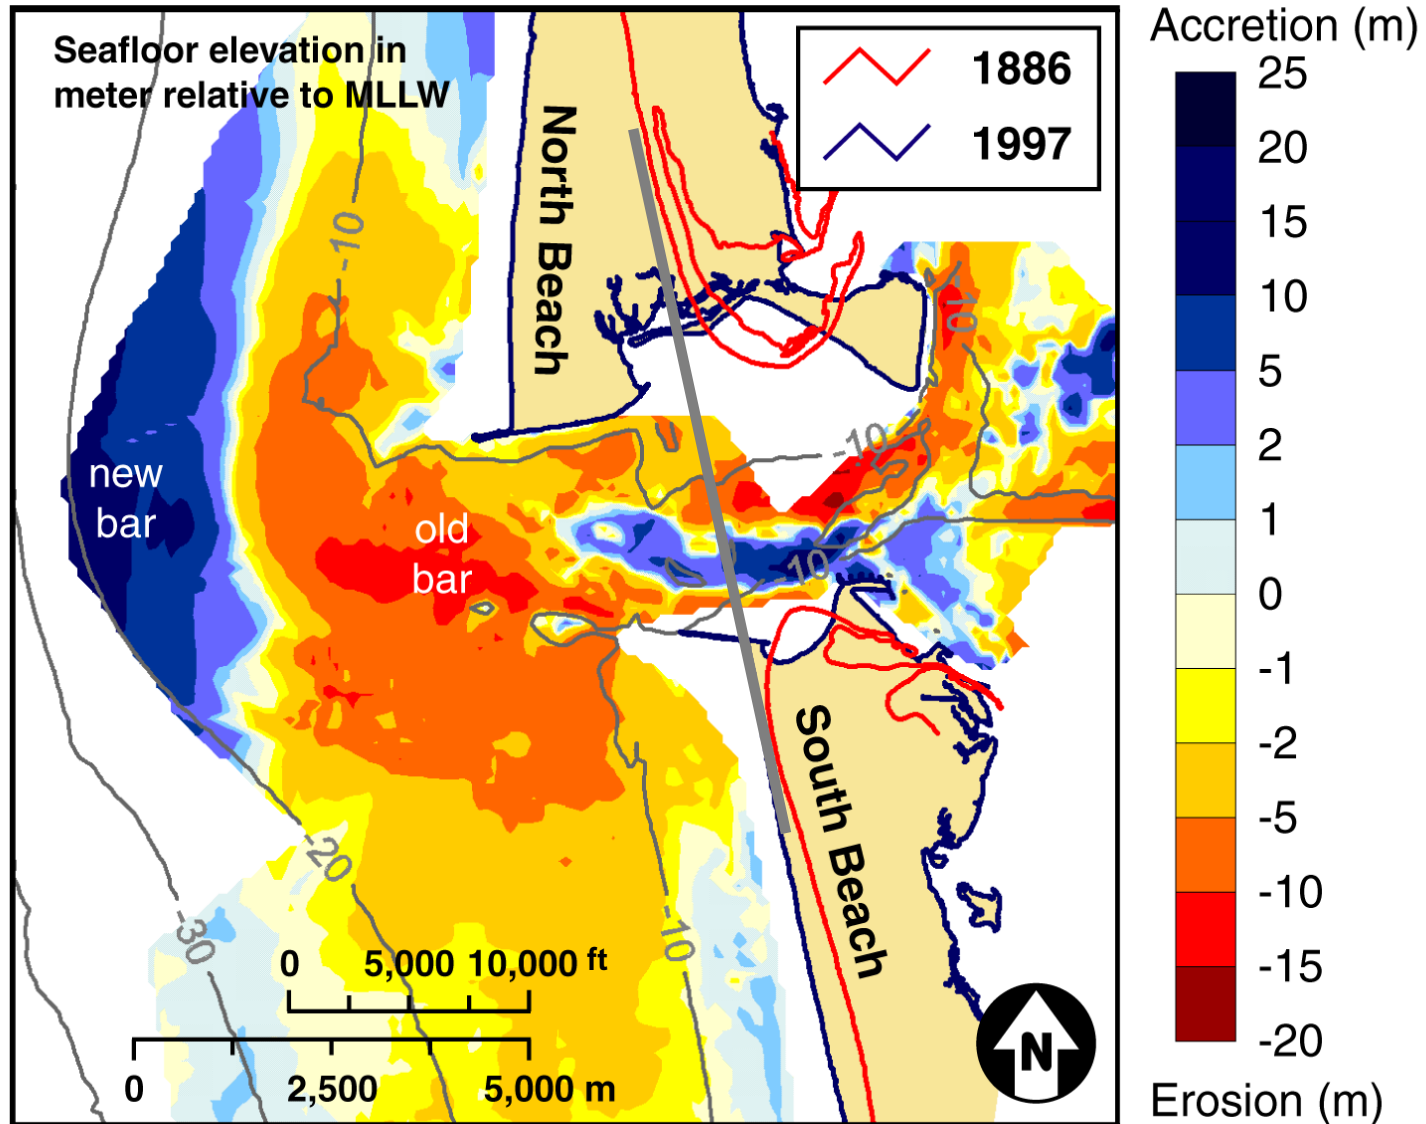
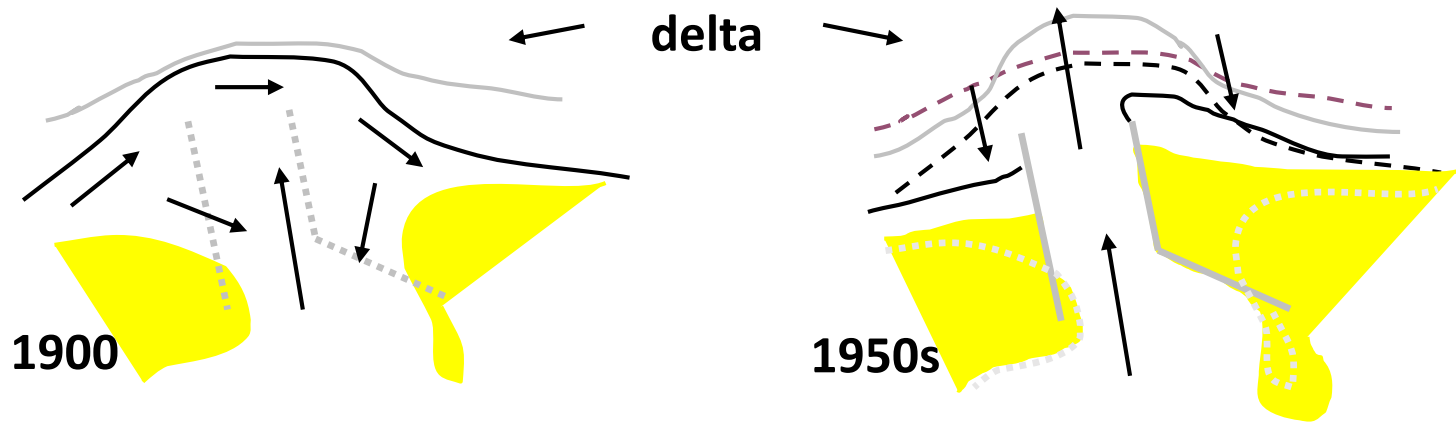
Grays Harbor Entrance Change 1886-1999

- Early 1900s: jetty construction at Grays Harbor and Columbia River entrances
- Delta flanks moved onshore, causing accretion of the adjacent beaches; centers migrated offshore
- Sediment transport away from the deltas caused the beaches to accrete up to 20 km away
- In recent decades the sand supply has diminished; shorelines adjacent to the jetties stopped accreting or began eroding

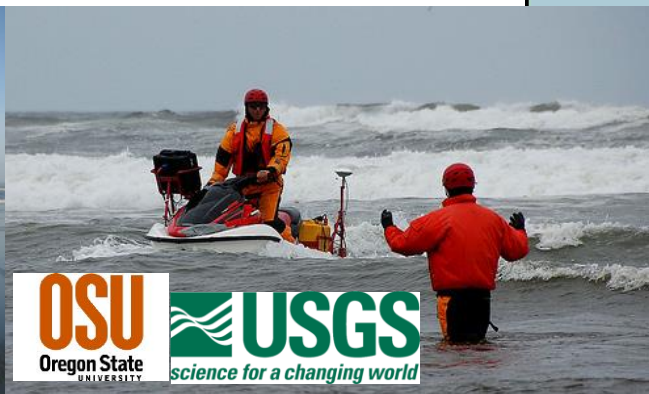
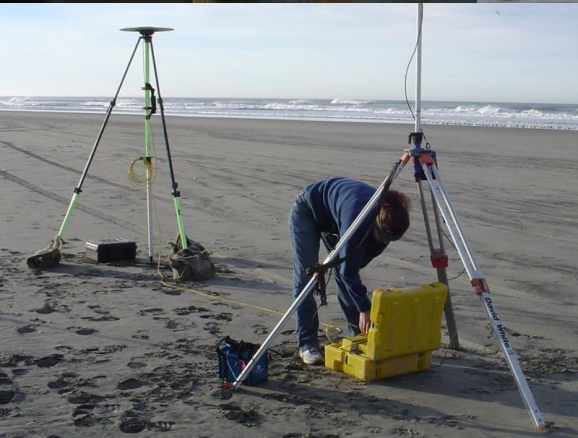
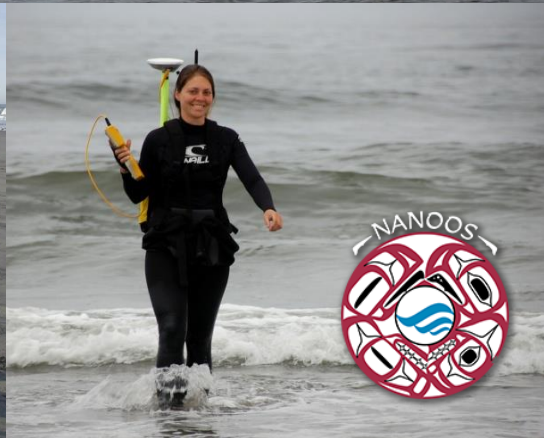
Columbia River Littoral Cell (CRLC) Coastal Morphology Monitoring

RTK-GPS ATV surface maps, beach profiles (to
wading depth), and CPS nearshore bathymetry

Quarterly beach profiles since summer 1997

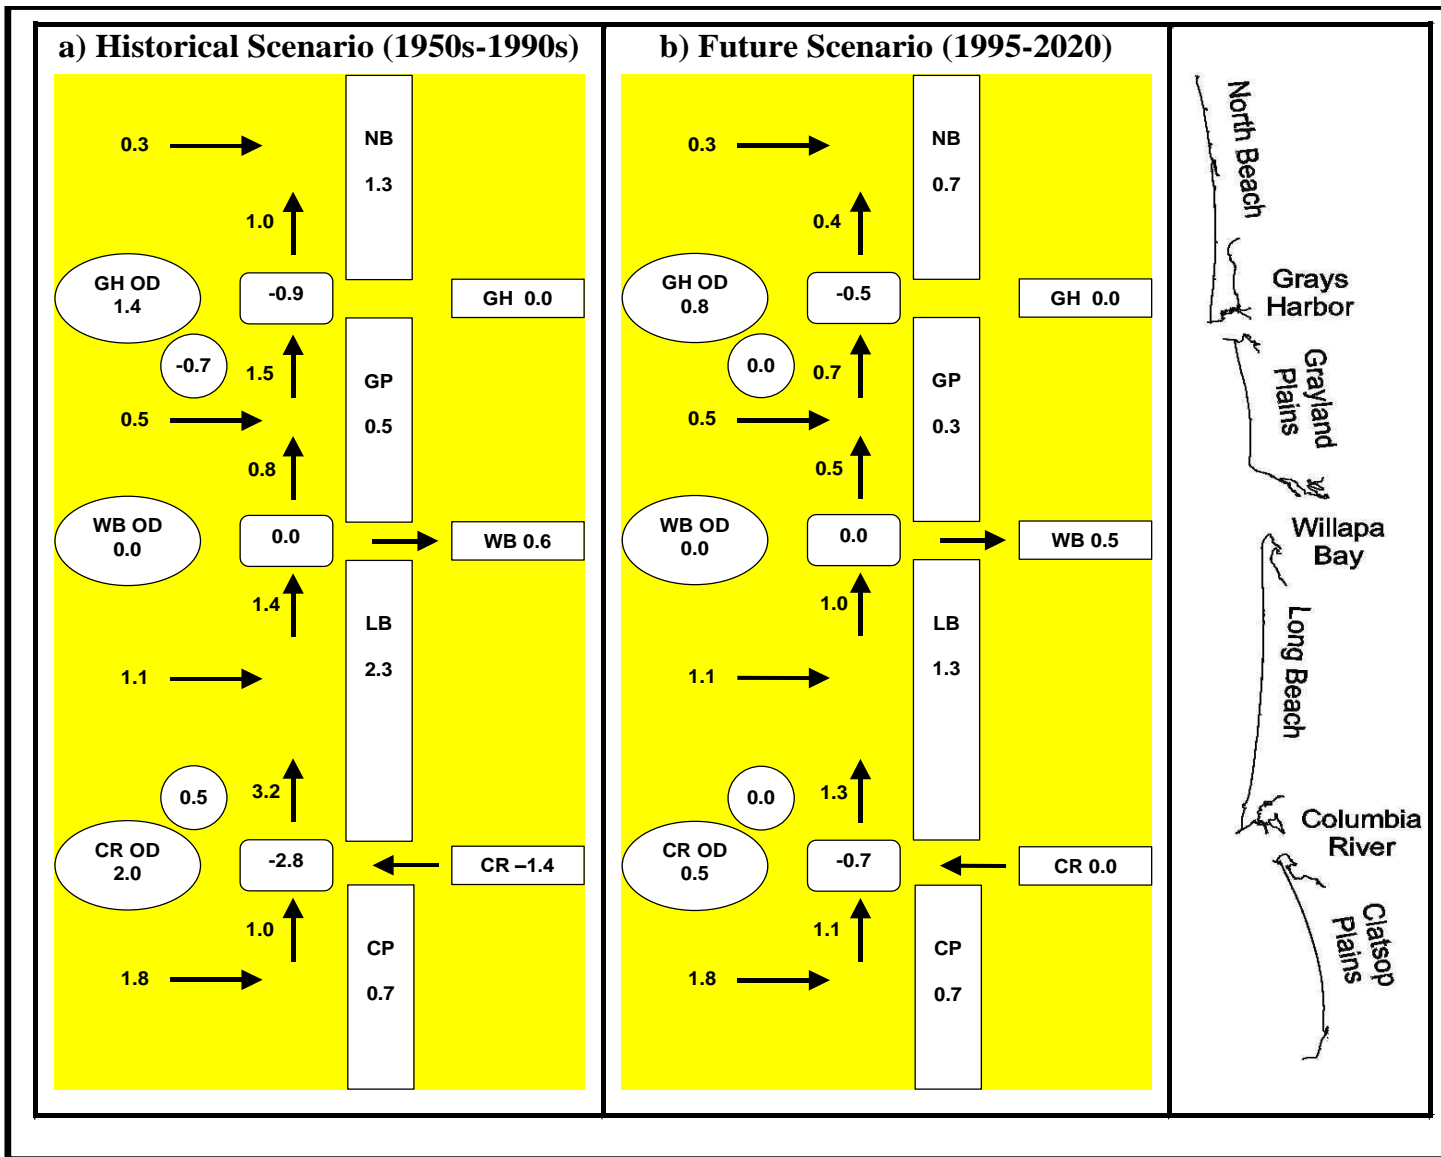
CRLC Sediment Budget

sediment flux in Mm^3/yr

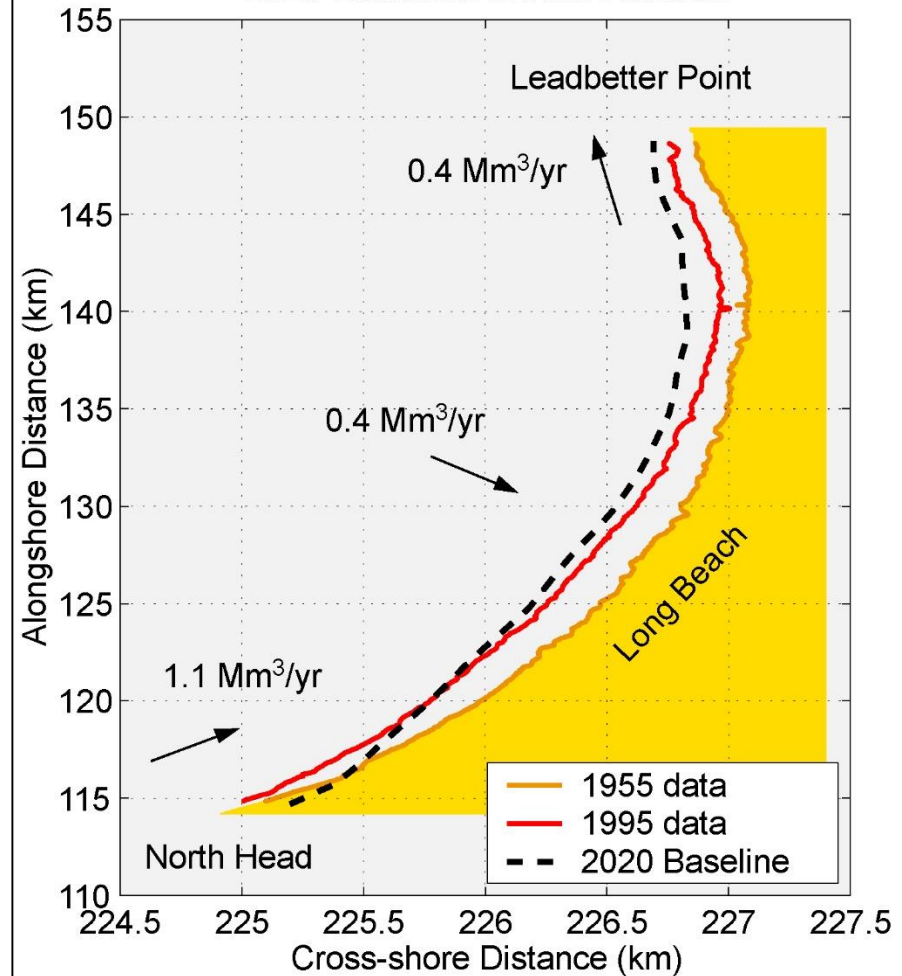
2020 Baseline Model Results

2.2 Mm³/yr to maintain LB in future

1.6 Mm³/yr: 250 m retreat; No supply: 640 m retreat

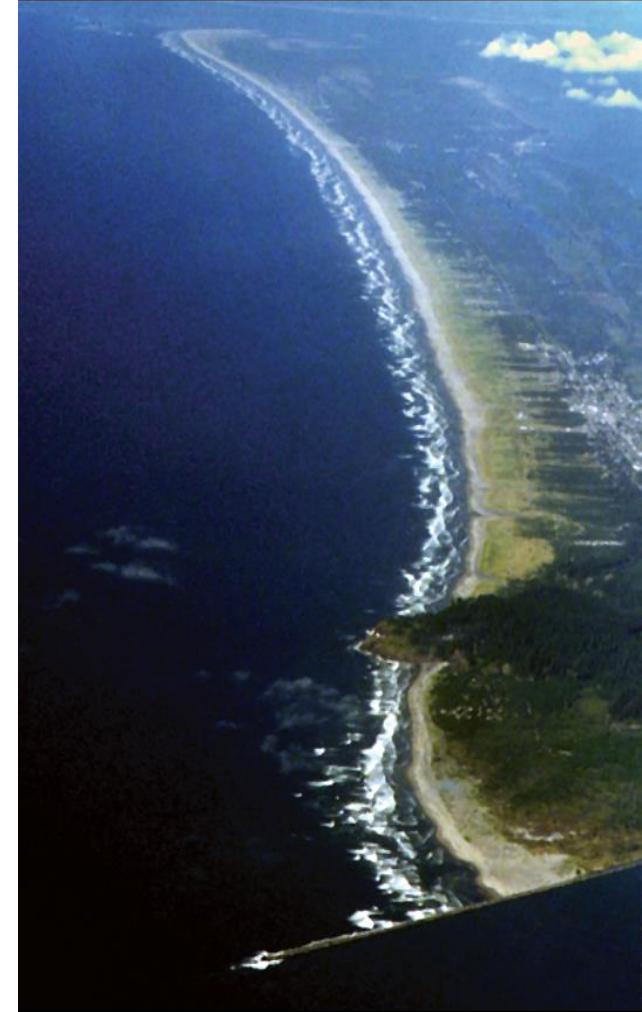
Columbia River Littoral Cell – Long Beach

- Beach erosion is tied to Columbia River sediment supply.
- The beach closest to the Columbia River has eroded most rapidly.
- Beach accretion continues northward at lower rates in the south and higher rates in the north.

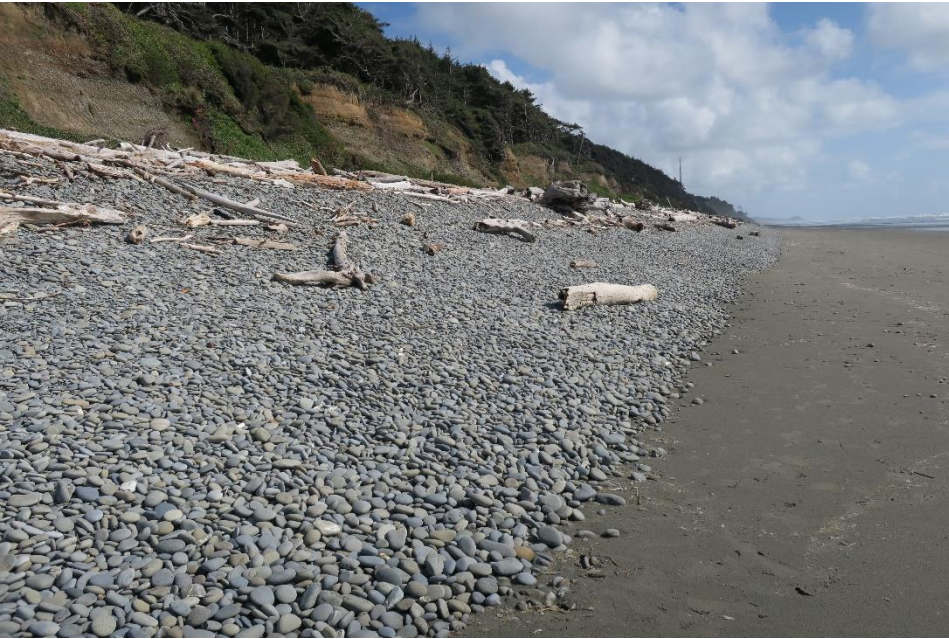
Kalaloch Beach 1

Natural cobble berm vs. built dynamic revetment

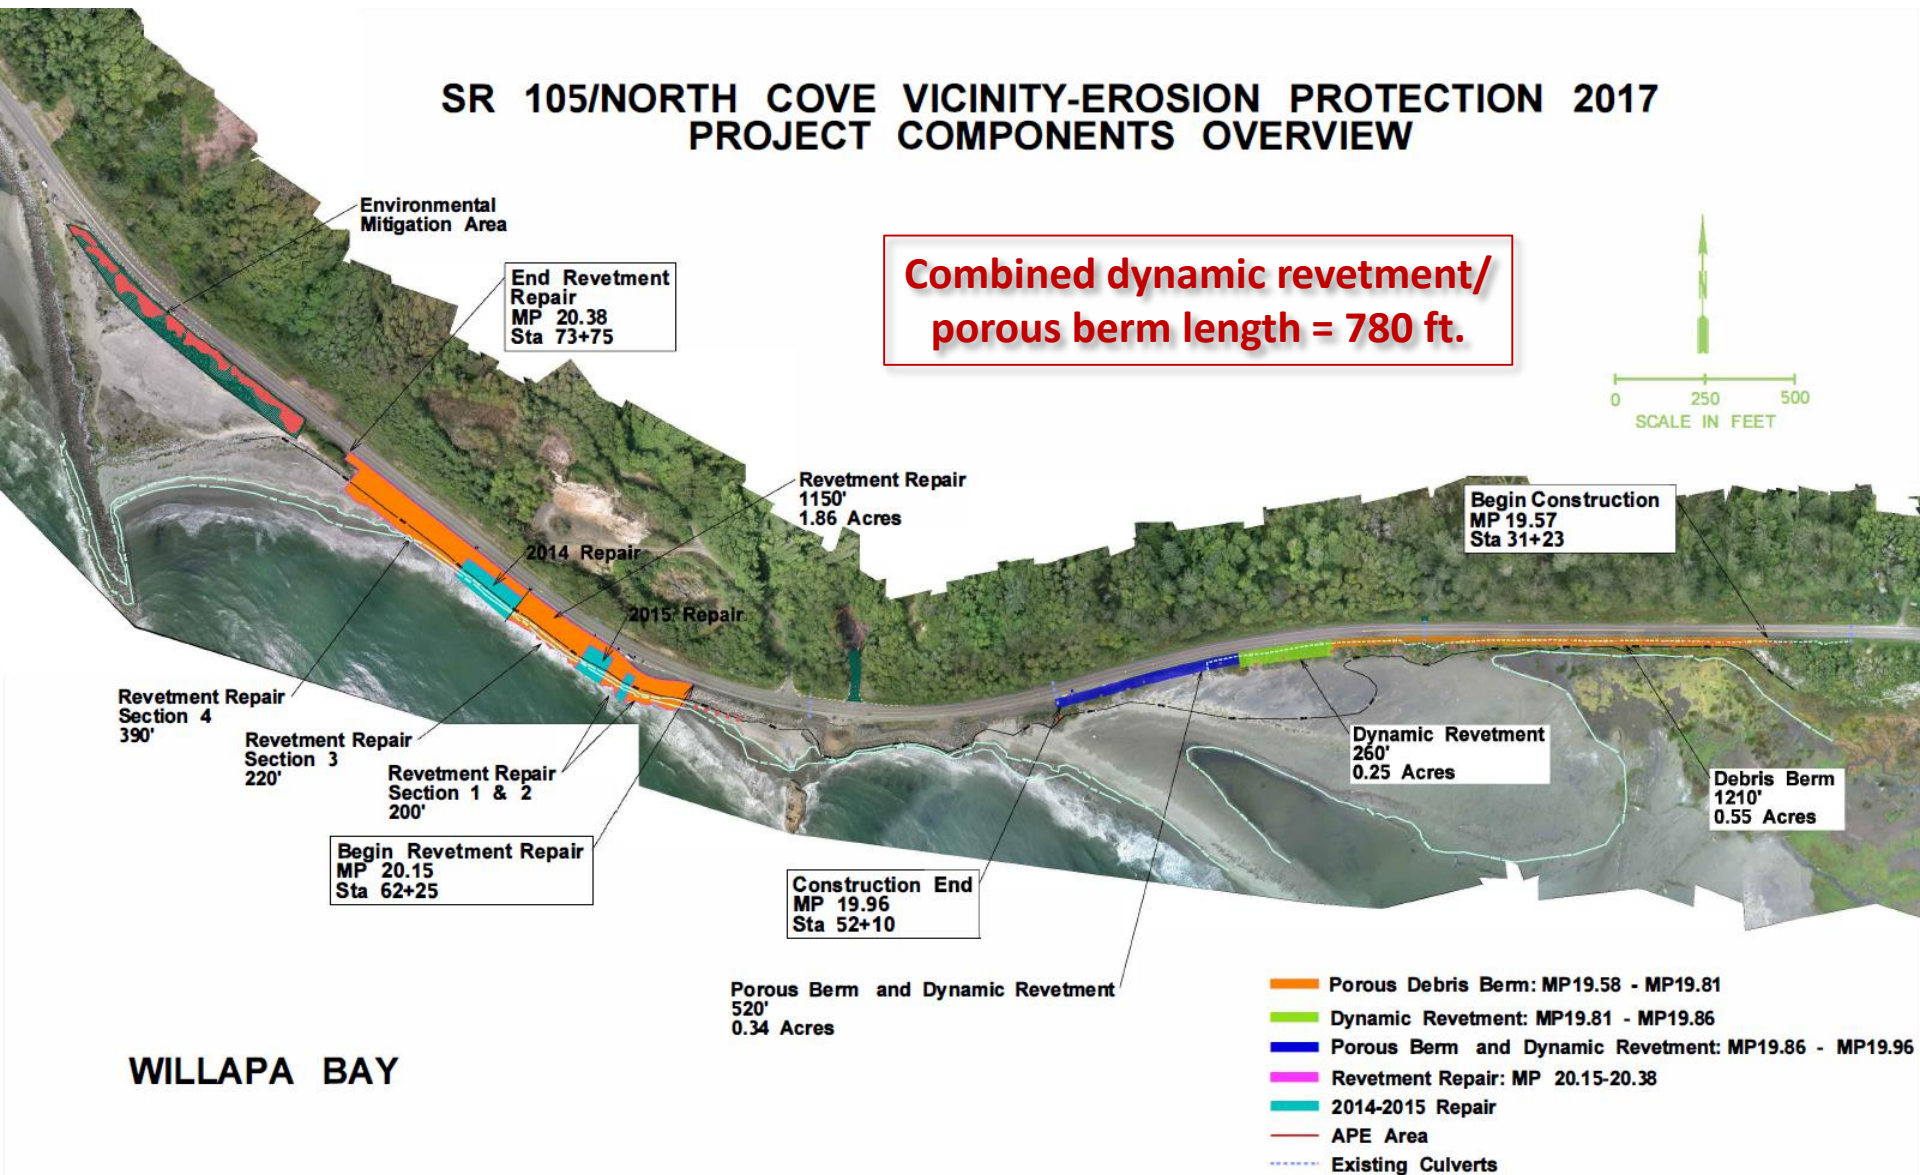
SR 105/NORTH COVE VICINITY-EROSION PROTECTION 2017 PROJECT COMPONENTS OVERVIEW

**Dynamic revetment = 260 ft. long x 40 ft. wide (top width),
composed of more than 2,000 cubic yards of cobble and gravel**

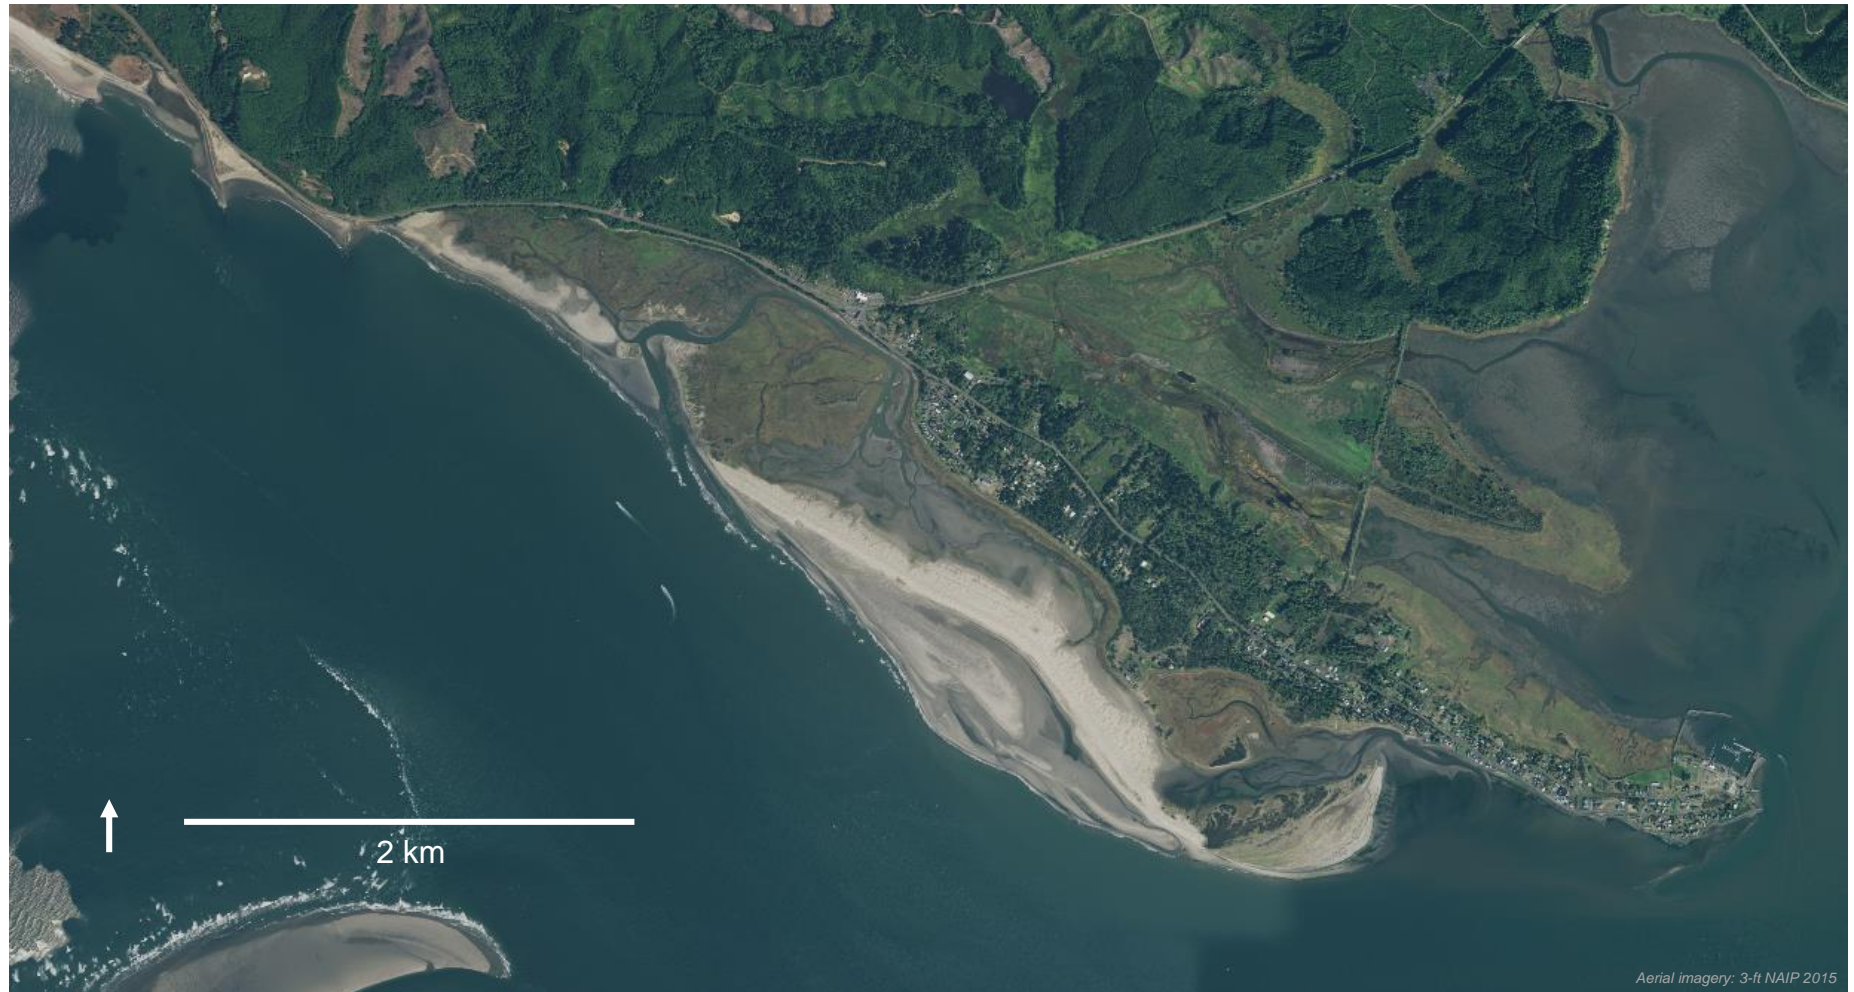
Shoalwater Bay Project

Graveyard Spit, Willapa Bay

- 600,000 cy sand to restore barrier dune to 25 ft MLLW top elevation in 2008
- 844,088 cy sand renourishment in summer 2018

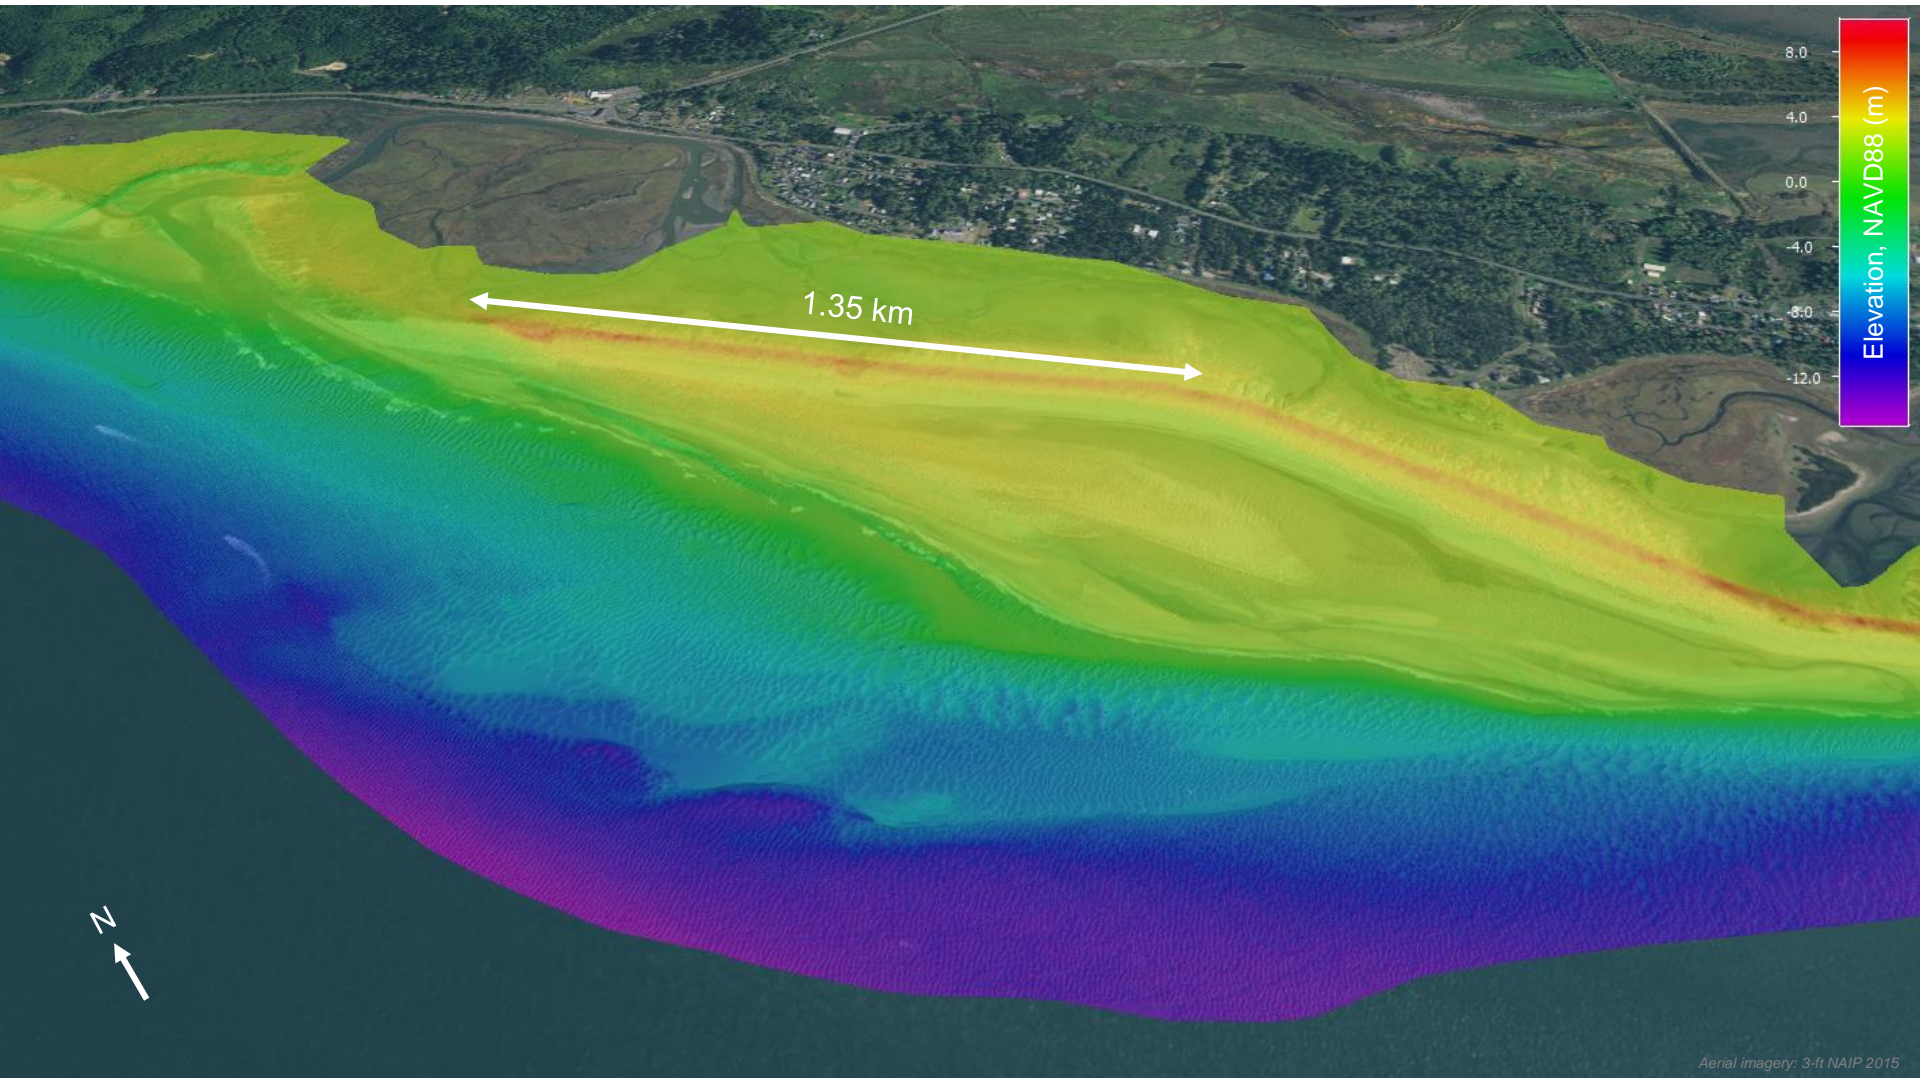
Shoalwater Bay Project Monitoring

Multibeam, Lidar, & Topo-merged DEM

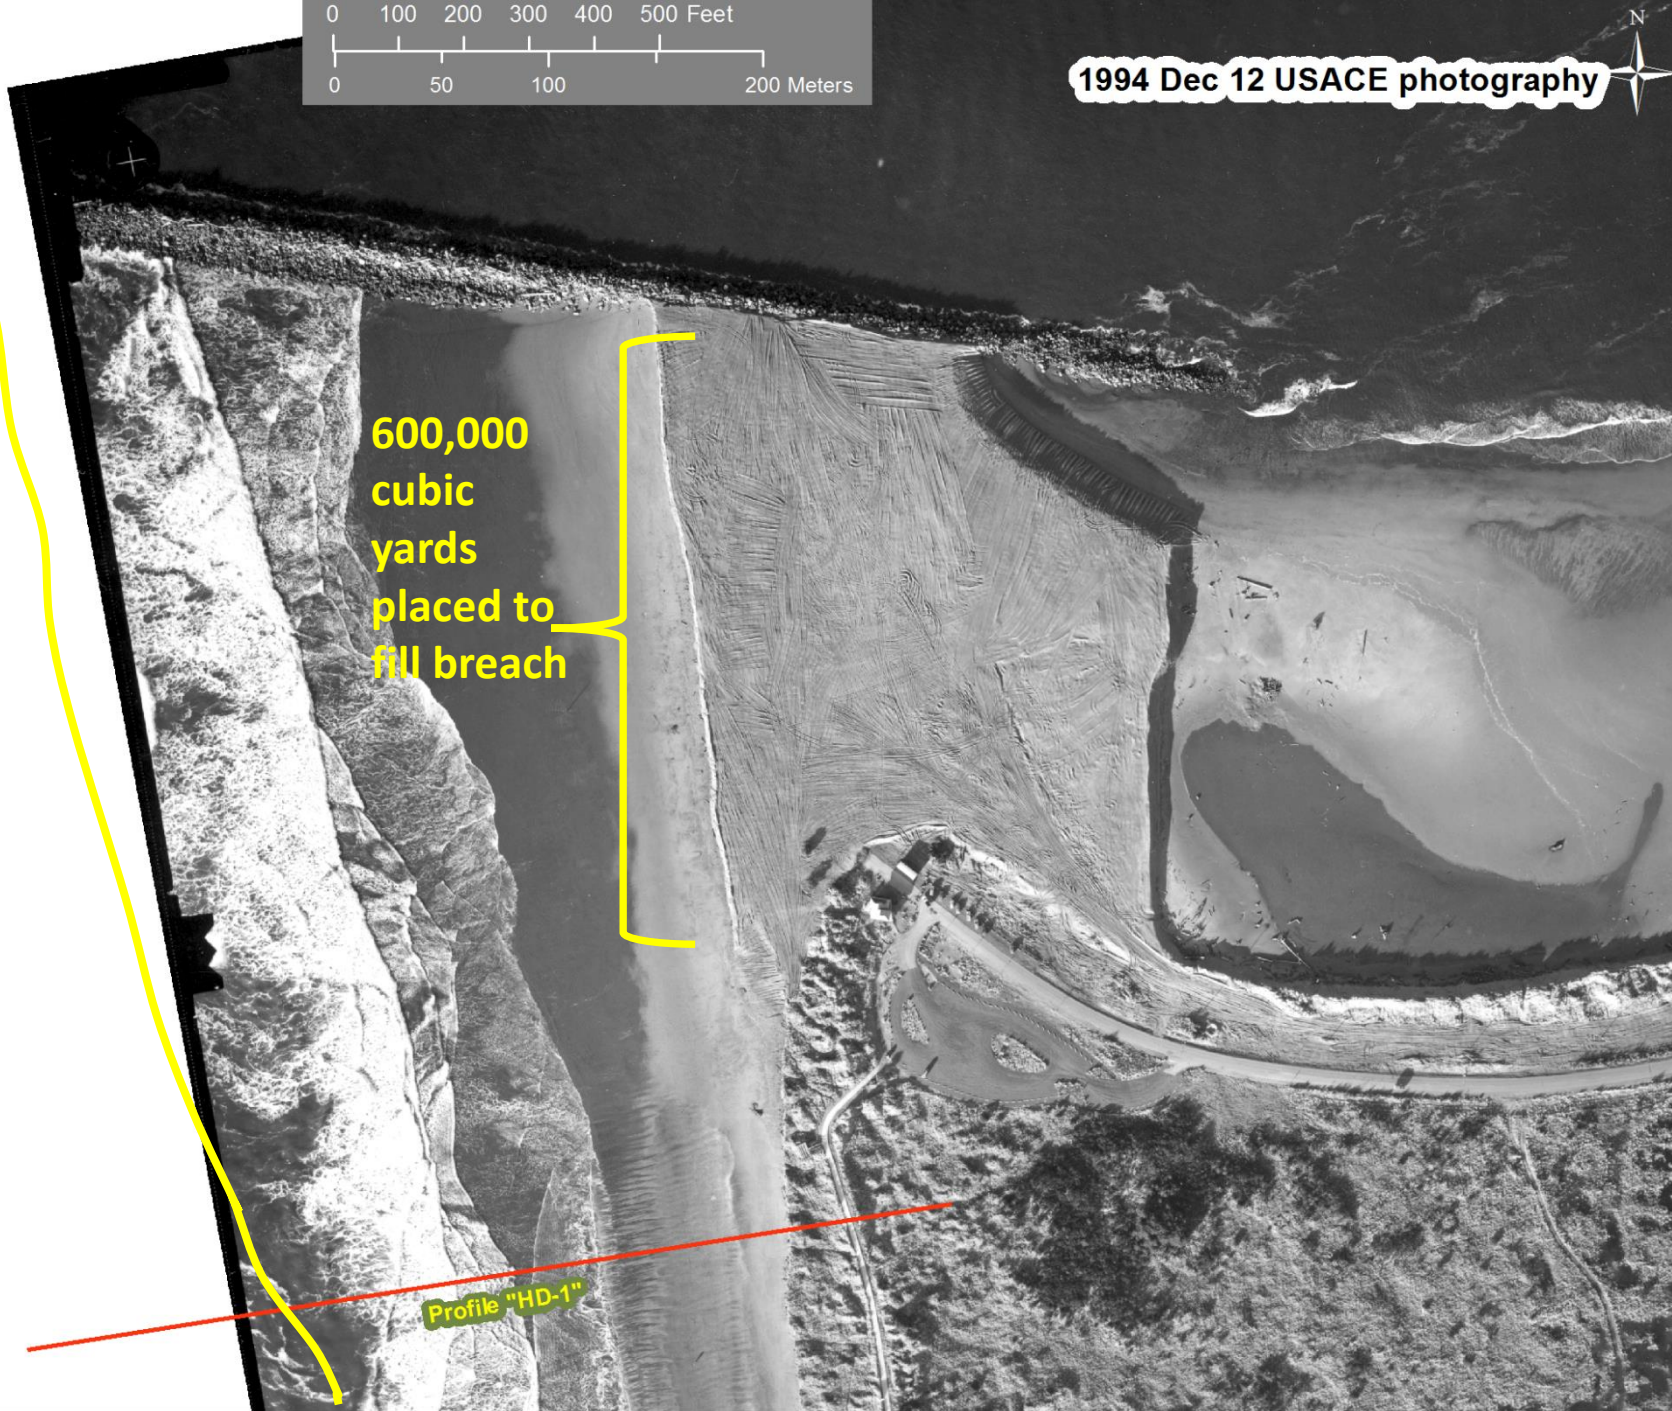
600,000
cubic
yards
placed to
fill breach

282 ft
high

Profile "HD-1"

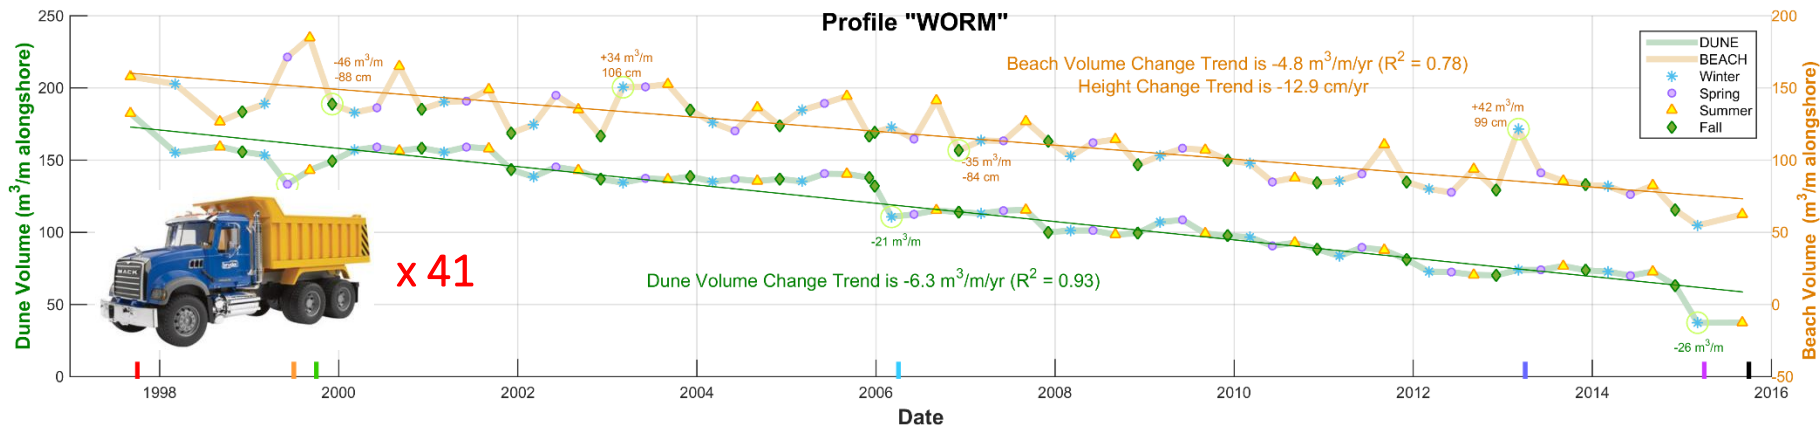
DUNE		BEACH	
Max Volume:	Sumr 1997, $182.4 \text{ m}^3/\text{m}$	Sumr 1999, $184.7 \text{ m}^3/\text{m}$	
Min Volume:	Wint 2015, $37.3 \text{ m}^3/\text{m}$	Wint 2015, $54.7 \text{ m}^3/\text{m}$	
Max 9-mo Accretion:	Spr 1999 to Wint 2000, $23.5 \text{ m}^3/\text{m}$	Fall 1998 to Sumr 1999, $51.3 \text{ m}^3/\text{m}$	
Max 9-mo Erosion:	Sumr 2014 to Wint 2015, $-35.5 \text{ m}^3/\text{m}$	Sumr 1999 to Wint 2000, $-51.8 \text{ m}^3/\text{m}$	
Most Stable 9-mo:	Spr 2004 to Wint 2005, $1.7 \text{ m}^3/\text{m}$	Spr 2010 to Wint 2011, $3.5 \text{ m}^3/\text{m}$

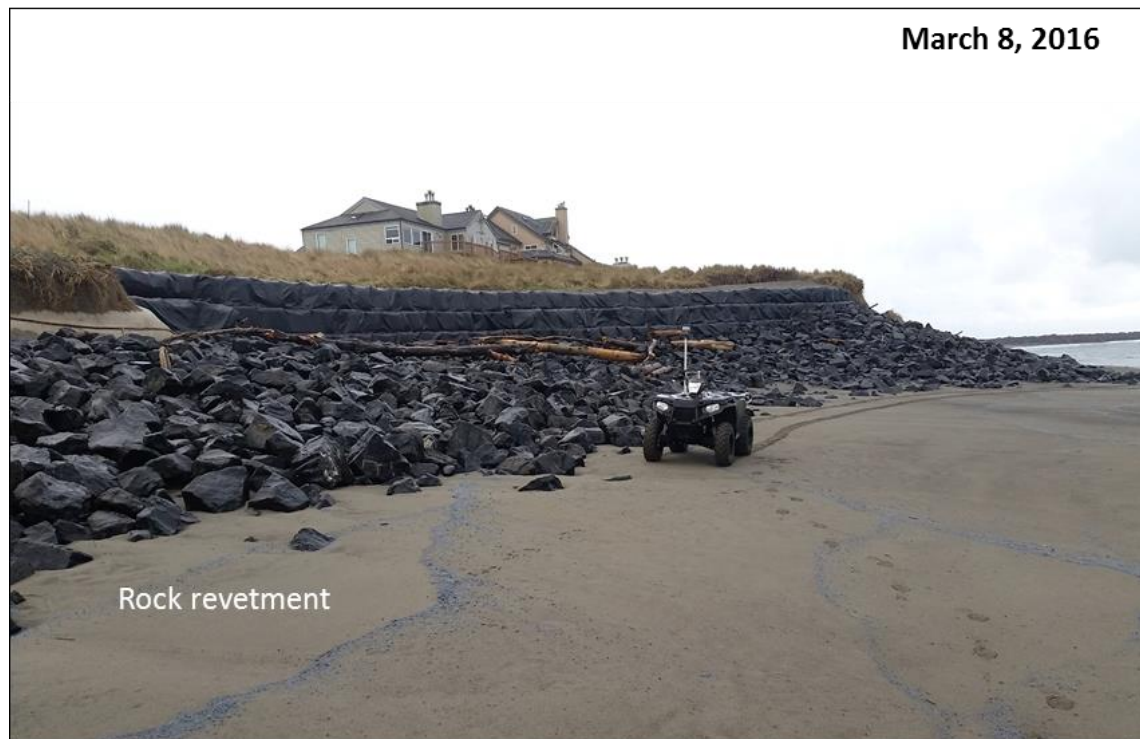
Rock revetment

End scour

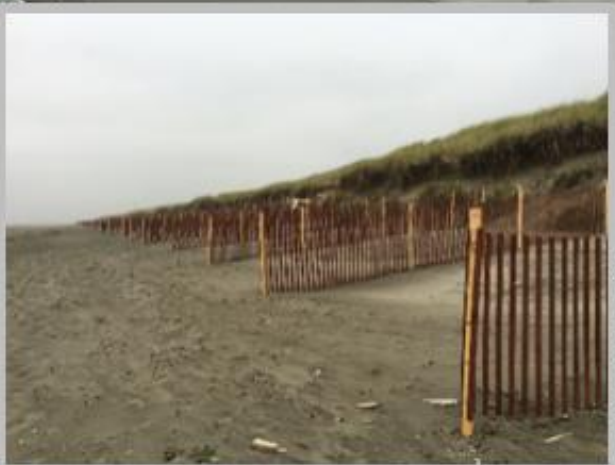
- North Jetty is deteriorating and affects shoreline stability
- Aggravated erosion occurring at end of rock structures
- Lack of suitable transitions between rock and dune sand
- Dune erosion scarp extends from jetty to 1.9 km north along shoreline
- Average erosion of 25,800 cubic yards/year of sediment from beaches and dunes
- A dune breach represents the highest risk to upland infrastructure
- Sand fences during Spring to Fall may help to increase resilience during the subsequent winter
- Beach and dune nourishment offers only a temporary solution
- Rehabilitation of Grays Harbor North Jetty is critical to preventing a chronic erosion problem

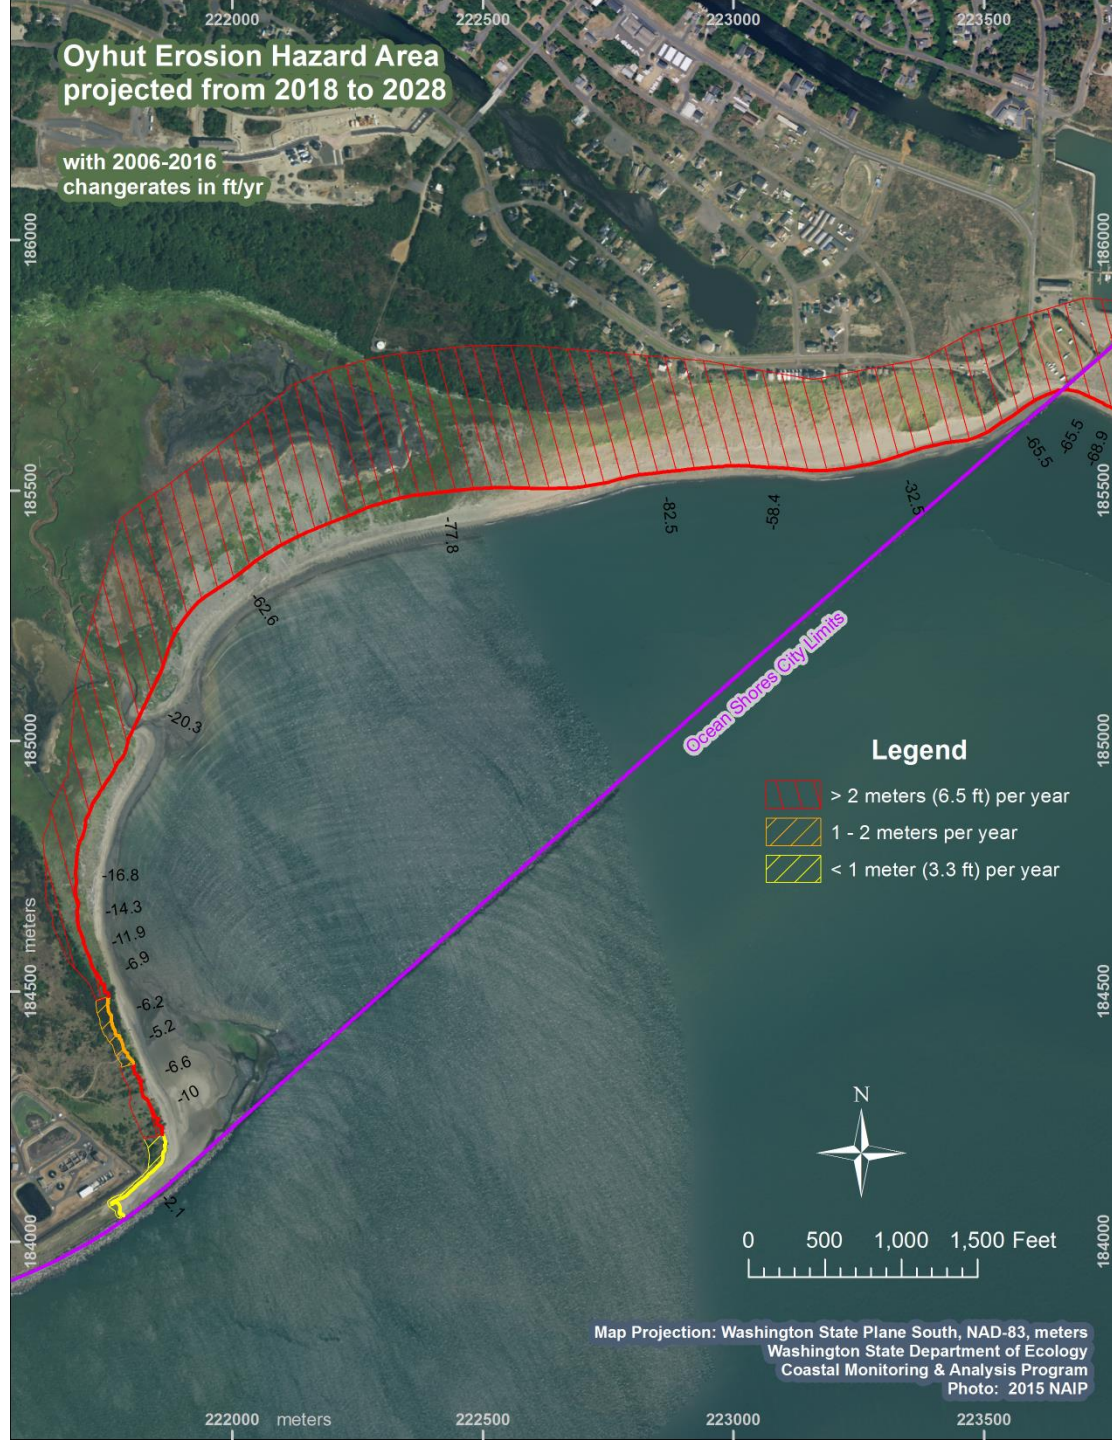
Oyhut Erosion Hazard Area projected from 2018 to 2028

with 2006-2016
changerates in ft/yr
