# Bioretention Hydrologic Performance Study III

## Purpose of the BHP III Study – How are they aging?

- Look at 50 (!) bioretention cells ten years old or older 2013 or earlier
- We characterized the plant community, measured the cell infiltration rate and soil composition, and the owners' O&M

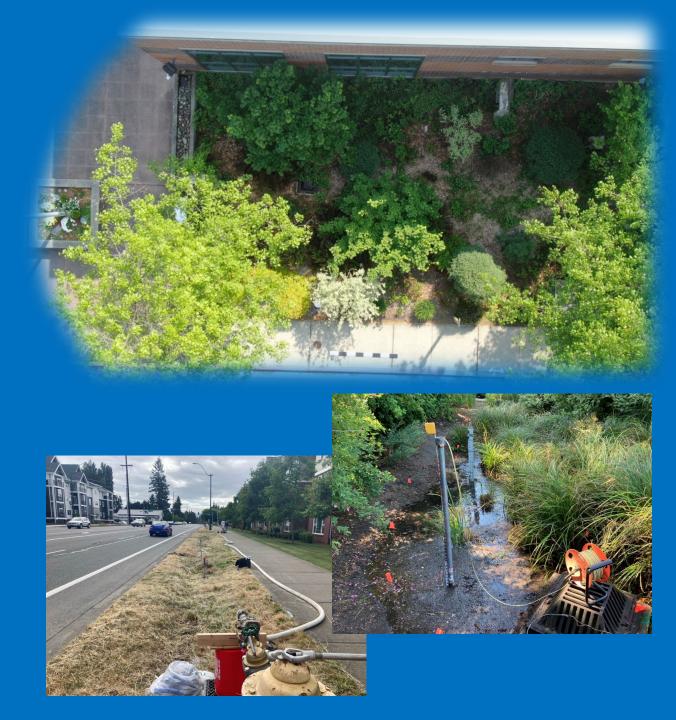
#### FIELD INVESTIGATION

- Plan review
- Drone imagery, utility locate
- Site access, hydrant permission
- Multiple shallow hand borings
- Shallow well point
- Controlled field infiltration test
- Geotechnical T-probe
- Laboratory testing
  - grain size, organic matter

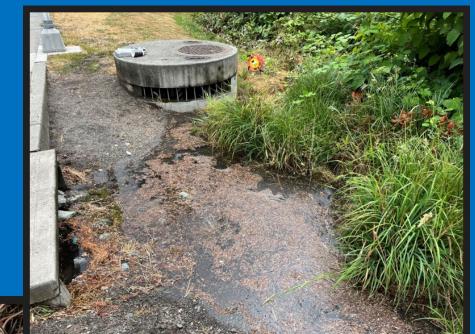
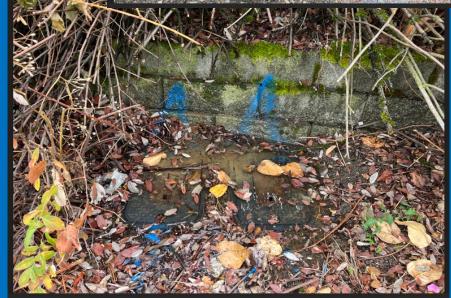
#### CELL CONDITION RELATIVE TO PLAN

- 38 cells consistent with as-builts
- 9 cells varied
  - Non-engineered overflows
  - Bypass
  - Landscaping modifications
- 3 cells did not have as-builts
- Inlets:
  - 17 cells -> 1+ inlet with erosion;
  - 32 cells -> 1+ inlet with blockage
- Outlets:
  - 41 cells -> engineered overflows
  - 11 cells -> debris buildup at overflow

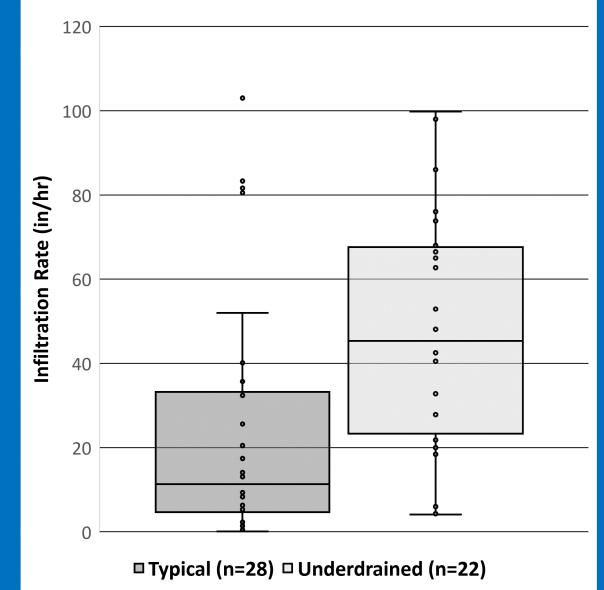
#### Facility Infiltration Rates: Typical and Underdrained

- Physically mostly resembled plans
- Some key differences
  - Non-engineered overflows(2), Lateral Flow(3)
  - Leaky structures (10 of 31)
  - Incorporated into lawn (1-2), Filled in (1)
- Infiltration and BSM soils:
- High rates persist, Typical < Underdrained
- No facility clogging
- Some inlet compaction, siltation
- BSM Most finer, esp. #200 fraction
- Wide range of organic matter content

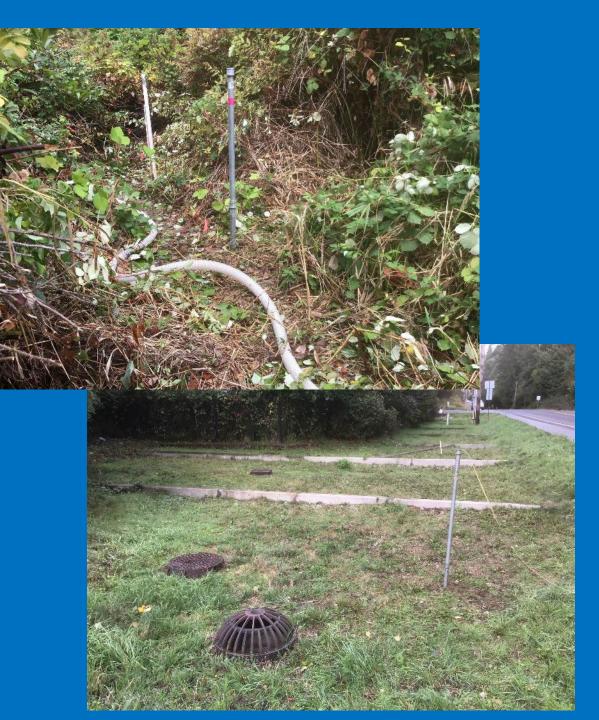
#### **KEY FINDINGS**

#### As-built/Design:

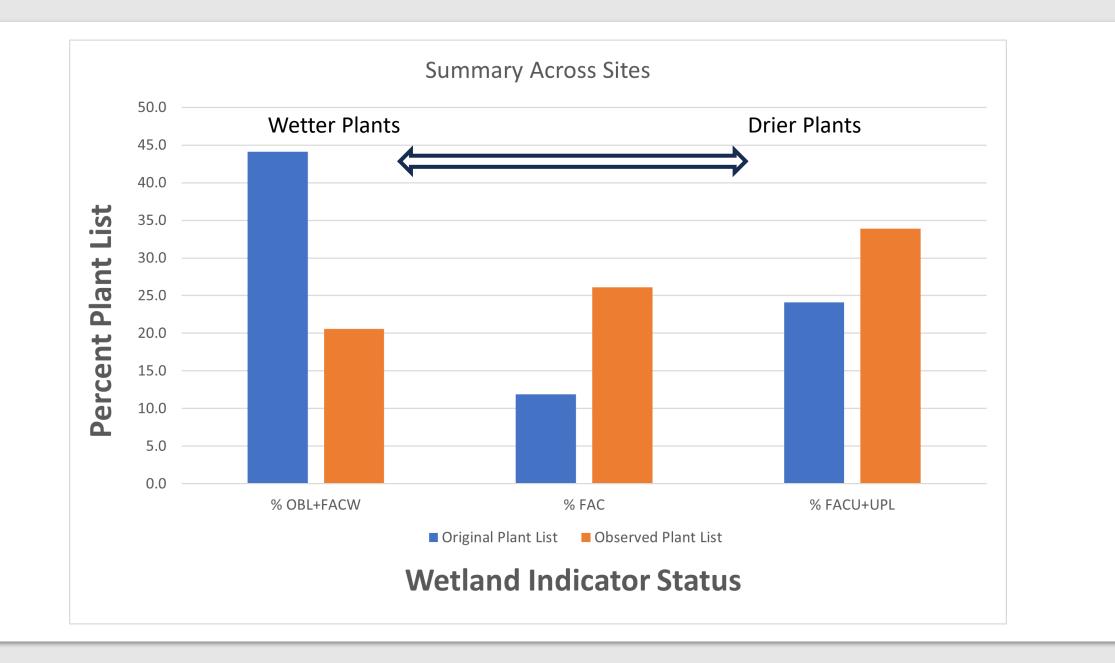
#### Wetland Indicator Status

- Approximately 75% of original plant lists shifted to drier plants
- The number of herbaceous plants increased over time
- Not many originally planted herbs survived to present
