LINCOLN COUNTY - WASHINGTON

ADA TRANSITION PLAN

FOR COMPLIANCE WITH THE AMERICANS WITH DISABILITIES ACT (ADA)

March 9, 2019

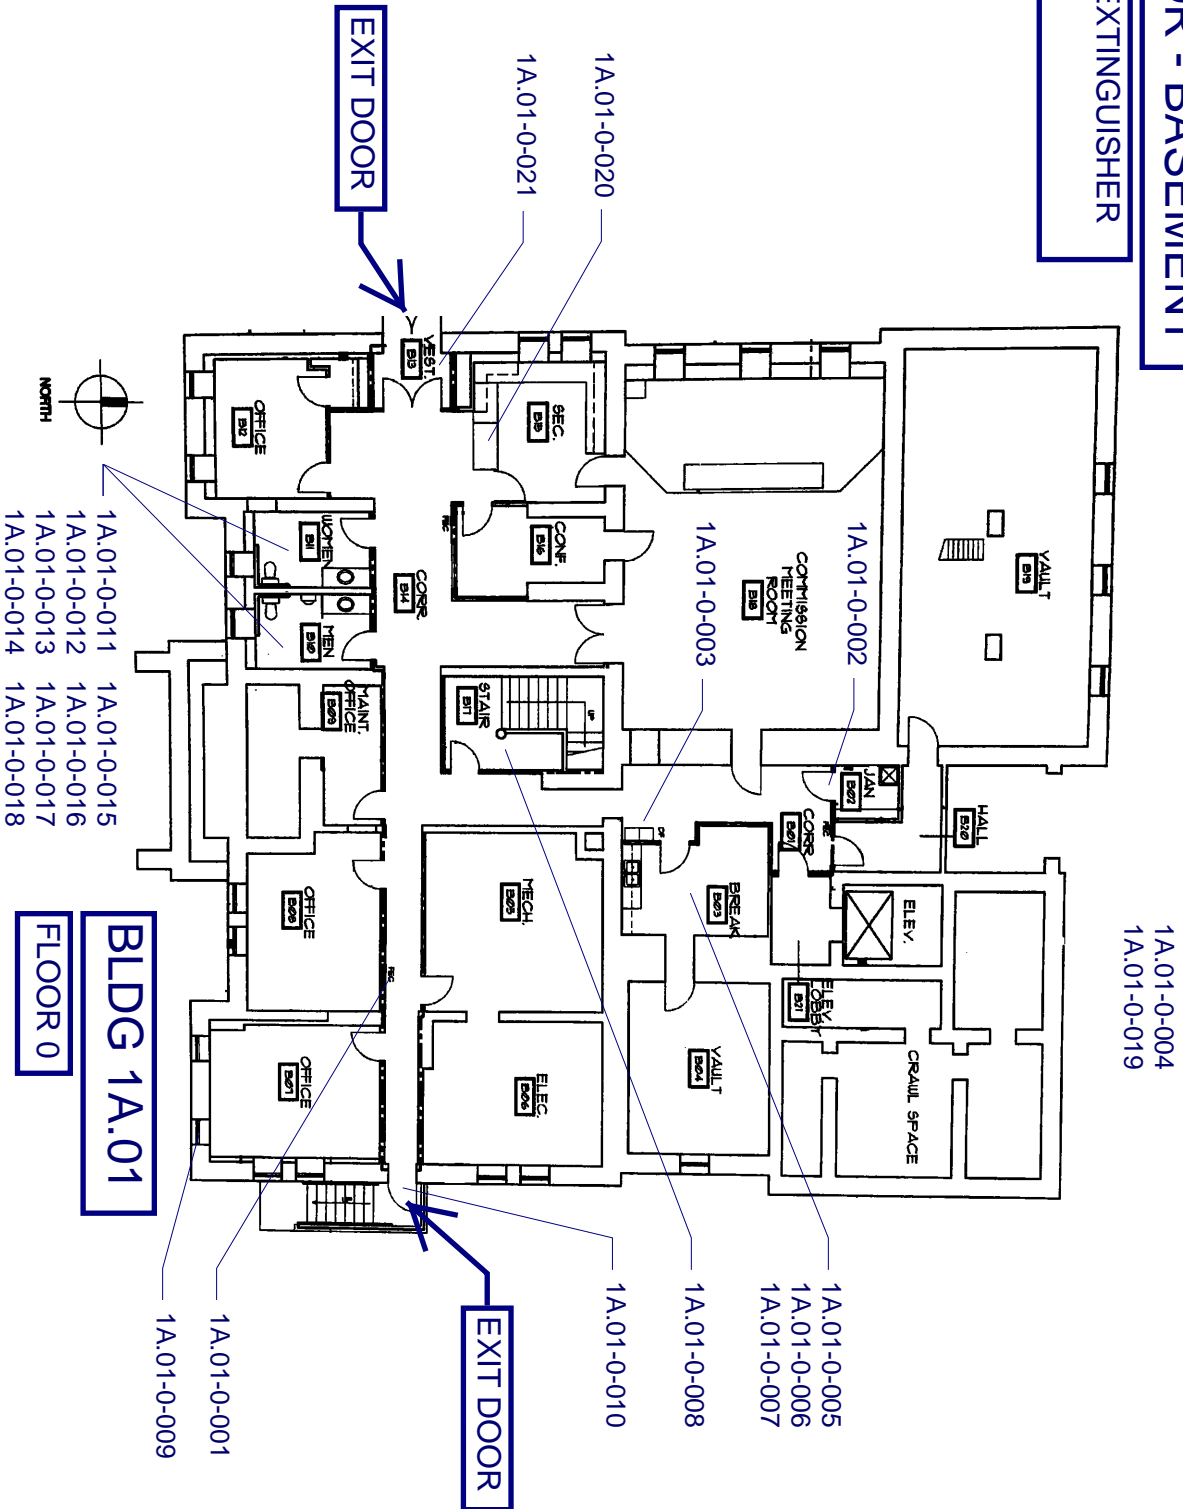
**GROUP 1A
COURTHOUSE
BUILDING 1A.01
INTERIOR - BASEMENT**

1A.01-0-011 1A.01-0-015
 1A.01-0-012 1A.01-0-016
 1A.01-0-013 1A.01-0-017
 1A.01-0-014 1A.01-0-018

1A.01-0-004
 1A.01-0-019

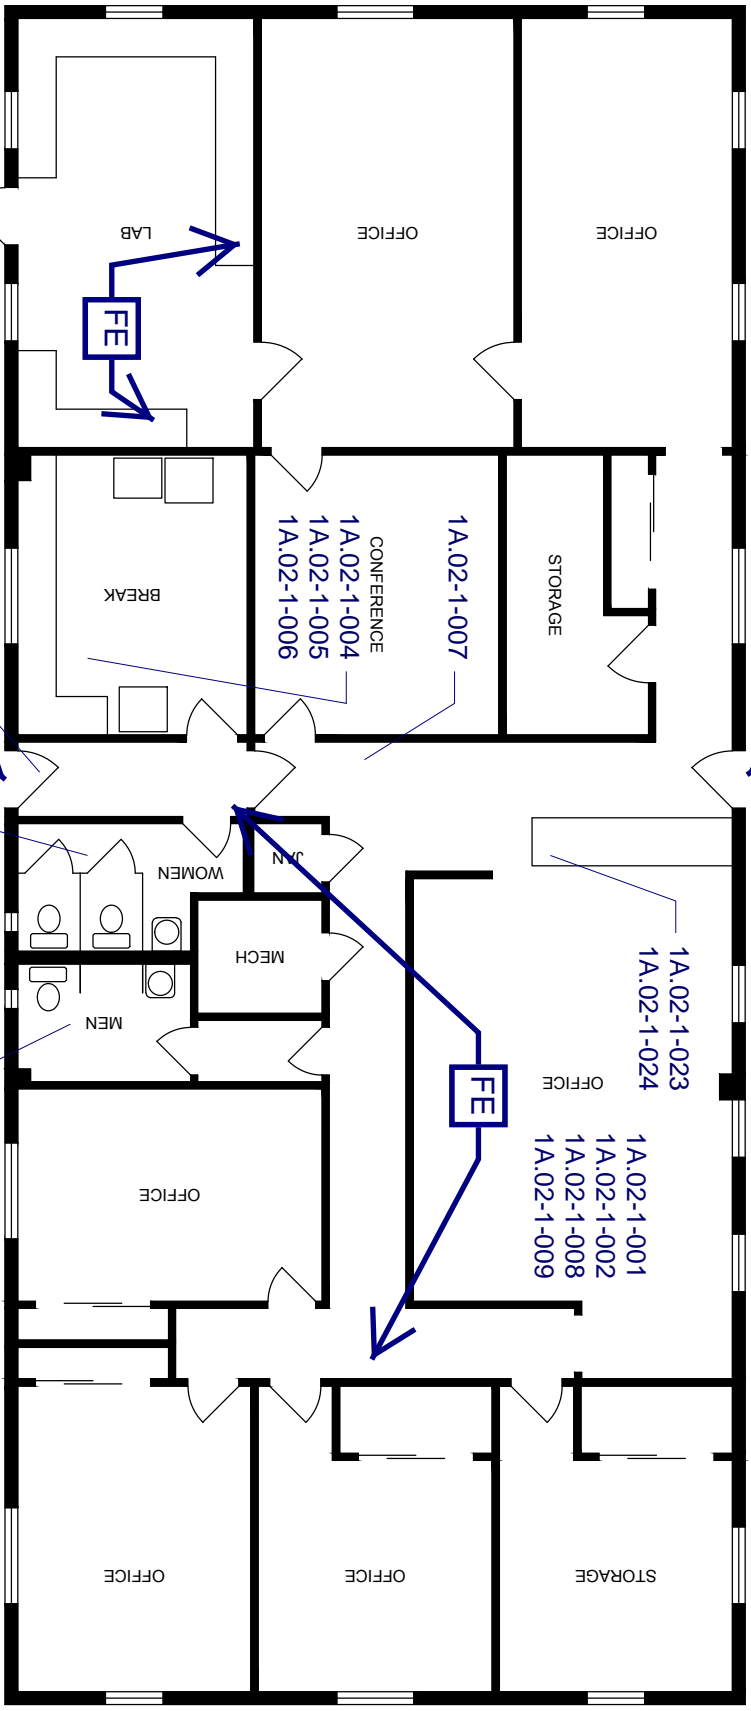
**BLDG 1A.02
FLOOR 1**

- 1A.02-1-003
- 1A.02-1-010
- 1A.02-1-011
- 1A.02-1-012
- 1A.02-1-013
- 1A.02-1-014
- 1A.02-1-015
- 1A.02-1-016
- 1A.02-1-017
- 1A.02-1-011
- 1A.02-1-012
- 1A.02-1-015
- 1A.02-1-018
- 1A.02-1-019
- 1A.02-1-020
- 1A.02-1-021
- 1A.02-1-022

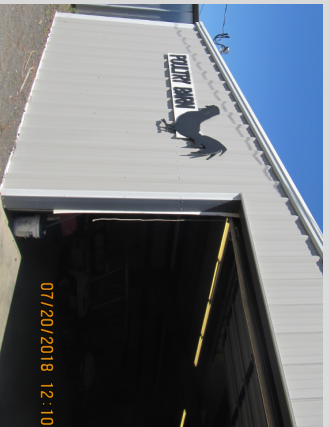
Exterior Non-Compliant Items							
Item No.	Location	Element	Barrier Description	Photo	Prevailing Code	Recommendation	Comments
2.8 - A - 001	POT-A	Door A	Vertical change in level height of 1-1/2 inches with no bevel

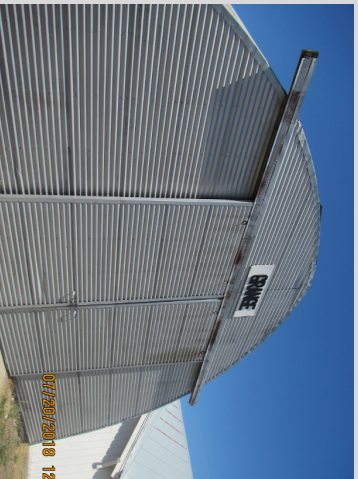
Exterior Non-Compliant Items							
Item No.	Location	Element	Barrier Description	Photo	Prevailing Code	Recommendation	Comments
2.9 - A - 001	POT-A	Door A	Gap widths: of 1/2 to 3/4 inches		2010 ADA Standards 302.3 and 303: Openings in floor or ground surfaces shall not allow passage of a sphere more than 1/2 inch diameter and changes in level of 1/4 inch high maximum shall be permitted to be vertical.	Remove and replace landing to meet these requirements.	Gaps occur between many of the panels.

2.9 - A - 002	POT-A	Door A	Door approach running slope of 13.1%		2010 ADA Standards 404 Doors, Doorways, and Gates 404.2, 4.4 Floor or Ground Surface. Slopes not steeper than 1:48 shall be permitted.	Remove and replace landing to meet these requirements.

2.9 - B - 003	POT-B	Door B	Door approach running slope of 12.5%		2010 ADA Standards 404 Doors, Doorways, and Gates 404.2, 4.4 Floor or Ground Surface. Slopes not steeper than 1:48 shall be permitted.	Remove and replace landing to meet these requirements.

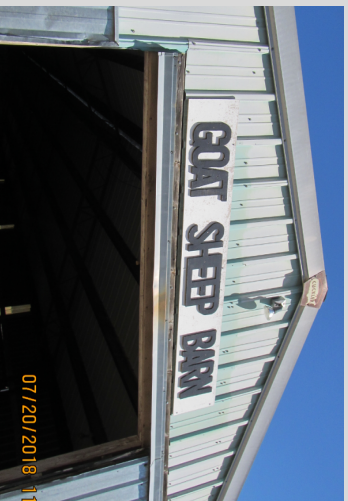
Item No.	Location	Element	Barrier Description	Photo	Prevailing Code	Recommendation	Comments
2.10 - A - 001	POT-A	Door A	Vertical change in level height of 1-1/4 inches with no bevel		2010 ADA Standards 403.4 Changes in Level. Changes in level shall comply with 303.303.2 Vertical. Changes in level of 1/4 inch high maximum shall be permitted to be vertical.303.3 Beveled. Changes in level between 1/4 inch high minimum and 1/2 inch high maximum shall be beveled with a slope not steeper than 1:2.	Provide concrete landing at door level with finished floor that also meets these and other path of travel requirements.

2.10 - B - 003	POT-B	Door B	Running slope of 5.4% in the upper courtyard area		2010 ADA Standards 403.3 Slope. The running slope of walking surfaces shall not be steeper than 1:20 (5.0%). The cross slope of walking surfaces shall not be steeper than 1:48 (2.0%).	Remove and replace door landing to comply with these and other requirements.	This door landing also serves as a ramp landing for the interior ramp inside Door B.

2.10 - B - 004	POT-B	Curb Ramp B	East curb ramp flare has running slope of 15.5%		2010 ADA Standards 406.3 Sides of Curb Ramps: Where provided, curb ramp flares shall not be steeper than 1:10 (10%).	Remove and replace interior curb ramp to comply with these and other requirements.	There is an interior curb ramp just inside Door A. It is assumed these two interior ramps are similar.

2.10 - B - 005	POT-B	Curb Ramp B	West curb ramp flare has running slope of 17.8%		2010 ADA Standards 406.3 Sides of Curb Ramps: Where provided, curb ramp flares shall not be steeper than 1:10 (10%).	Remove and replace interior curb ramp to comply with these and other requirements.	There is an interior curb ramp just inside Door A. It is assumed these two interior ramps are similar.

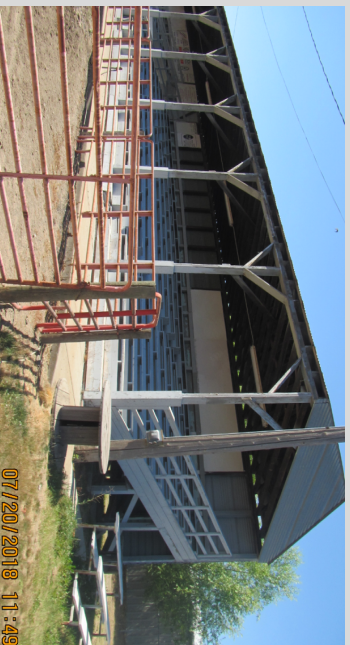
Exterior Non-Compliant Items							
Item No.	Location	Element	Barrier Description	Photo	Prevailing Code	Recommendation	Comments
2.11 - A - 001	POT-A	Wheelchair Spaces A	Wheelchair seating is not vertically dispersed		2010 ADA Standards 221.2.3.2 Vertical Dispersion. Wheelchair spaces shall be dispersed vertically at varying distances from the screen, performance area, or playing field. In addition, wheelchair spaces shall be located in each balcony or mezzanine that is located on an accessible route.	Provide wheelchair seating at multiple viewing levels complying with this and other path of travel requirements.

2.11 - A - 003	POT-A	Wheelchair Spaces A	Wheelchair space running slope of 17.4%		2010 ADA Standards 802.1.1 Floor or Ground Surface. The floor or ground surface of wheelchair spaces shall comply with 302 [surfaces shall be level]. Changes in level are not permitted. Exception: Slopes not steeper than 1:48 (2.0%) shall be permitted.	Remove and replace cracked concrete at wheelchair space.

2.11 - A - 004	POT-A	Wheelchair Spaces A	Gap widths: 3-1/2 inch, depth 1-1/2 inch		2010 ADA Standards 302.3 and 303: Openings in floor or ground surfaces shall not allow passage of a sphere more than 1/2 inch diameter and changes in level of 1/4 inch high maximum shall be permitted to be vertical.	Remove and replace cracked concrete at wheelchair space.

2.11 - A - 005	POT-A	Stairs A	Riser heights of 4 inches and 7-3/4 inches, not uniform		2010 ADA Standards 504.2 Treads and Risers. All steps on a flight of stairs shall have uniform riser heights and uniform tread depths. Risers shall be 4 inches high minimum and 7 inches high maximum. Treads shall be 11 inches deep minimum.	Remove and replace steps to comply with this and other requirements.

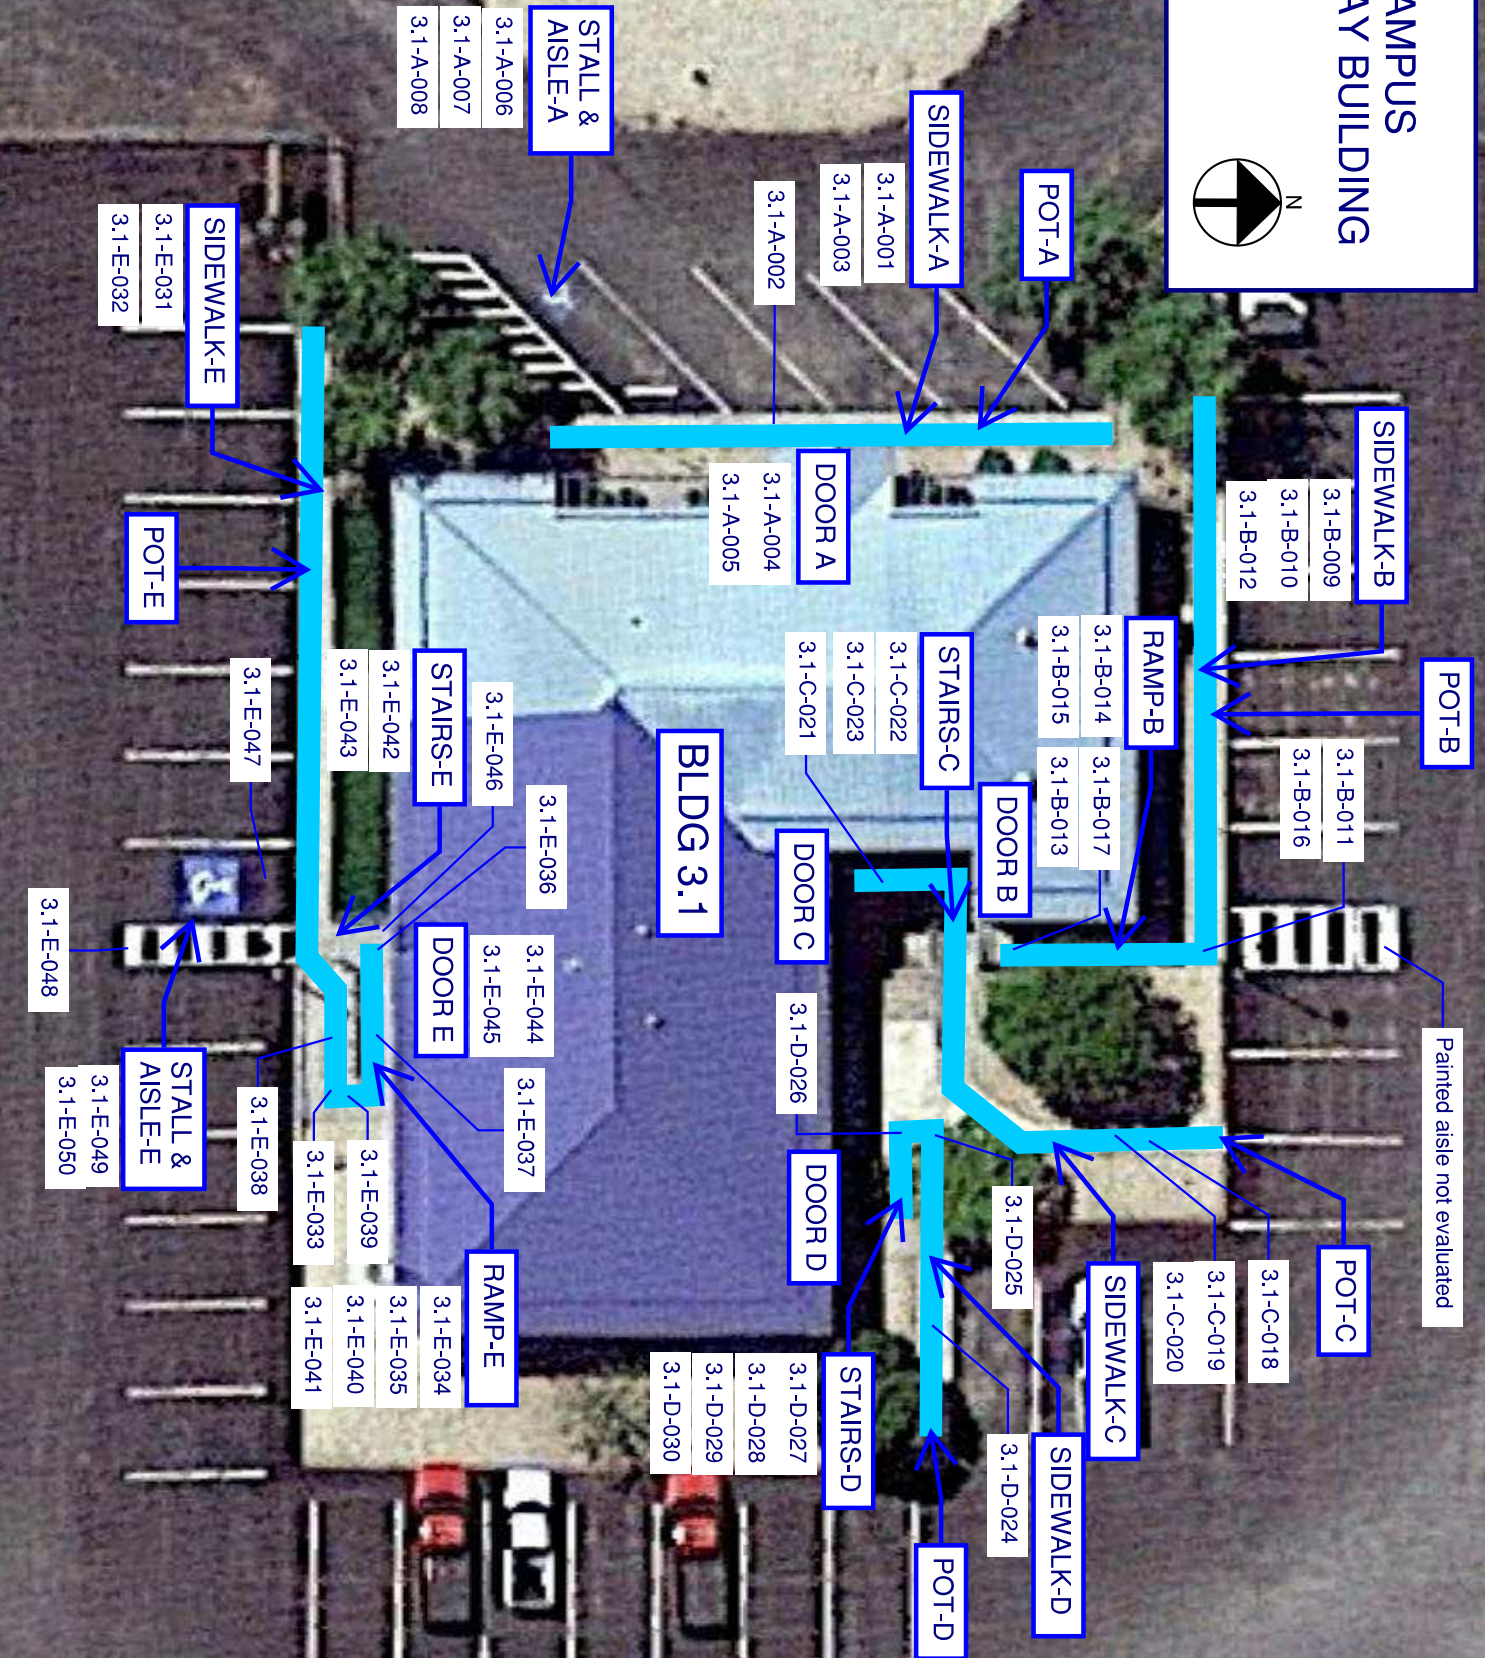
GROUP 3
PUBLIC WORKS CAMPUS
3.1 ADMIN HIGHWAY BUILDING
EXTERIOR
Not to Scale
6/19/2018

Painted aisle not evaluated

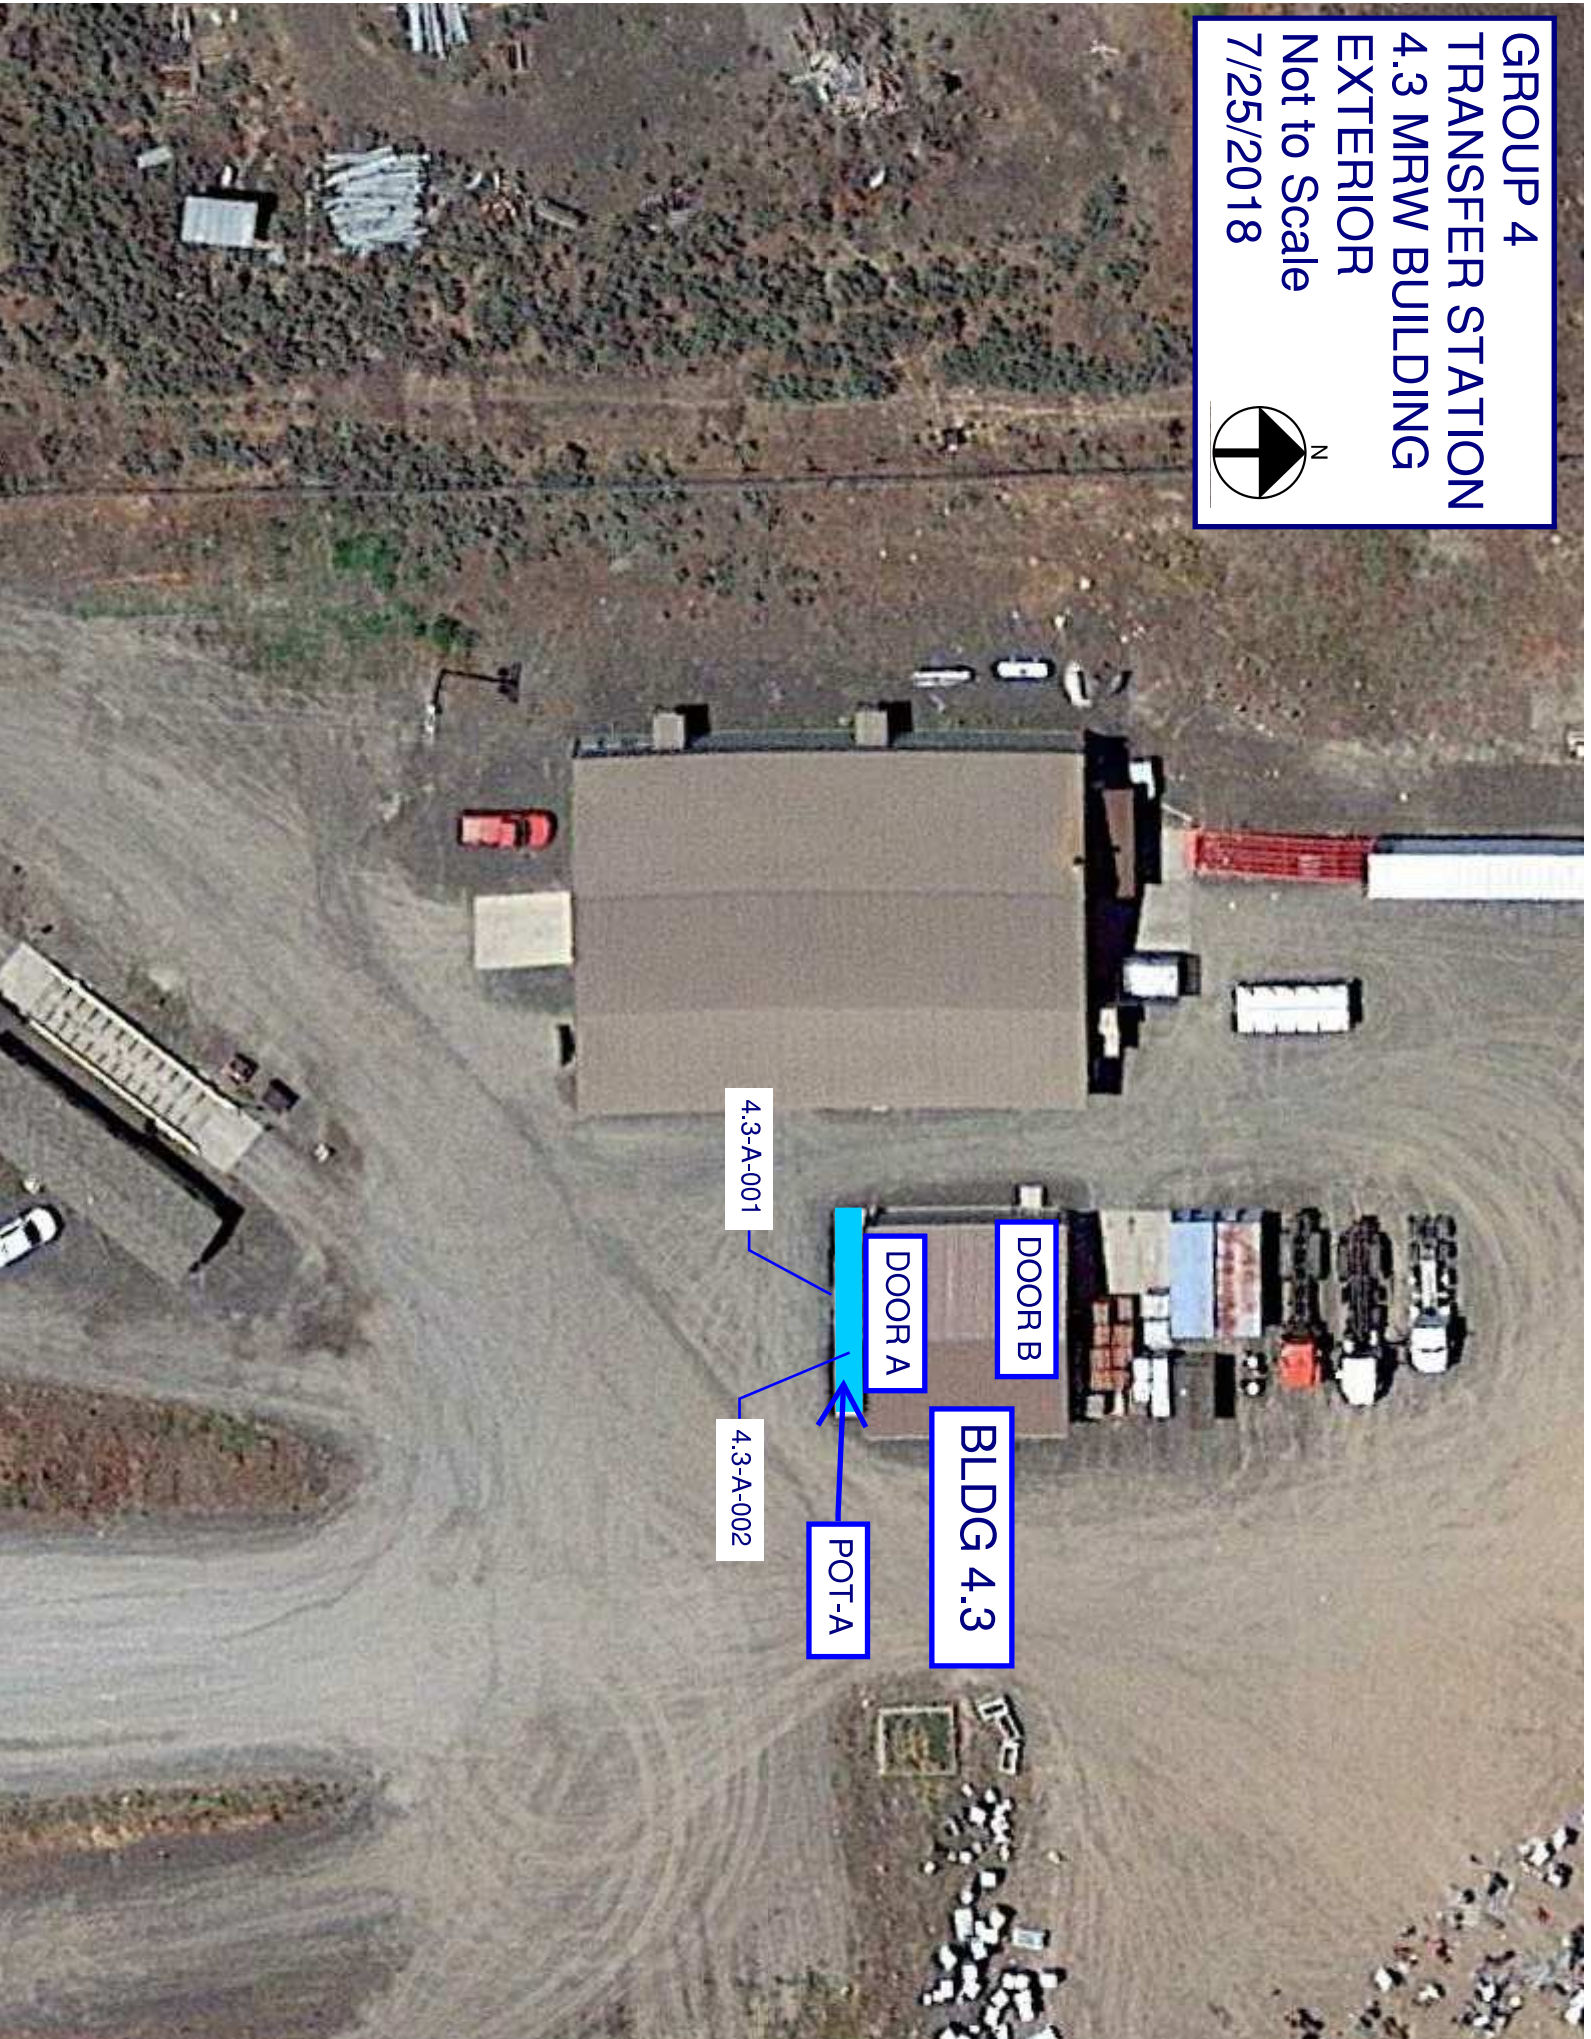
GROUP 4
TRANSFER STATION
4.3 MRW BUILDING
EXTERIOR
Not to Scale
7/25/2018

4.3-A-001

4.3-A-002

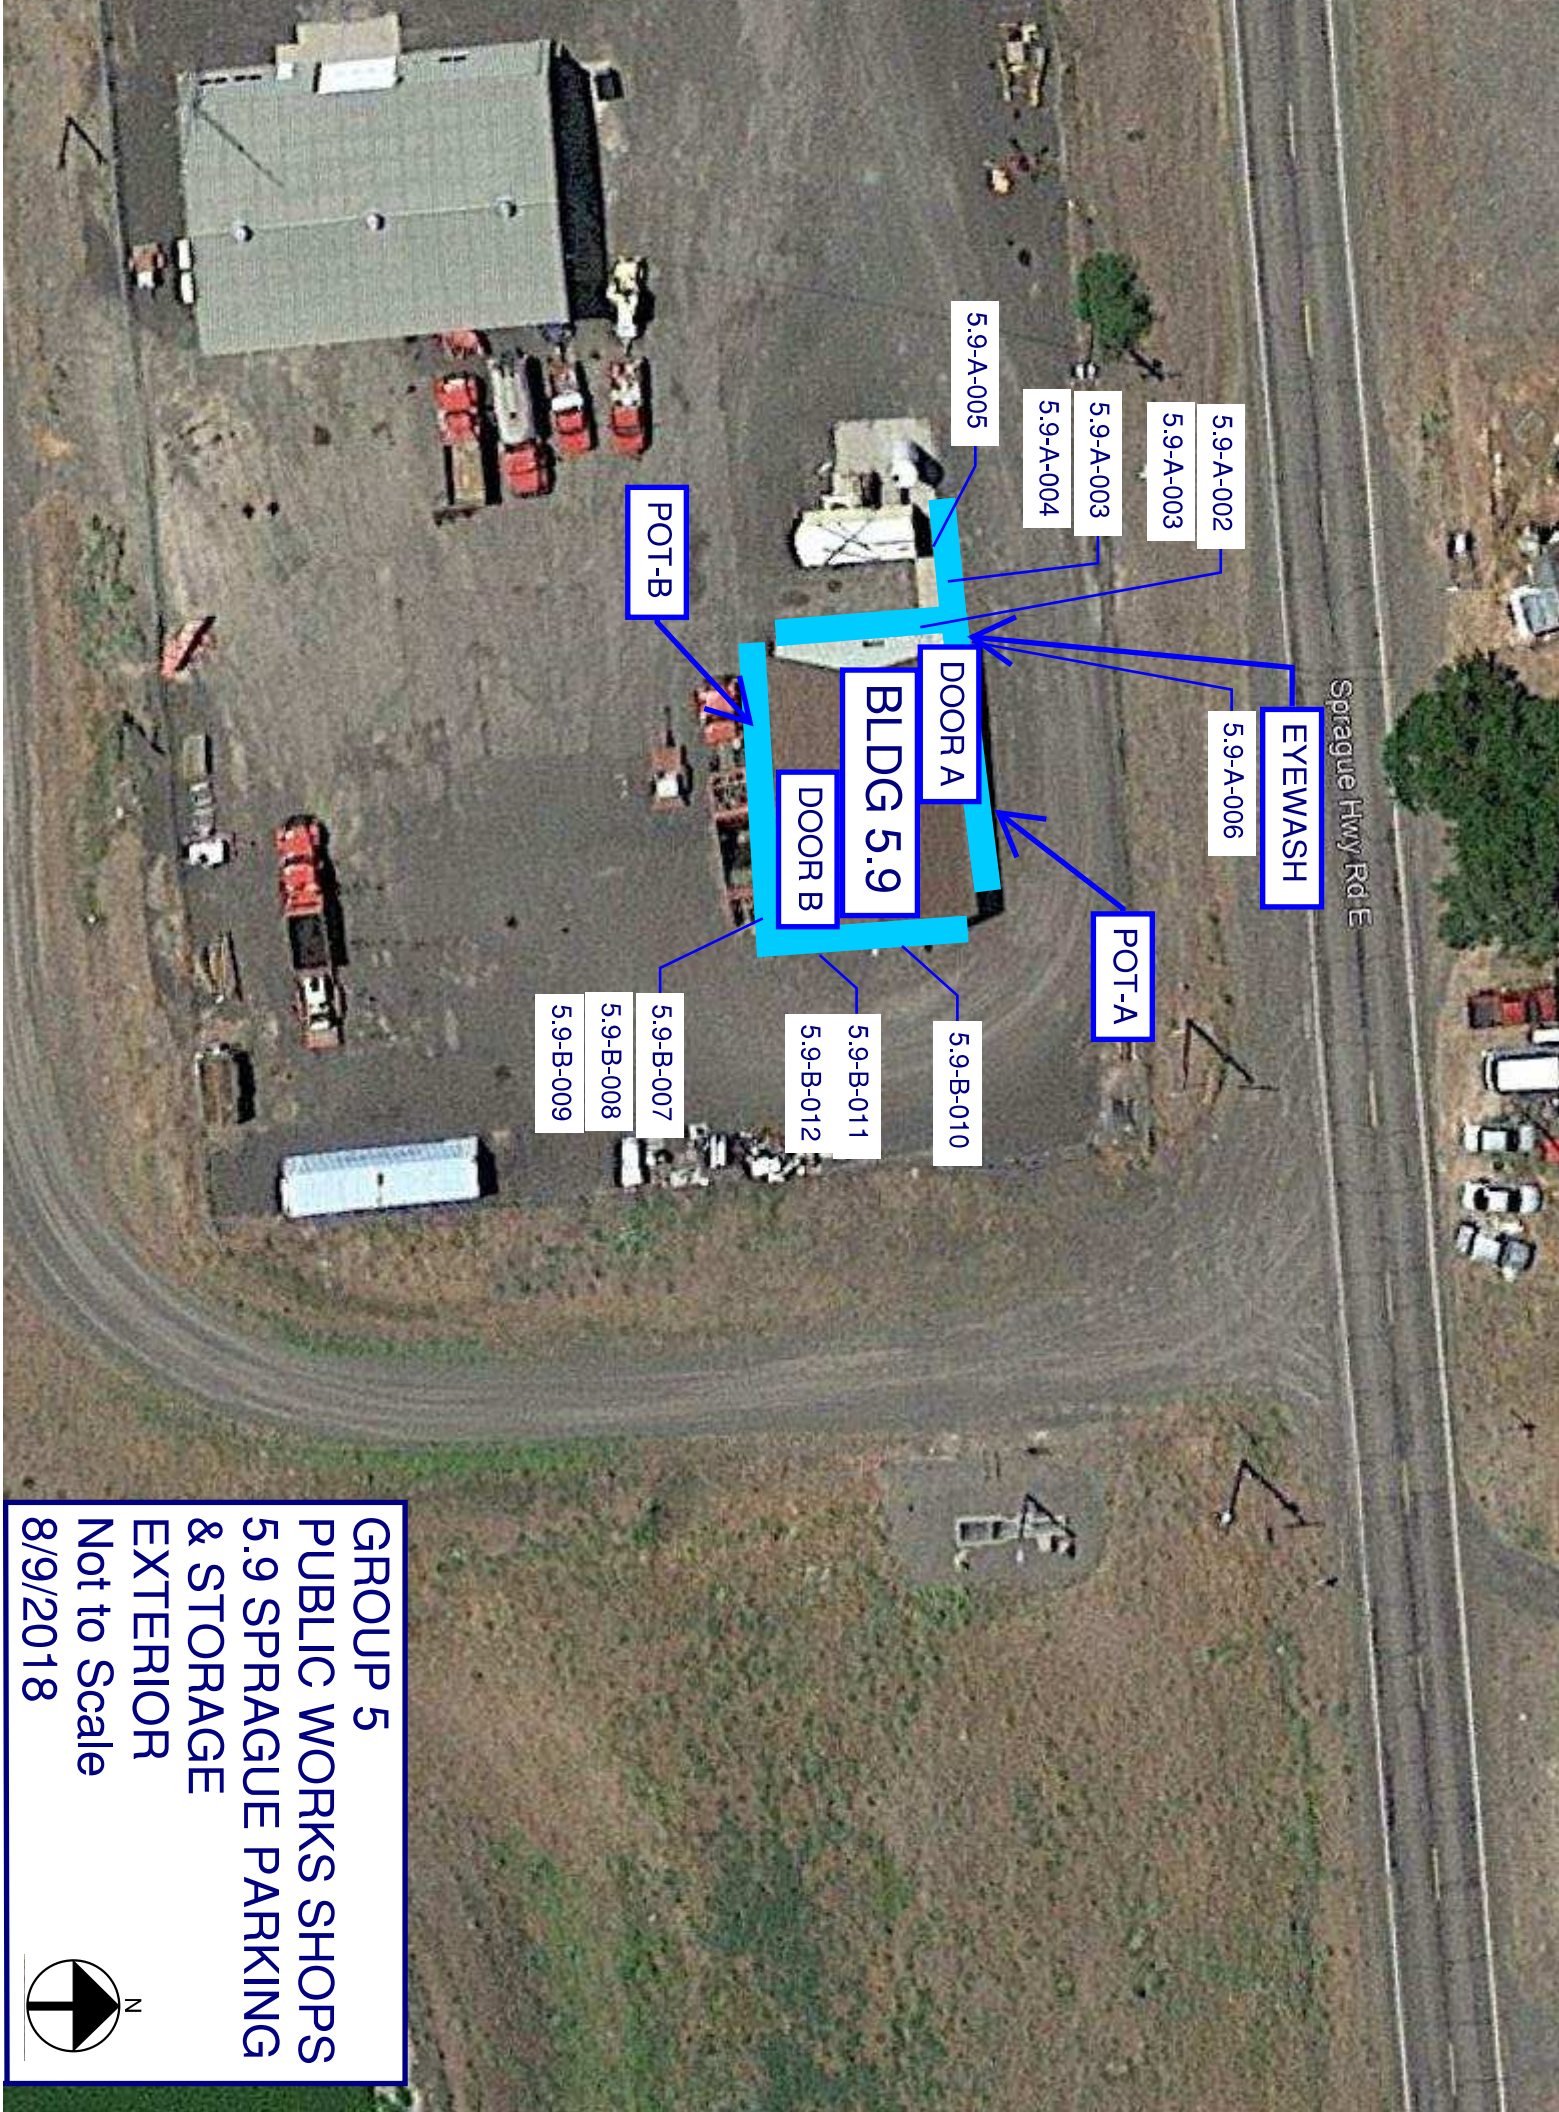
GROUP 5
PUBLIC WORKS SHOPS
5.8 SPRAGUE SHOP
EXTERIOR
Not to Scale
8/9/2018

EYEWASH
