Chehalis-Centralia Airport Pump Station Replacement Project Performs Flawlessly [Chehalis, WA]

The Chehalis-Centralia Airport Pump Station Replacement Project involves the design and replacement of the WWII-era Airport pump station located at the northeast corner of the Chehalis-Centralia Airport property. During the 2007 flood event, the pump house was submerged, failed to operate (i.e., pump), and was subsequently shut down. This in turn necessitate breaching to existing airport levee to let the water out. The new pump design includes a redundant pump in case the primary pump fails during a significant flooding event.

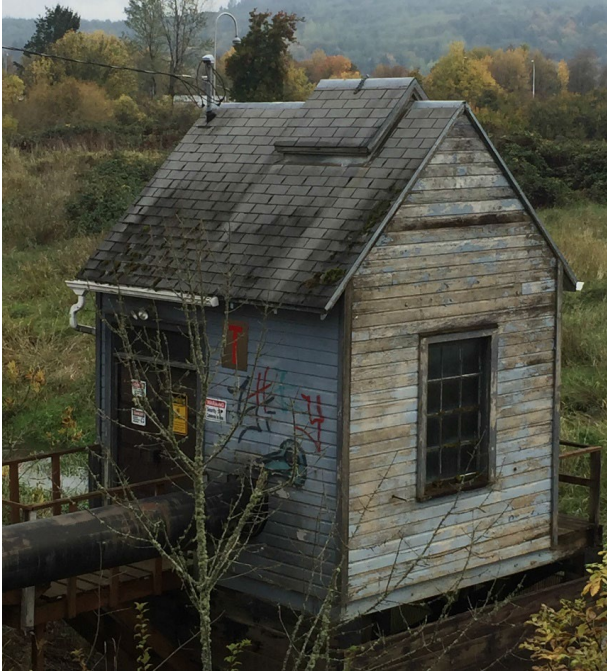
Figure 1 – Before, 1940's ear pump station

The Chehalis-Centralia Airport was one of many casualties as a result of the December 2007 flood. Failure of the 1940's WWII era pump necessitated a breaching of the airport levee and further added to the catastrophic impact and delayed recovery from the 2007 event.

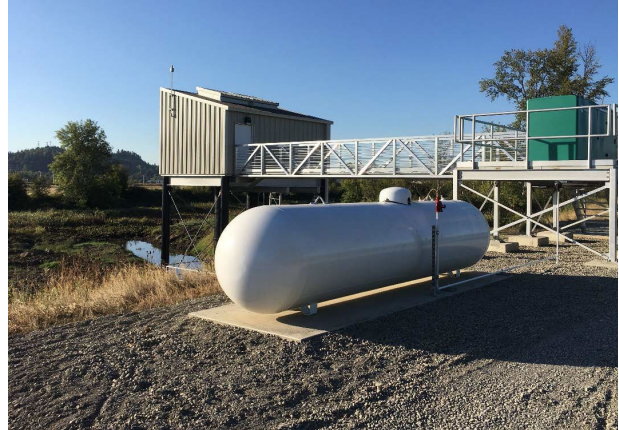
Figure 2 – After, today's pump station

The purpose of the Airport Pump Project was to replace an aged WWII-era levee pump station located inside the levee at the northeast corner of the airport with a new modernized and flood-proofed redundant pump station with back-up generator and substantially greater pumping power. The new pump station has two new electric pumps capable of pumping 10,000 to 12,000 gallons per minute, a new generator capable of supplying electricity to the pump station in the event the local electrical grid should fail, and auxillary back-up pump capacity.
