Redmond Paired Watershed Study

Water Year 2022 Data Summary Report

Prepared for
City of Redmond

Prepared by
Herrera Environmental Consultants, Inc.

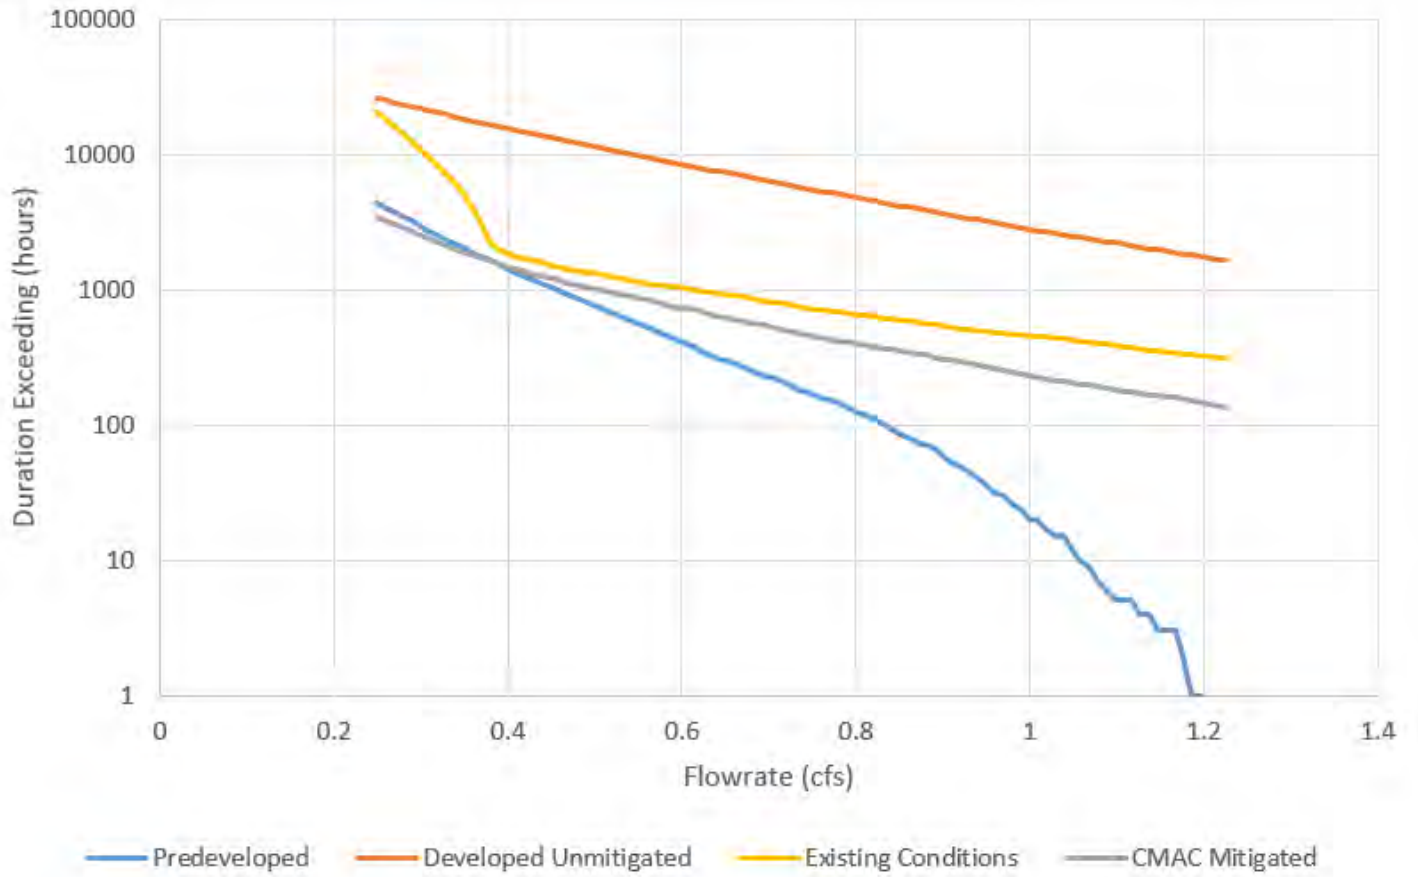
City of Redmond
CMAC Retrofit Pilot Project
Flow Duration Plot
Curry Pond

Note: Flow durations were brought as close as possible to pre-developed durations by adjusting the active orifice sizes and CMAC control parameters. Passing conditions could not be achieved for all flow durations because of the volume of the existing ponds.

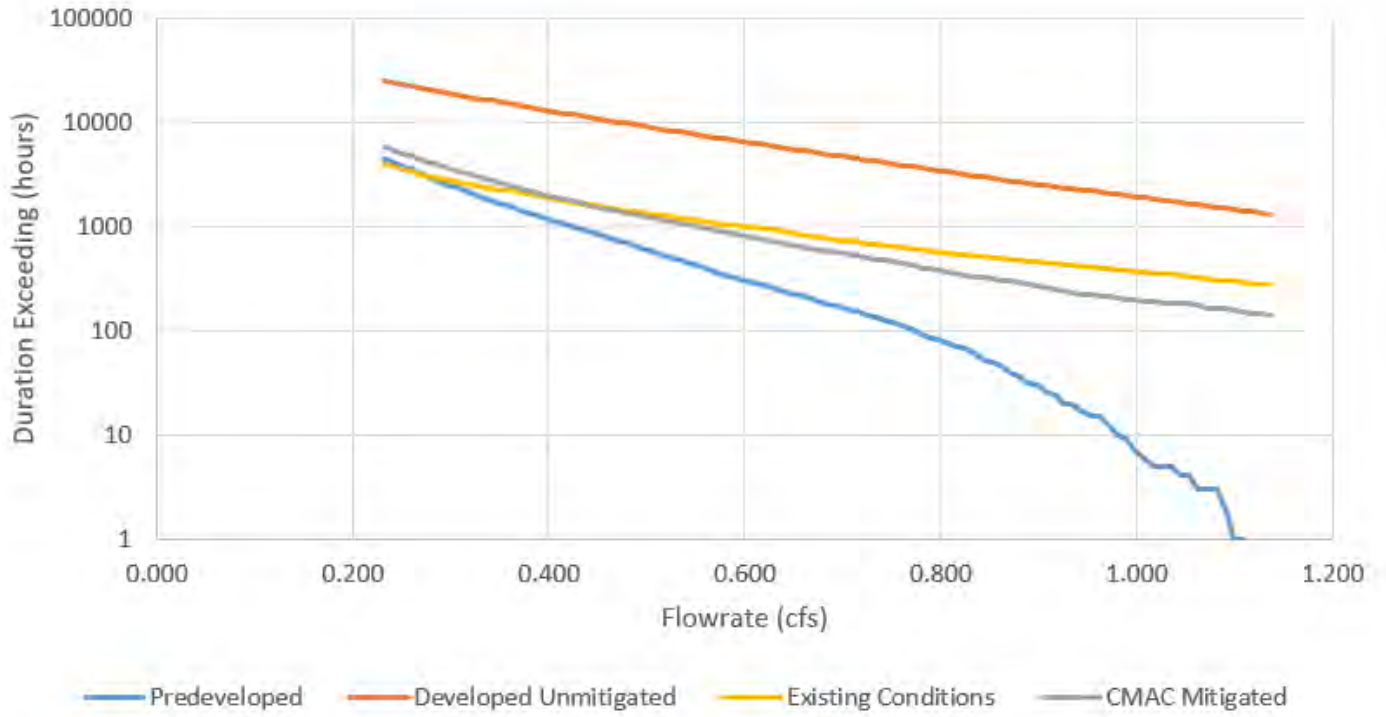
City of Redmond
CMAC Retrofit Pilot Project
Flow Duration Plot
Taloora Aye Pond

Note: Flow durations were brought as close as possible to pre-developed durations by adjusting the active orifice sizes and CMAC control parameters. Passing conditions could not be achieved for all flow durations because of the volume of the existing ponds.

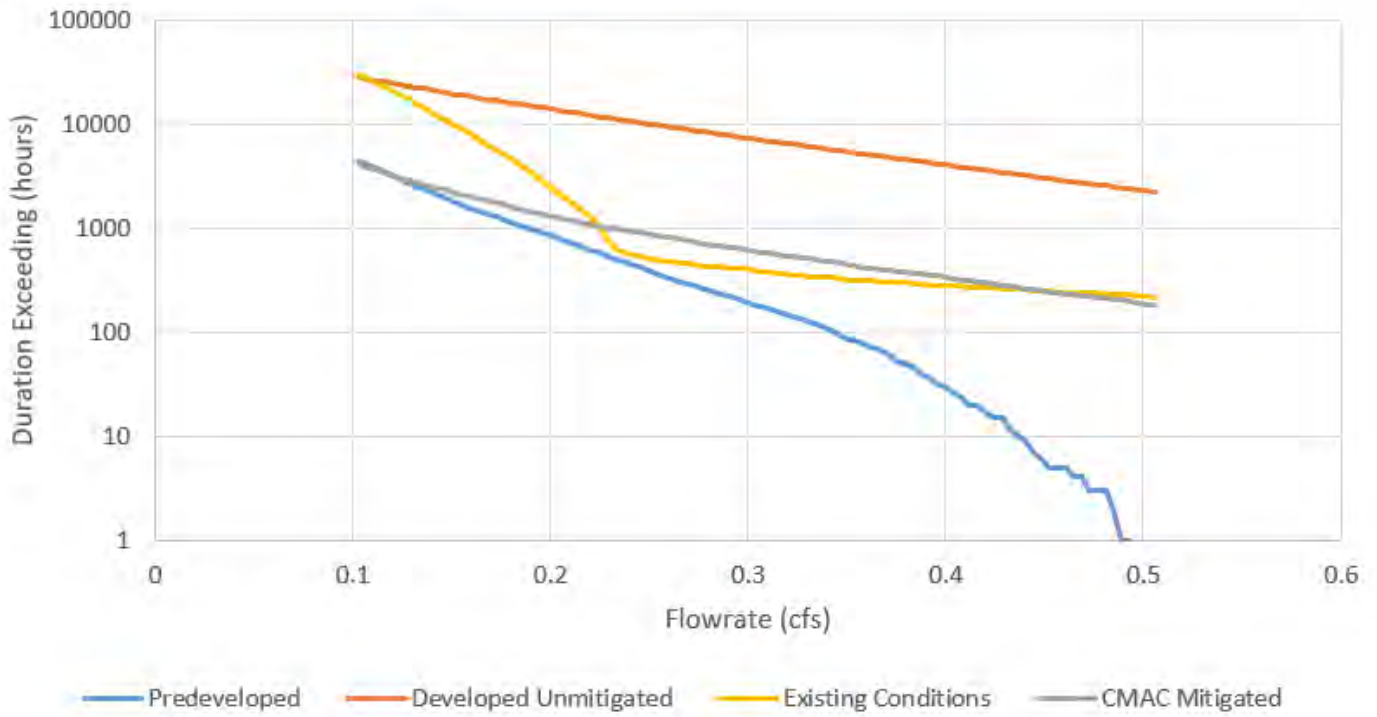
City of Redmond
CMAC Retrofit Pilot Project
Flow Duration Plot
Fischer Village Pond 1

Note: Flow Parameters were brought as close as possible to pre-developed durations by adjusting the active orifice sizes and CMAC control parameters. Passing conditions could not be achieved for all flow durations because of the volume of the existing ponds.
